Safety Recall Code: 42L2

Suspension Strut

January 28, 2022

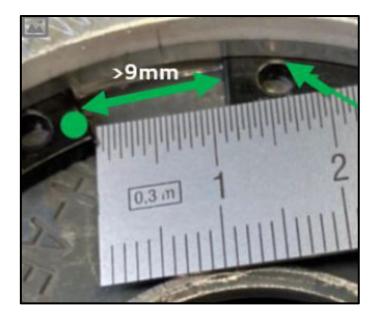
Repair Overview

A retaining ring on top of the suspension strut could come loose due to a potentially insufficient notch. If the retaining ring on top of the suspension strut gets loose, the air within the pneumatic spring will be released, leading to a loss of ride comfort accompanied by a drop in ride height on the affected suspension strut. Vehicle handling capabilities could be affected, increasing the risk of a crash.

- Check BOTH front air suspension strut circlips.
- Replace strut(s), if necessary.

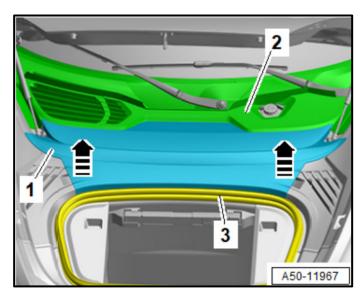
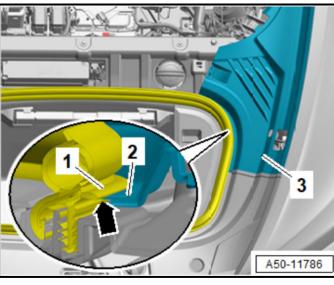
Section B - Air Strut Circlip Inspection

- If the measured distance of the circlip is less than 9 mm and/or if the two holes on the circlip are not in direct contact with the flange:
 - The affected strut must be replaced.
 - Proceed to Section C.

Remove front plenum chamber cover:

- Loosen the plenum chamber cover <1> out of the catches in direction of <arrows> and remove it from the luggage compartment seal <3>.
- Remove the front plenum chamber cover forward in the direction of travel out of the plenum chamber cover <2>.
