Safety Recall

Code: 90S9

Subject	Gateway Control Module																									
Release Date	March 08, 2023																									
REVISION SUMMARY	Added additional sealant part number																									
Affected Vehicles

Subject: Safety Recall 90S9 – Gateway Control Module

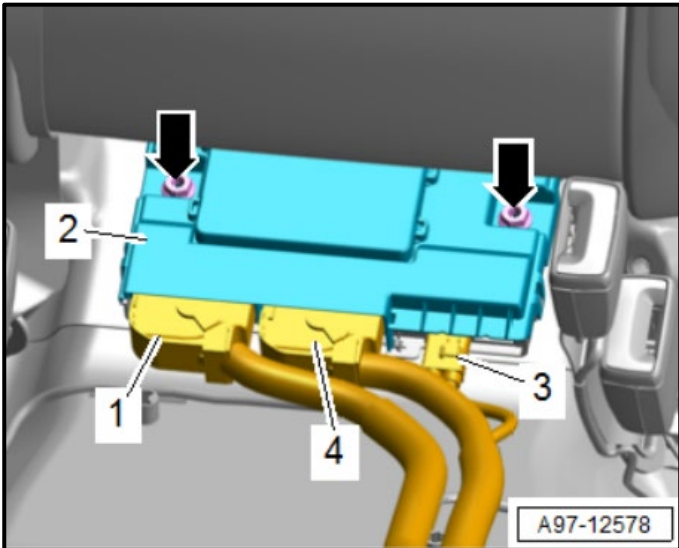
Unbolt gateway control module:

The electrical connectors remain connected.

- Remove and discard the nuts <arrows>.

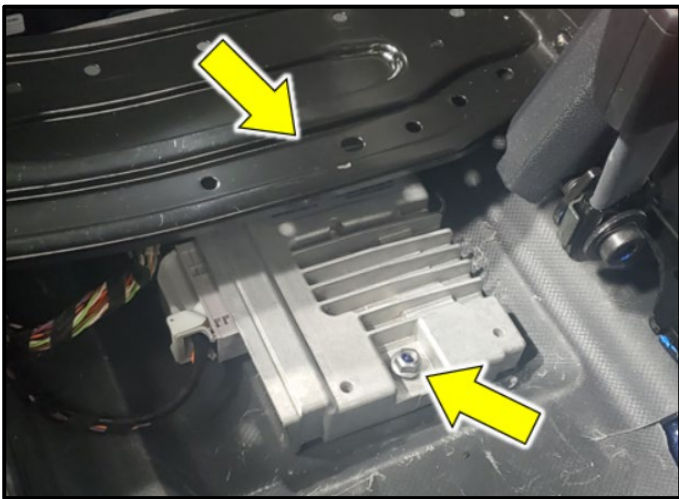
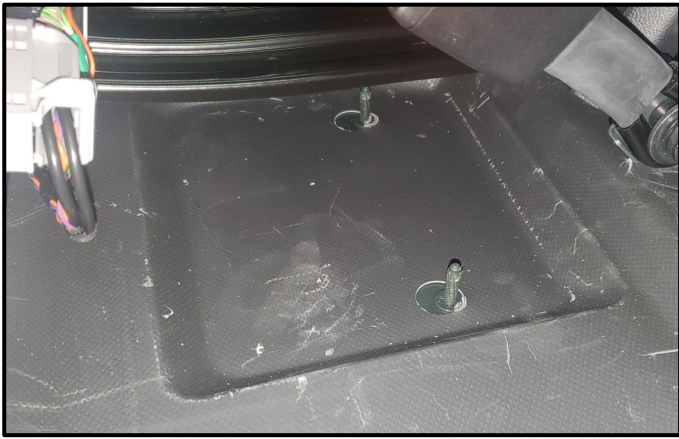
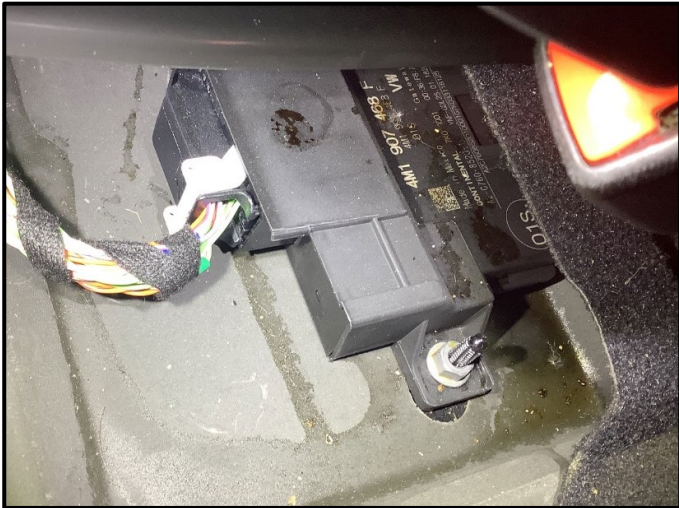
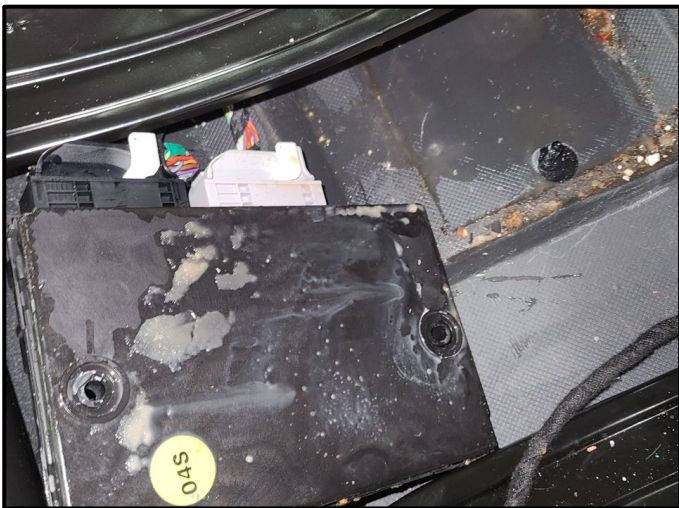
- Inspect the recessed well that the gateway was in.
- If any liquid or traces of liquid are present:
 - Take photos showing liquid or traces of liquid are present.
 - U.S. Dealers - Upload photos to Doc-It.
 - Canada Dealers - Upload photos to an ATA WEB Ticket
 - The gateway control module must be replaced.
 - The connector pins must be inspected and any corroded pins replaced.

If liquid is found on gateway, it is not necessary to contact Audi Warranty.
 If photos are not uploaded to Doc-It (U.S. Dealers) or to an ATA WEB Ticket (Canadian dealers), the claim for the gateway control module will be cancelled.

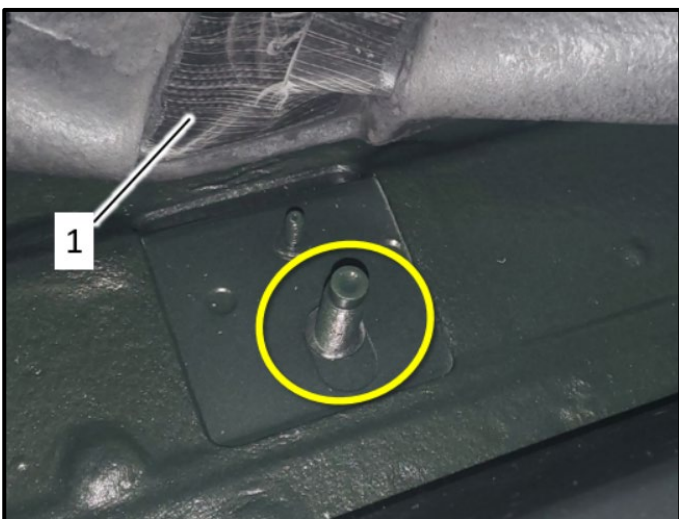
- The stud and area requiring sealant shown <circle>.

- Position floor insulation <1> out of the way.
- Ensure area is free of dirt and debris.
- Clean area to be sealed <circle> with isopropyl alcohol.
- Allow cleaning solution to completely dry.
