Product Safety Recall

N202324251 Roof Rail Air Bag Inflator May Rupture

Release Date: July 2022

Revision: 04

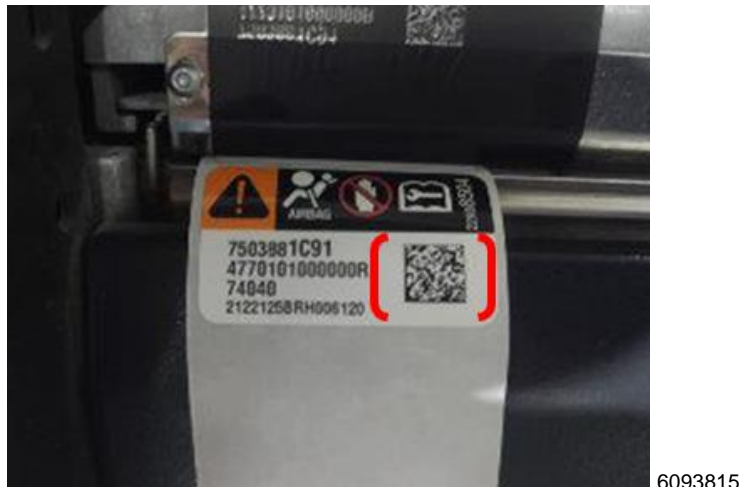
Please center ONLY the QR Code within the Red Brackets as seen below. If the scan function is inaccurate, please use the guide below for entering the information manually into the RPT fields.

From the recall example photo above:

Part Number: 7503881C91
