Product Safety Recall

N202324251 Roof Rail Air Bag Inflator May Rupture

Release Date: June 2022

Revision: 03

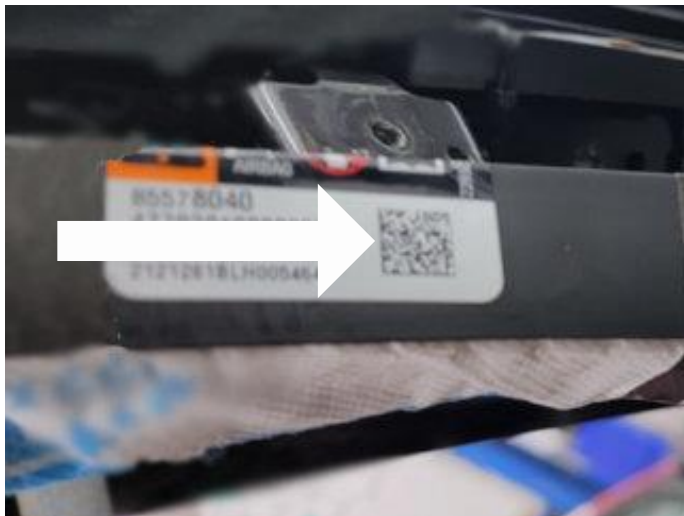
6058856

IMPORTANT: See the Roof Rail Airbag Serial Number Recording section above before installing the roof rail airbag assemblies.

1. Replace the left and right front and rear row seat roof rail airbag. Refer to *Front and Rear Row Seat Roof Rail Airbag Replacement* in SI.
2. Handle the removed airbag modules as follows:
Scrap the airbag modules. **The removed airbag assemblies must be deployed immediately upon removal from the vehicle.** Refer to *Inflatable Restraint Module Handling and Scrapping* in SI.
