Product Safety Recall

N202324251 Roof Rail Air Bag Inflator May Rupture

Release Date: May 2022

Revision: 02

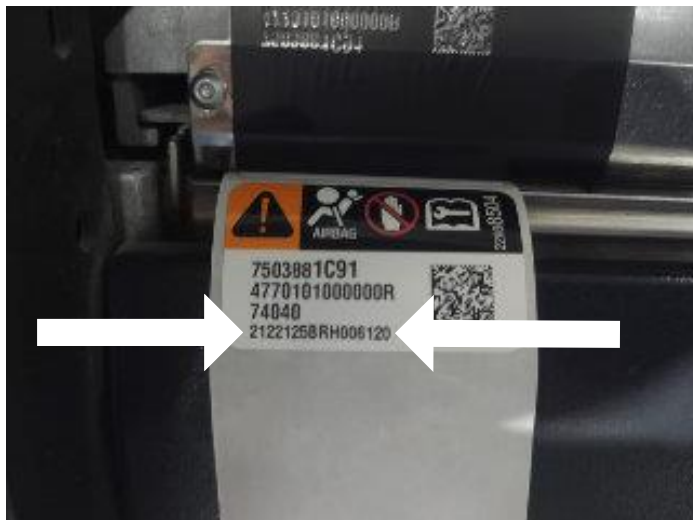
6070604

IMPORTANT: * (TECHNICIAN and WARRANTY ADMINISTRATOR) SERIAL NUMBER RECORDING REQUIREMENT. The replacement left and right roof rail airbag assembly serial numbers must be captured by the technician and recorded on the job card. The Warranty Administrator **MUST** enter the replacement left and right roof rail airbag assembly serial numbers in GWM (Global Warranty Management) or in DMS (Dealer Management System). Enter the serial number of the **replacement RIGHT roof rail airbag** in the 'Labor Operation Dependency Code' field (1) per the screen above. Enter the **serial number of the LEFT roof rail airbag** in the 'General Comments' comments section. Failure to enter these serial numbers will cause the claim to reject.

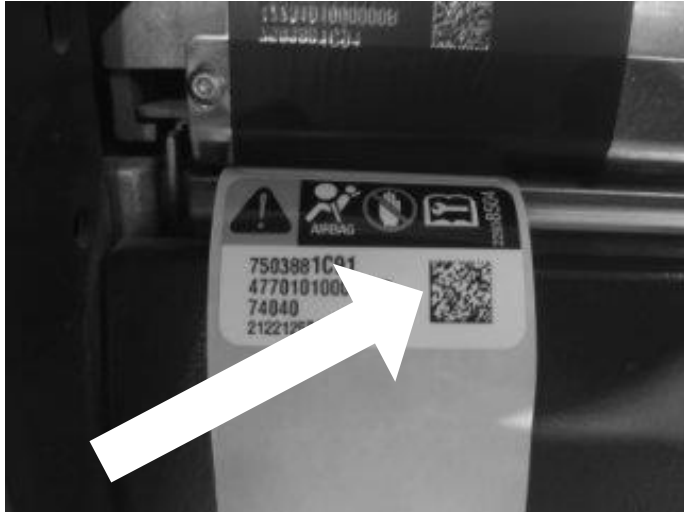
6070519

IMPORTANT NOTE: Since there are 2 new parts being installed for this recall remedy, you are **REQUIRED** to use RPT to:

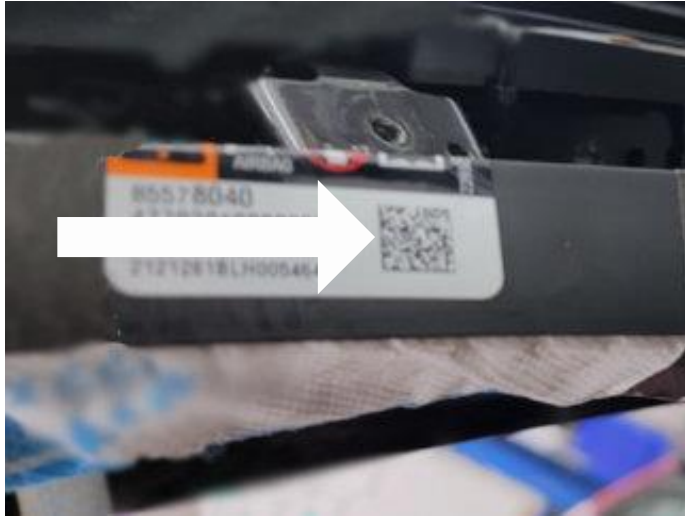
6058856

IMPORTANT: See the Roof Rail Airbag Serial Number Recording section above before installing the roof rail airbag assemblies.

1. Replace the left and right front and rear row seat roof rail airbag. Refer to *Front and Rear Row Seat Roof Rail Airbag Replacement* in SI.
2. Handle the removed airbag modules as follows:
Scrap the airbag modules. **The removed airbag assemblies must be deployed immediately upon removal from the vehicle.** Refer to *Inflatable Restraint Module Handling and Scrapping* in SI.
