Stacy L. Balzer
 Operating Director
 Service Engineering Operations
 Ford Customer Service Division

December 14, 2022

SUBJECT: **NEW VEHICLE DEMONSTRATION / DELIVERY HOLD**
Safety Recall 22S06 - Supplement #2
 Certain 2015-2017 Model Year Mustang Vehicles
 Luggage Compartment Lid Wiring Inspection and Rear View Camera Improper Function

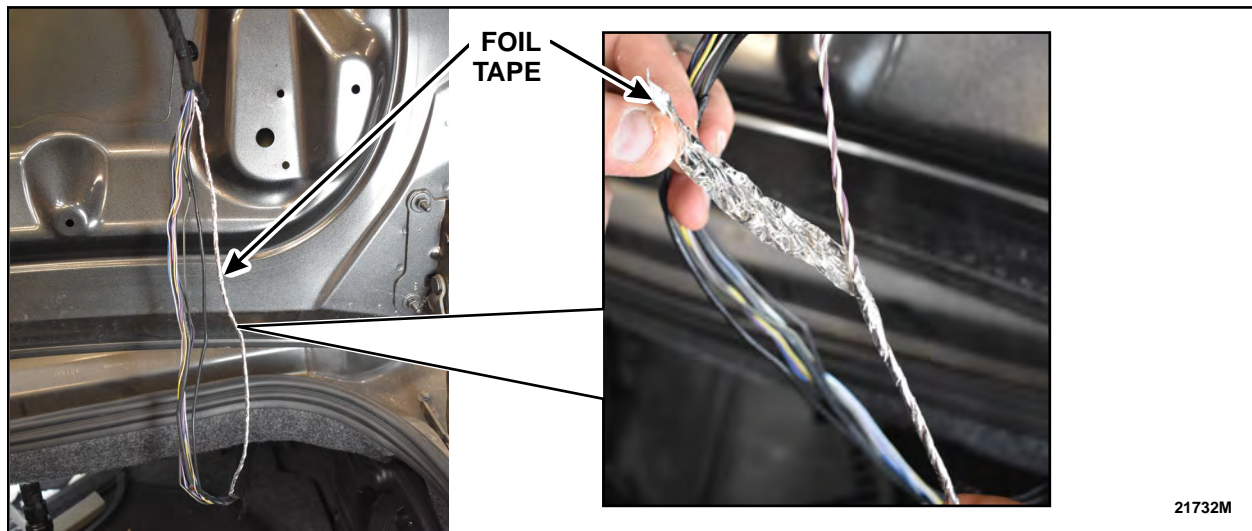
FIGURE 14

19. Inspect the entire exposed portion of the wiring harness for any sign(s) of damage or chafing.

See Figure 14.

NOTE: One example of wiring damage, others similar.

20. Cut out the damaged section of the harness. Make the cut at the location of the harness noted. See Figure 16.

21. Splice in the *new* section of harness, matching wire colors on the existing vehicle harness and the replacement section of harness as necessary. Follow the recommended wiring splice procedures in Section 5 of the Wiring Diagram using solder not wire crimps. Stagger the location of each of the wire splices along the harness to minimize the overall size of the repair.
