March 16, 2022

**SUBJECT: NEW VEHICLE DEMONSTRATION / DELIVERY HOLD
 Safety Recall 22S06**

Certain 2015-2017 Model Year Mustang Vehicles
 Luggage Compartment Lid Wiring Inspection and Rear View Camera Improper
 Function

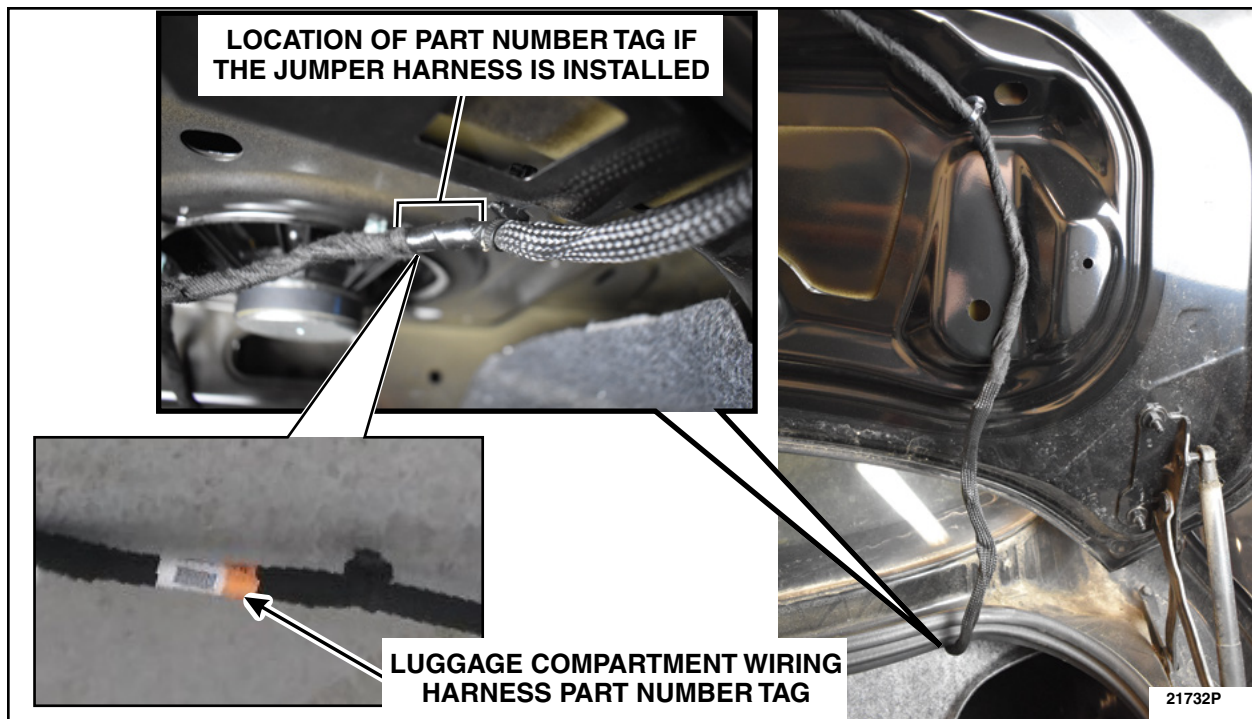
FIGURE 1

1. Open the luggage compartment lid of the vehicle.
2. Inspect the luggage compartment wiring harness, after the first wire harness push pin retainer, within the luggage compartment for a part number tag. See Figure 1.
 - Is a part number tag located on the luggage compartment wiring harness?

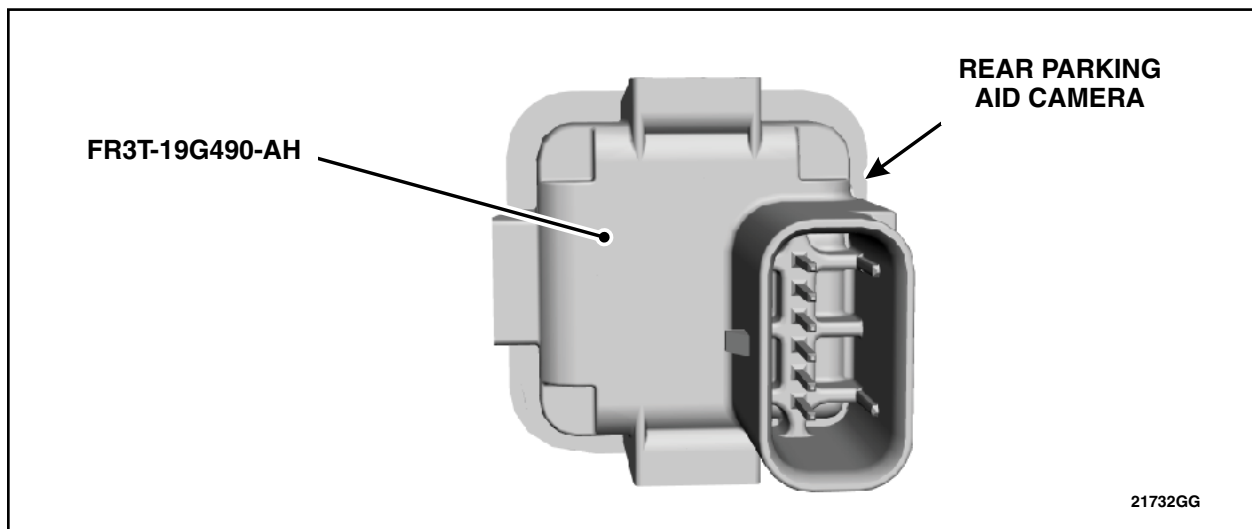
FIGURE 2

3. Remove the Rear Parking Aid Camera. Please follow the Workshop Manual (WSM) procedures in Section 413-13B.
4. With the rear parking aid camera out of the vehicle, inspect the engineering part number on the back of the camera. See Figure 2.
 - Is the part number FR3T-19G490-AH?
 - YES - Reinstall the Rear Parking Aid Camera. Please follow the WSM procedures in Section 413-13B. Do not install the luggage compartment lid trim at this time. Proceed to Step 6.
 - NO - Replace the Rear Parking Aid Camera. Please follow the WSM procedures in Section 413-13B. Do not install the luggage compartment lid trim at this time. Proceed to Step 5.

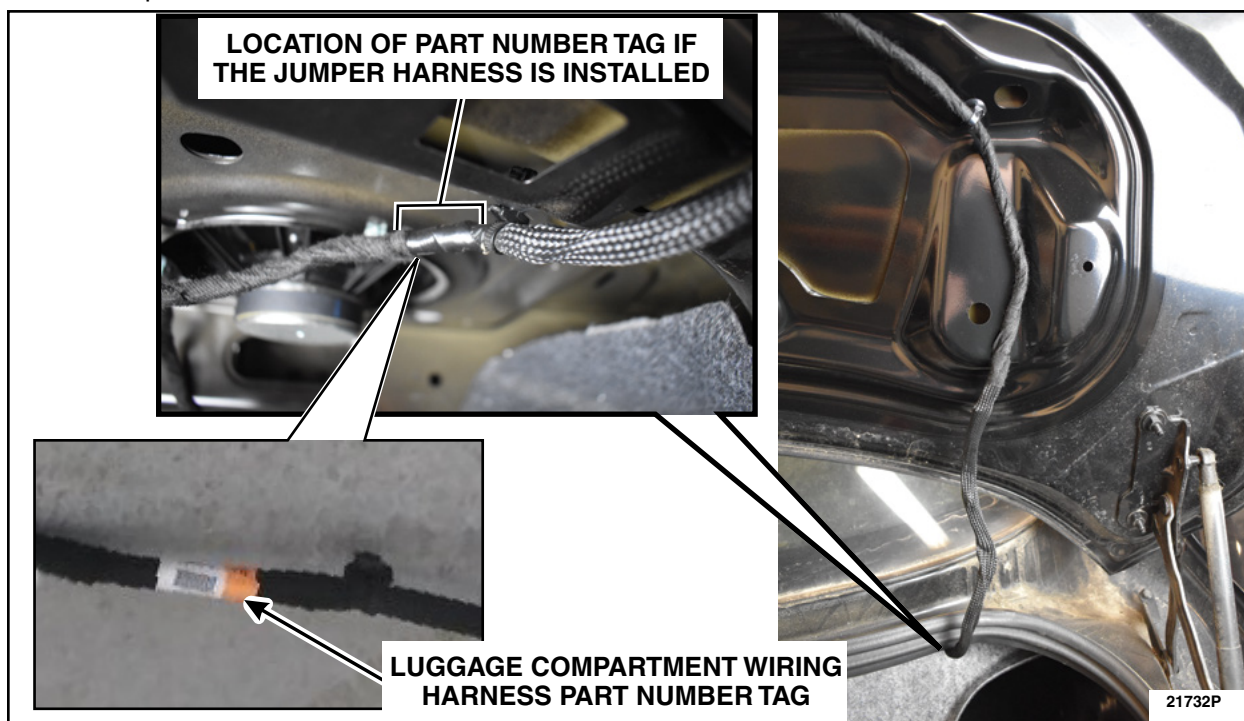
FIGURE 3

6. Inspect the luggage compartment wiring harness, after the first wire harness push pin retainer, within the luggage compartment for a part number tag. See Figure 3.
