Stacy L. Balzer
 Operating Director
 Service Engineering Operations
 Ford Customer Service Division

August 31, 2023

SUBJECT: **NEW VEHICLE DEMONSTRATION / DELIVERY HOLD**
Safety Recall 22S06 - Supplement #3
 Certain 2015-2017 Model Year Mustang Vehicles
 Luggage Compartment Lid Wiring Inspection and Rear View Camera Improper Function

Luggage Compartment Lid Wiring Inspection and Rear View Camera Improper Function

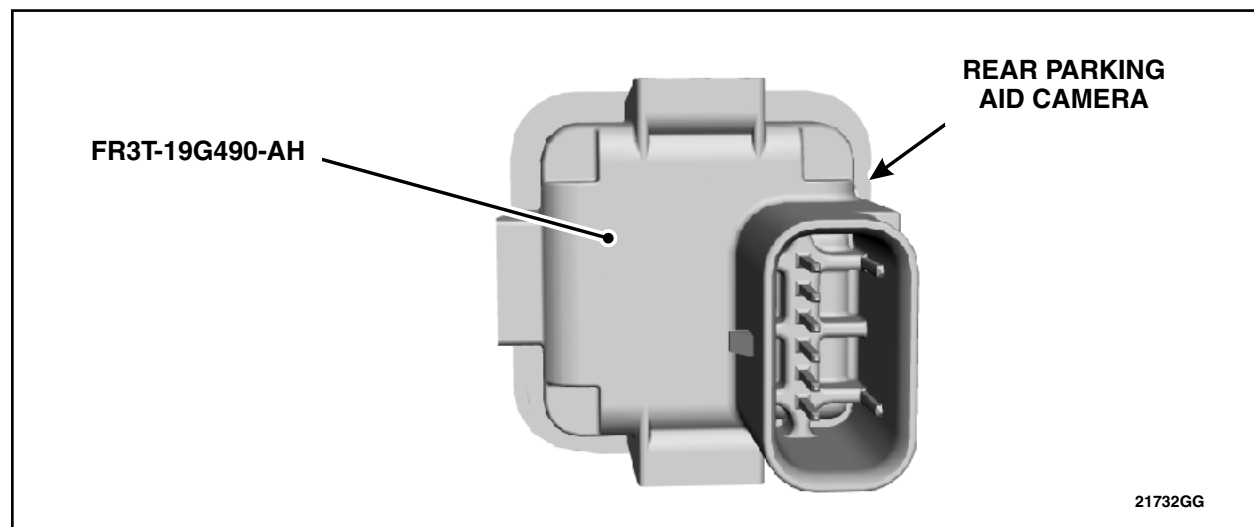
FIGURE 1

3. With the rear parking aid camera out of the vehicle, inspect the engineering part number on the back of the camera. See Figure 1.

YES - Reinstall the Rear Parking Aid Camera. Please follow the WSM procedures in Section 413-13B. Do not install the luggage compartment lid trim at this time. Proceed to Step 4.

NO - Replace the Rear Parking Aid Camera. Please follow the WSM procedures in Section 413-13B. Do not install the luggage compartment lid trim at this time. Proceed to Step 4.

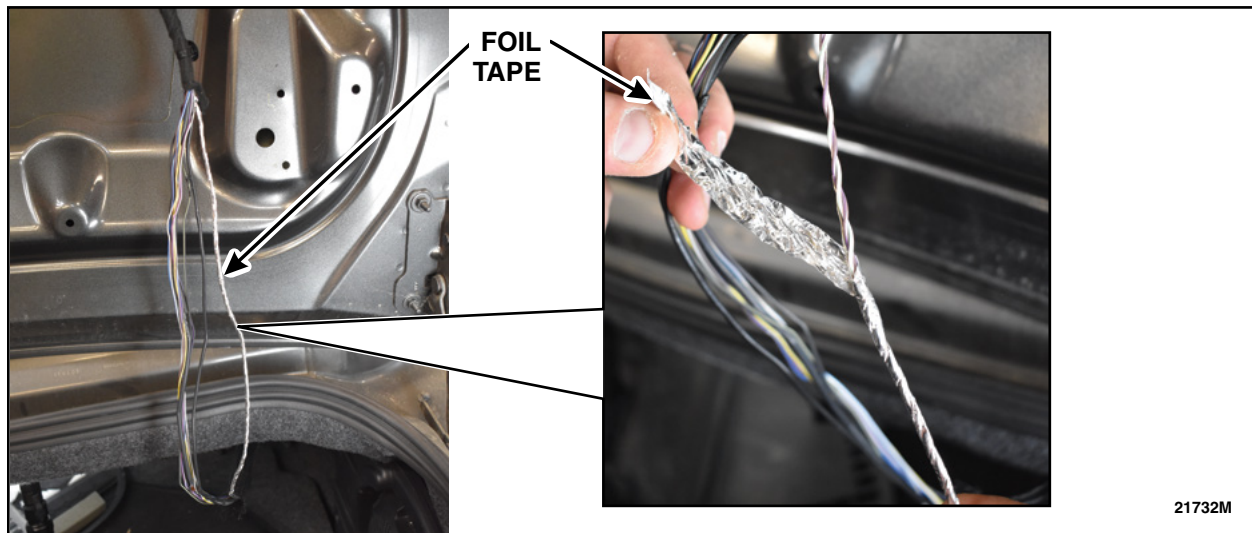
FIGURE 14

19. Inspect the entire exposed portion of the wiring harness for any sign(s) of damage or chafing.
See Figure 14.

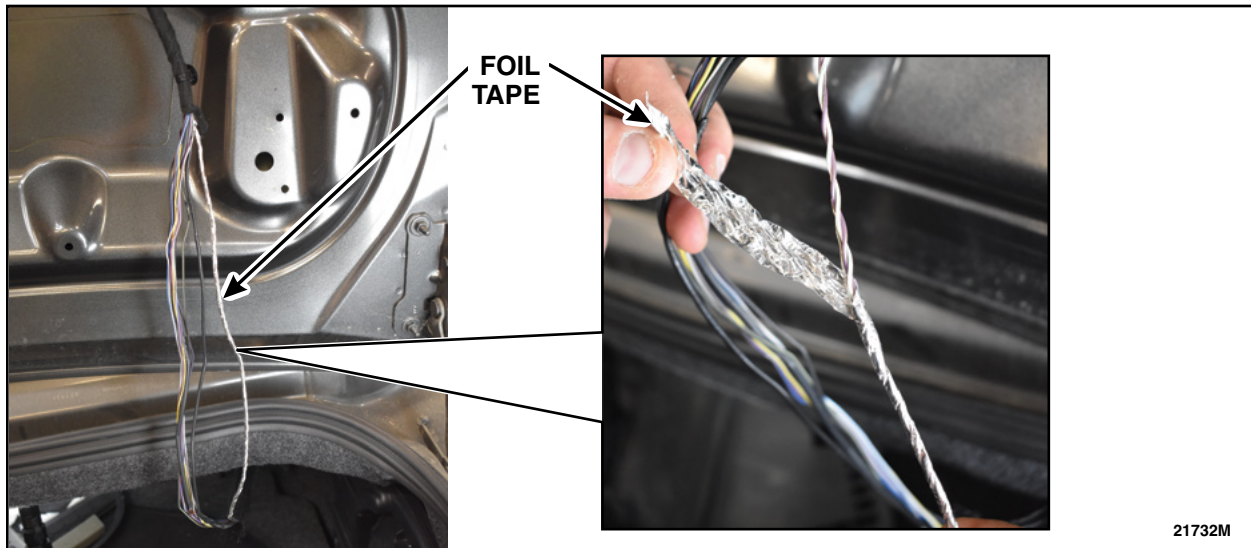
FIGURE 38

52. Inspect the entire exposed portion of the wiring harness for any sign(s) of damage or chafing.

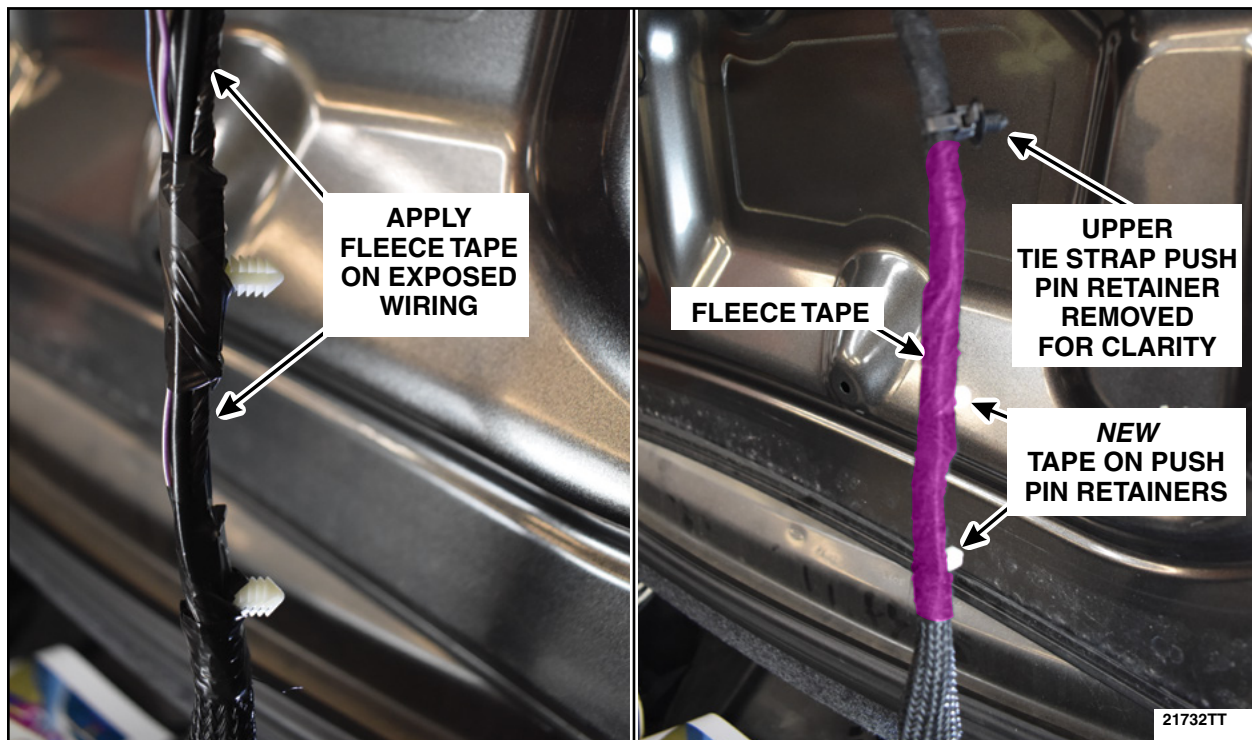
FIGURE 53

NOTE: Upper tie strap push pin retainer disconnected for clarity.

72. Wrap the remaining exposed wiring starting at the first new tape on push pin retainer after the mesh sleeve up to the upper tie strap push pin retainer using Tesa® 51608 PET Fleece or equivalent fleece tape. See Figure 53.
