SUBJECT: **NEW VEHICLE DEMONSTRATION / DELIVERY HOLD**
Safety Recall 22S06 - Supplement #1
 Certain 2015-2017 Model Year Mustang Vehicles
 Luggage Compartment Lid Wiring Inspection and Rear View Camera Improper Function

Safety Recall 22S06 - Supplement #1

Certain 2015-2017 Model Year Mustang Vehicles

Luggage Compartment Lid Wiring Inspection and Rear View Camera Improper Function

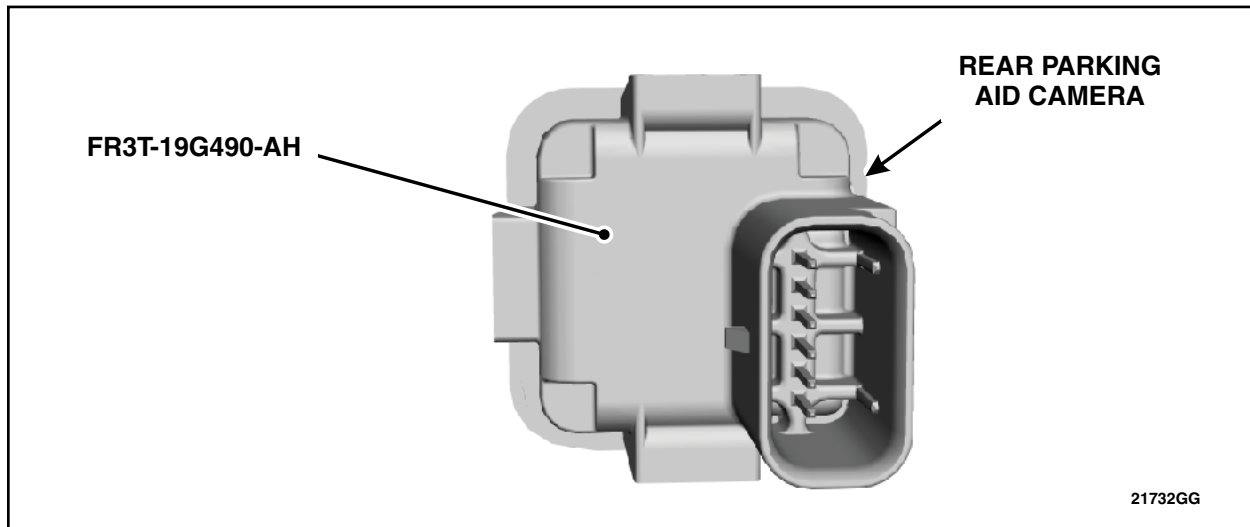
FIGURE 1

4. With the rear parking aid camera out of the vehicle, inspect the engineering part number on the back of the camera. See Figure 1.

YES - Reinstall the Rear Parking Aid Camera. Please follow the WSM procedures in Section 413-13B. Do not install the luggage compartment lid trim at this time. Proceed to Step 6.

NO - Replace the Rear Parking Aid Camera. Please follow the WSM procedures in Section 413-13B. Do not install the luggage compartment lid trim at this time. Proceed to Step 5.
