IMPORTANT RECALL CAMPAIGN UPDATE

Campaign No. 2022050015, May 2022

SUBJECT: **Model GL-Class, ML-Class, and R-Class (X164, W164 and 251 platform)
Model Year 2006-2012**

Inspect Brake Booster – without Pedal Rework

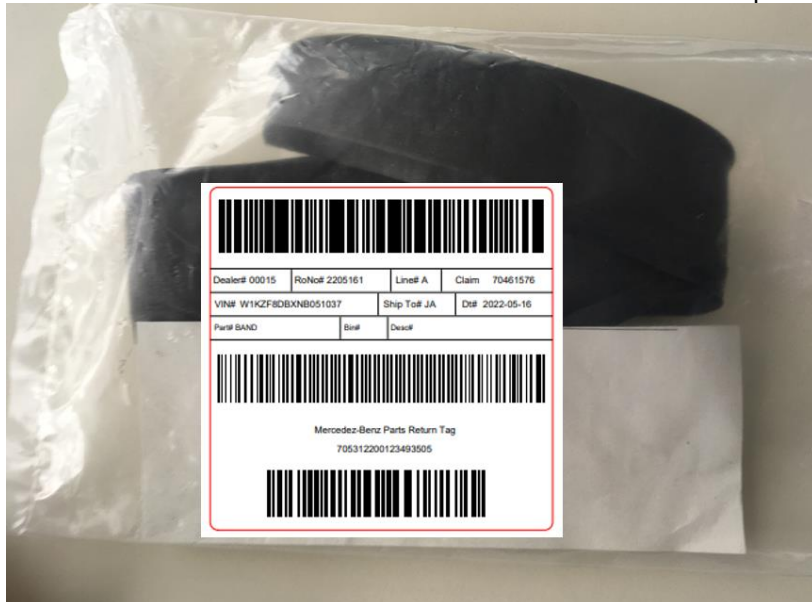
- For each vehicle processed, print out the part return barcode from the NetStar Parts Disposition application
- Pack the rubber sleeve with the part return barcode in a plastic bag and seal securely with barcode **visible from the outside** (see figure 1).
- For Dedicated Delivery Service (DDS) dealers, please forward parts in bulk (10-20 pcs per Load List unless time does not permit) to your facing PDC using the normal DDS warranty parts return process. Please ensure you include a Dealer Return slip marked for Warranty.
- For non-DDS dealers, please forward parts in bulk (10-20 pcs per Load List unless time does not permit) directly to the QEC using the normal FedEx Ground warranty parts return process.

All rubber sleeves should be individually tagged with a warranty parts return barcode and bagged. Recommend that bulk sleeve shipments are placed into a single overpack bag and then packaged in a small box with a copy of the Load List affixed to the box. Failure to return the rubber sleeve within the pre-defined time period will result in a non-return part debit.
