Safety Recall Launch Notification

Campaign #	NHTSA ID	Description	Update Communication Module SIM Card Software – Wave 4
2023110006	22V365	23P5497319

Recall Campaign Bulletin

SIM Card Communication Module – Wave 4

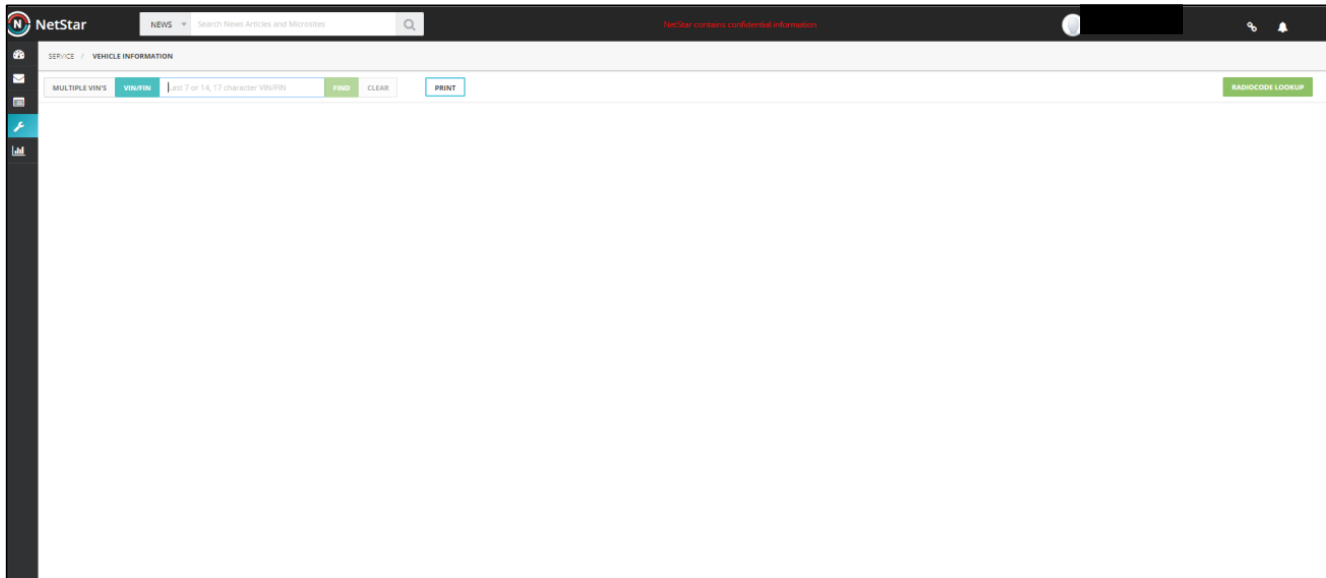
Figure 4

1. Log in to "NetStar" and call up the Vehicle Master Inquiry (VMI) screen (**Figure 4**).

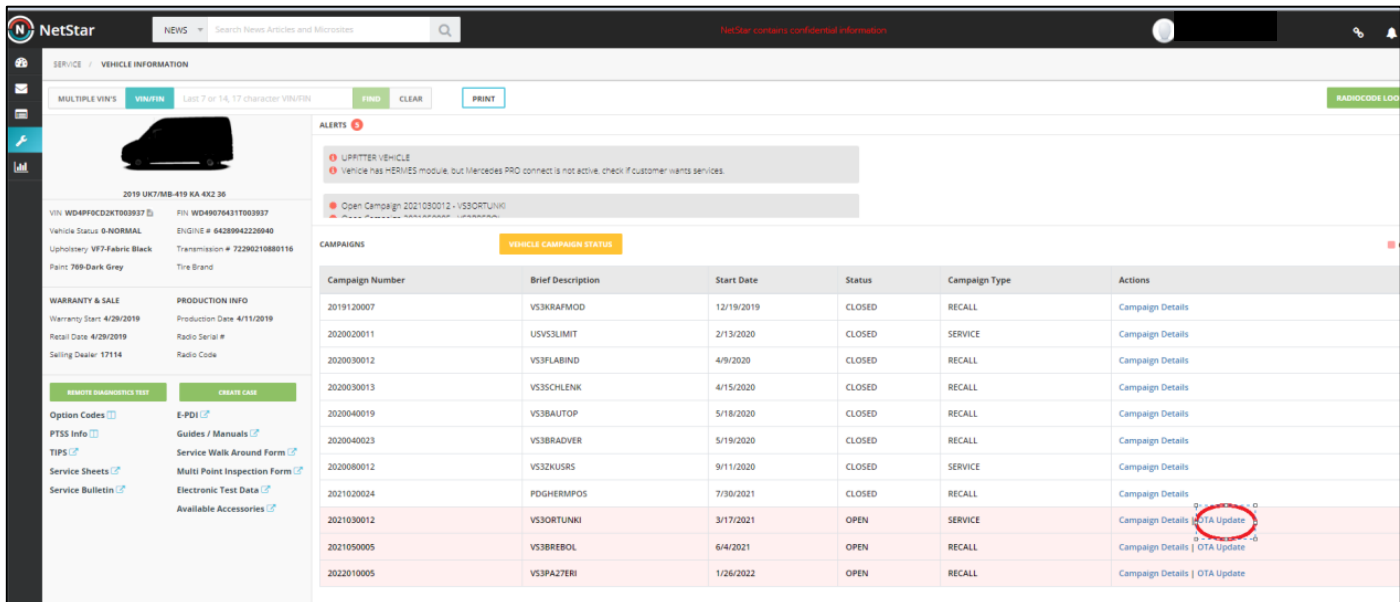
i The "OTA Update" link becomes visible in the campaign table (next to Campaign Number 2023110006) in the VMI screen when the campaign is open for the selected vehicle.

Figure 5 – In the "Actions" column, "OTA Update" is available, listed next to Campaign Number 2023110006

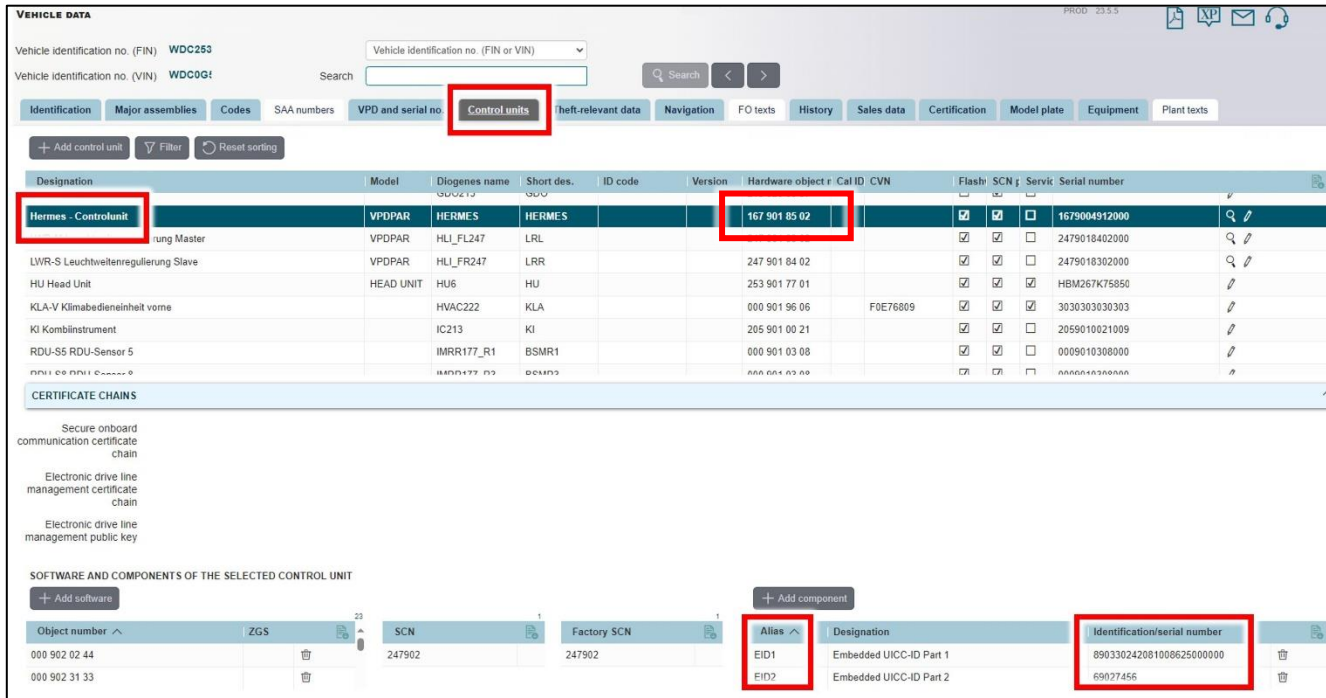
Figure 7**

**** NOTE: The HERMES Hardware object number is necessary for determining replacement part number!**
- E.g. shown in Figure 7 – Hardware object number is 167 901 85 02

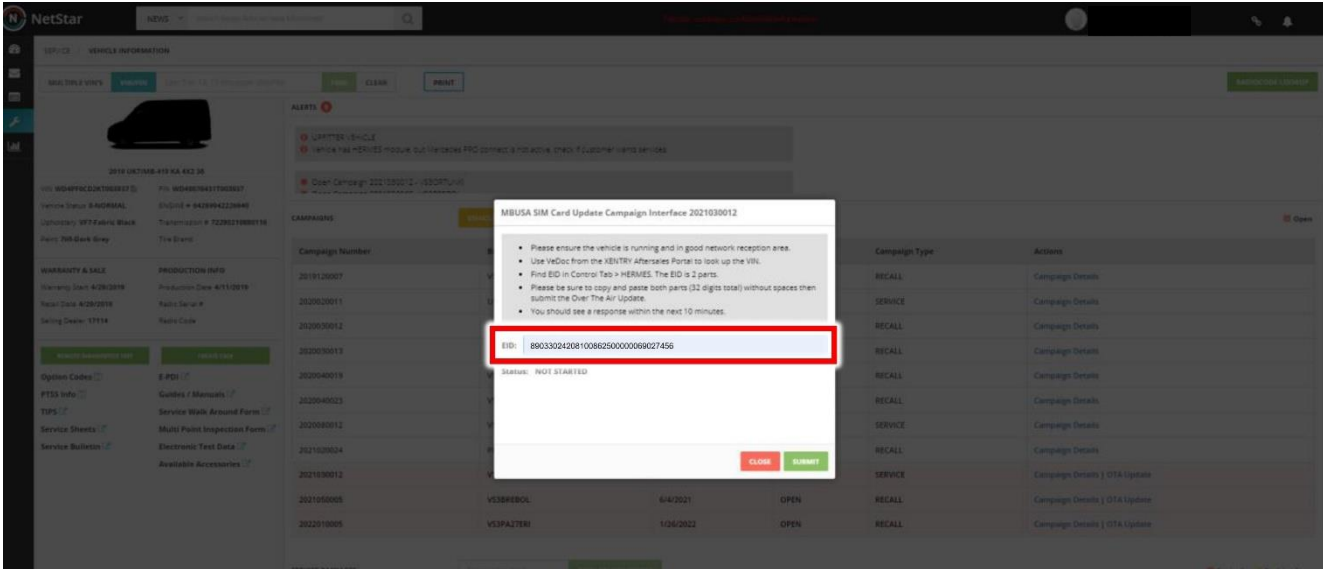
i To do this, enter the **EID1 + EID2** numbers from VeDoc **without spaces or special characters** as shown. (e.g.: 89033024208100862500000069027456 – **EXAMPLE ONLY**).

Figure 8 – EID1 + EID2 input

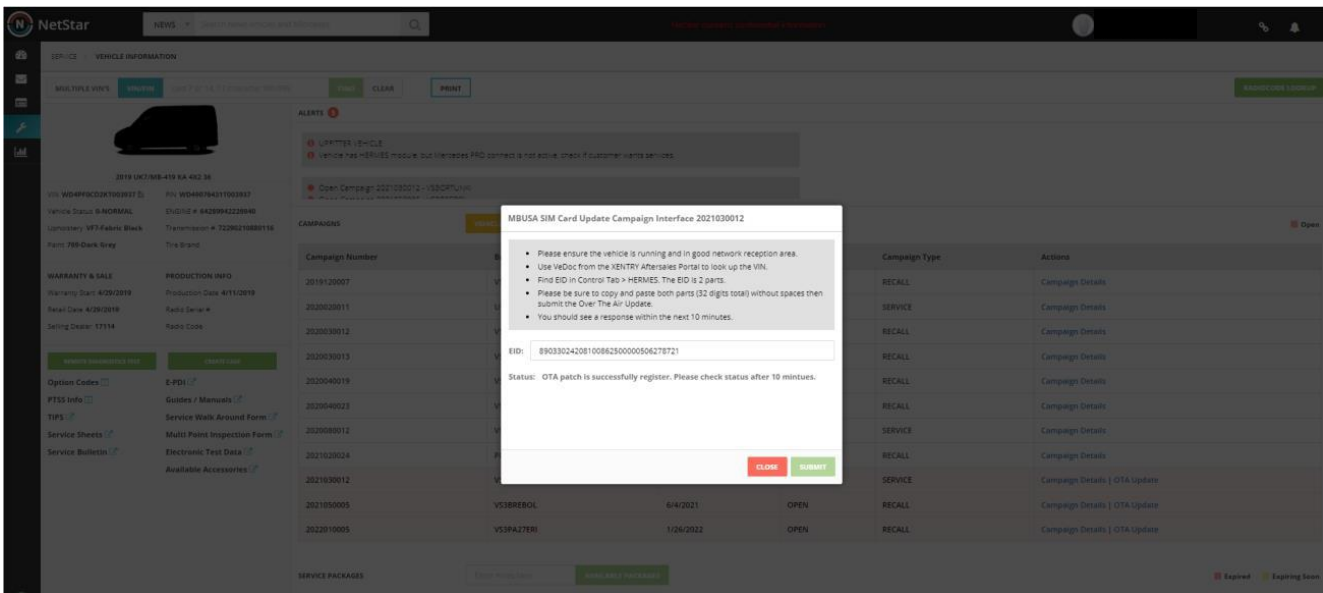
Figure 9 (screen on "NetStar" after the OTA update has been registered successfully)
Status: OTA patch is successfully registered. Please check status after 10 minutes
