David J. Johnson
 Director
 Service Engineering Operations
 Ford Customer Service Division

August 15, 2022

**SUBJECT: NEW VEHICLE DEMONSTRATION / DELIVERY HOLD -
 Safety Recall 22S53**

Certain 2021-2022 Model Year F-150 Vehicles Equipped with Crew Cab, 145" Wheelbase, 4x4, One-Piece Aluminum Driveshaft, and MFAL BHDAA (Less Sound Insulation Packs)* Loose/Sagging Underbody Insulators

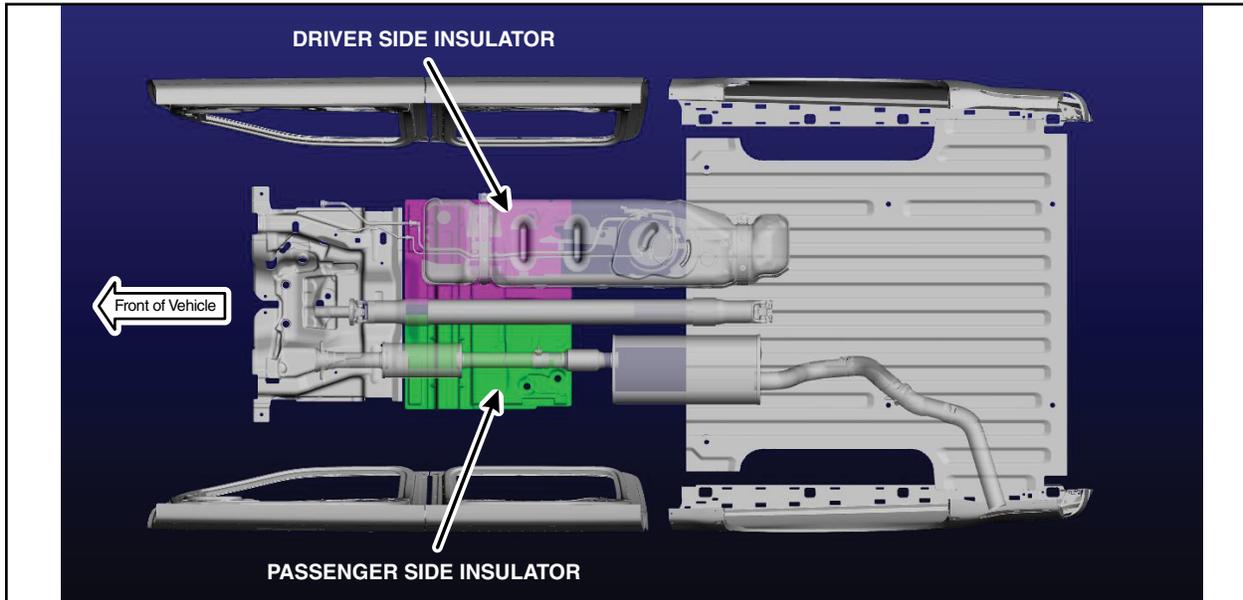
FIGURE 1

1. With the vehicle in NEUTRAL, position it on a hoist. Please follow Workshop Manual (WSM) procedures in Section 100-02.
2. Are either one or both of the underbody insulators present on the vehicle? See Figure 1.

NOTE: The passenger side insulator is located directly above the exhaust.

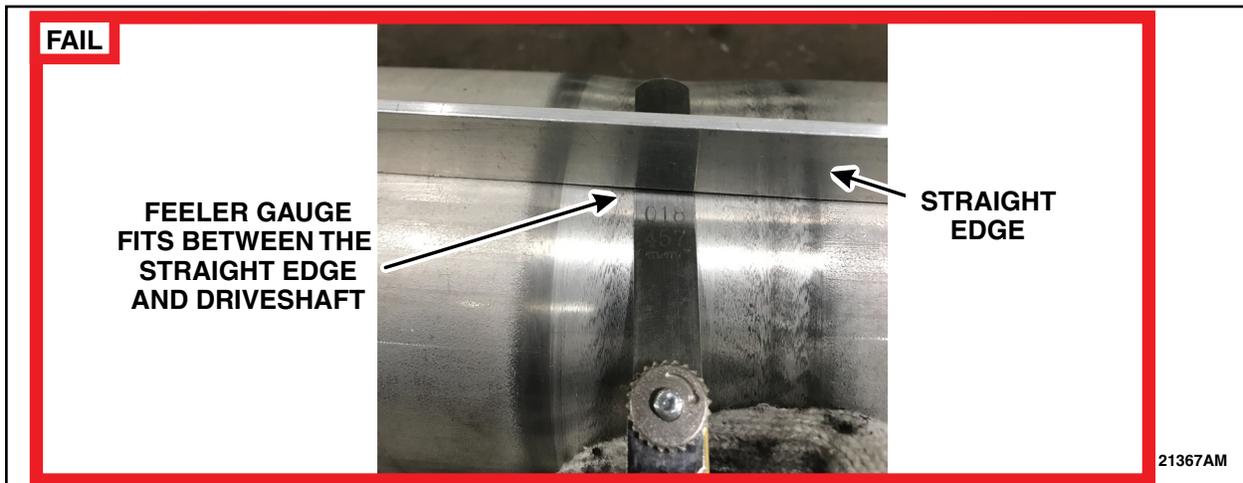
FIGURE 4

- Place a straight edge along the driveshaft over the wear mark and attempt to fit a 0.018in (0.45mm) feeler gauge between the flat edge and the wear mark. Can the feeler gauge fit between the straight edge and anywhere along the wear mark? See Figures 3 and 4.

Yes – Does not pass inspection. Contact the SSSC and provide a picture of the driveshaft with the feeler gauge fitting between the straight edge and wear mark. Once approved, rear driveshaft replacement will be required, but do not install at this time. Proceed to step 10.

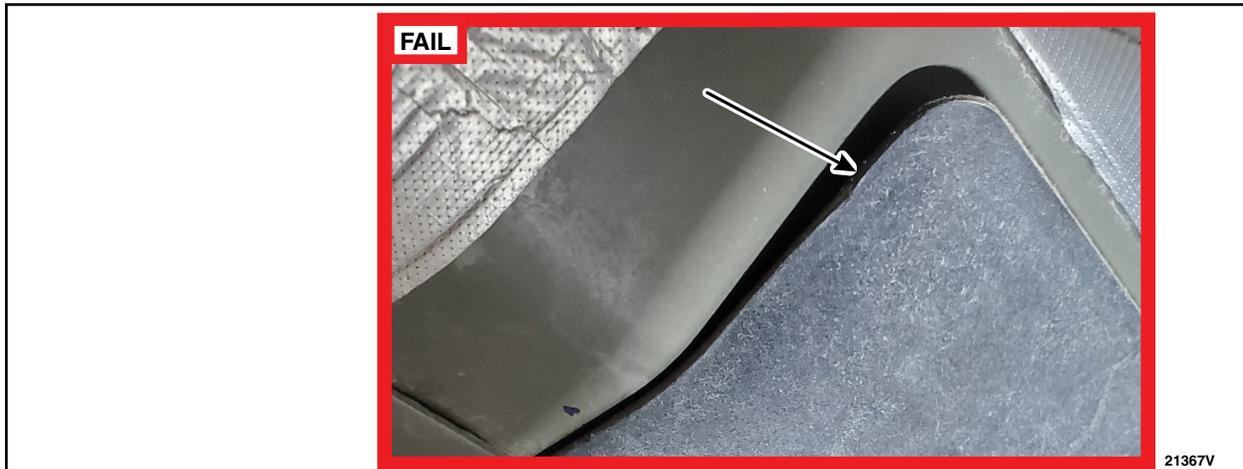
FIGURE 10

10. Inspect the driver side insulator for any edges hanging down or touching the fuel tank. Is the insulator hanging down or touching the fuel tank? See Figure 10.

Yes – Does not pass inspection. Proceed to step 11.

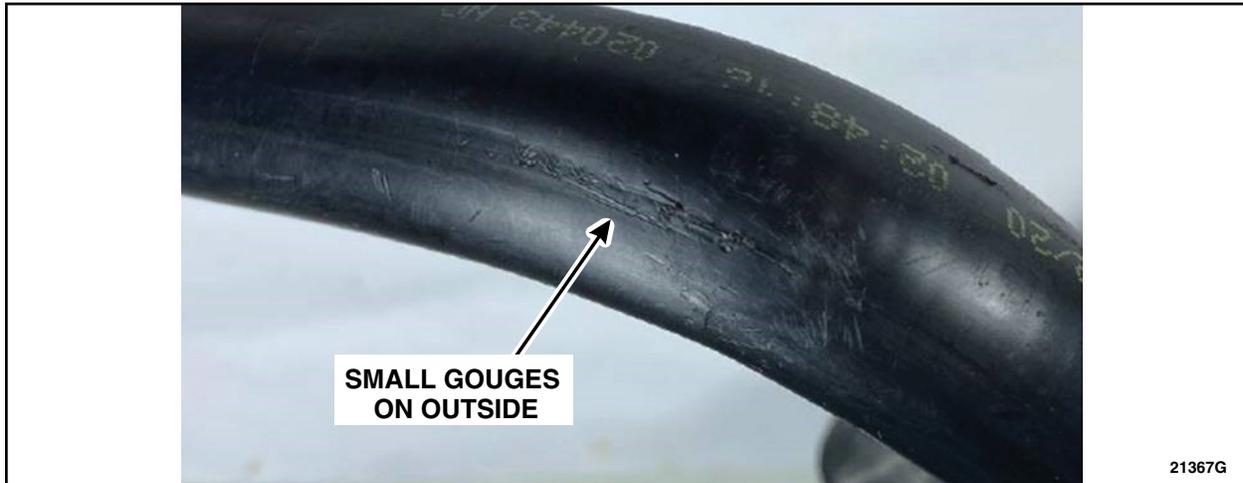
FIGURE 12

12. Inspect the vapor line for any damage caused by the driver side insulator. Is there any damage to the line? See Figures 11 through 13.

Yes – Does not pass inspection. Replace the damaged line. Please follow WSM procedures in Section 310-01, then proceed to step 13.

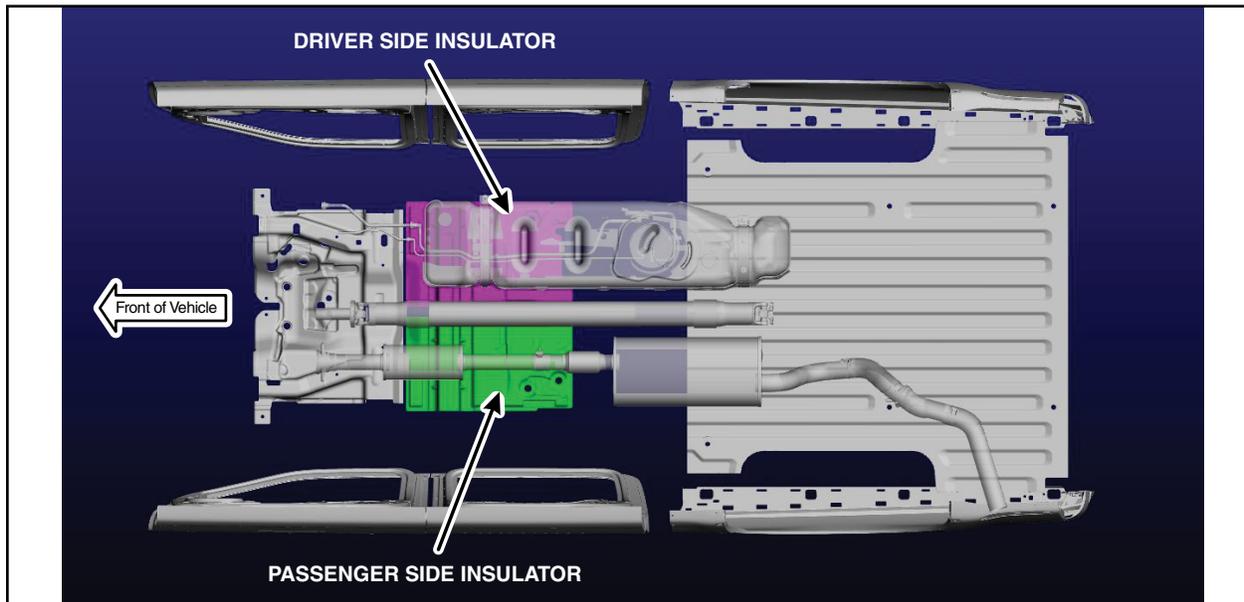
FIGURE 1

1. With the vehicle in NEUTRAL, position it on a hoist. Please follow Workshop Manual (WSM) procedures in Section 100-02.
2. Are either one or both of the underbody insulators present on the vehicle? See Figure 1.

NOTE: The passenger side insulator is located directly above the exhaust.

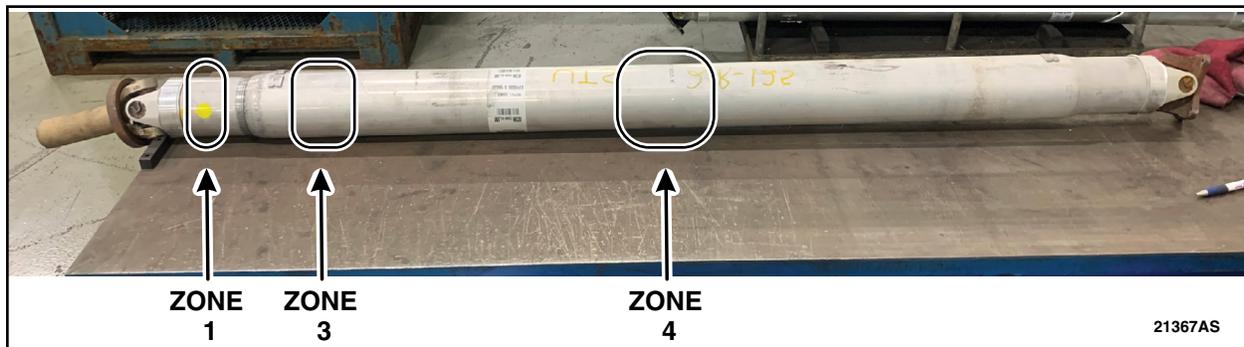
FIGURE 2

4. Inspect Zones 1, 3 and 4 of the rear driveshaft for any marks caused by the front and/or rear edges of the passenger side insulator. Are there any marks present in Zones 1, 3 or 4?
See Figure 2.

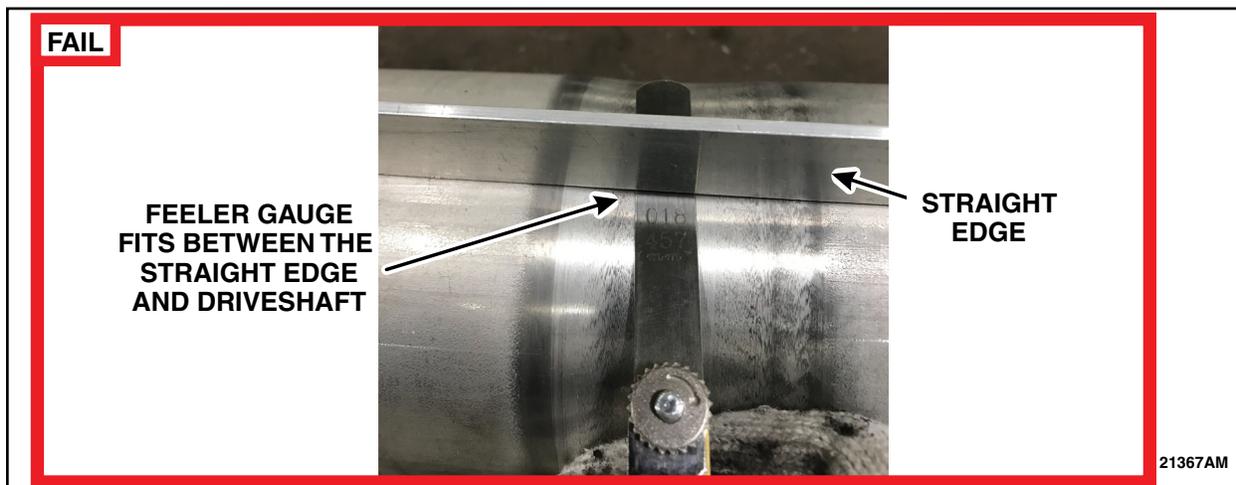
FIGURE 4

6. Place a straight edge along the driveshaft over the wear mark and attempt to fit a 0.018in (0.45mm) feeler gauge between the flat edge and the wear mark. Can the feeler gauge fit between the straight edge and anywhere along the wear mark? See Figures 3 and 4.

Yes – Does not pass inspection. Contact the SSSC and provide a picture of the driveshaft with the feeler gauge fitting between the straight edge and wear mark. Once approved, rear driveshaft replacement will be required, but do not install at this time. Proceed to step 9.

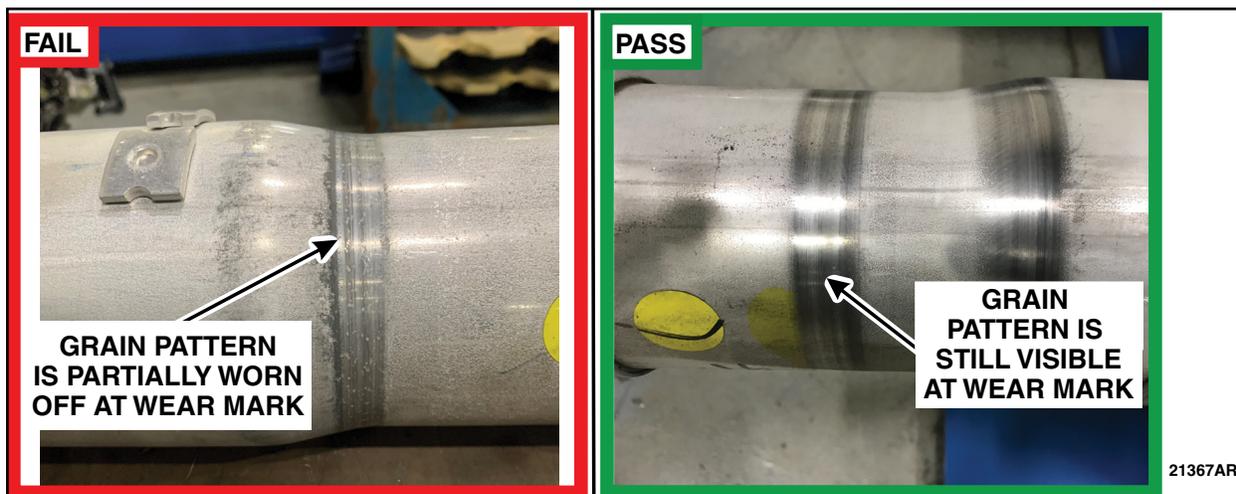
FIGURE 7

8. Inspect the marks found on Zone 2. Is the aluminum tube surface grain pattern worn off, completely smooth, or have an appearance of necking? See Figures 6 through 9.

Yes – Does not pass inspection. Contact the SSSC and provide a picture of the driveshaft with the grain pattern worn off. Be sure to show a clear image of the grain pattern missing. Once approved, rear driveshaft replacement will be required, but do not install at this time. Proceed to step 9.

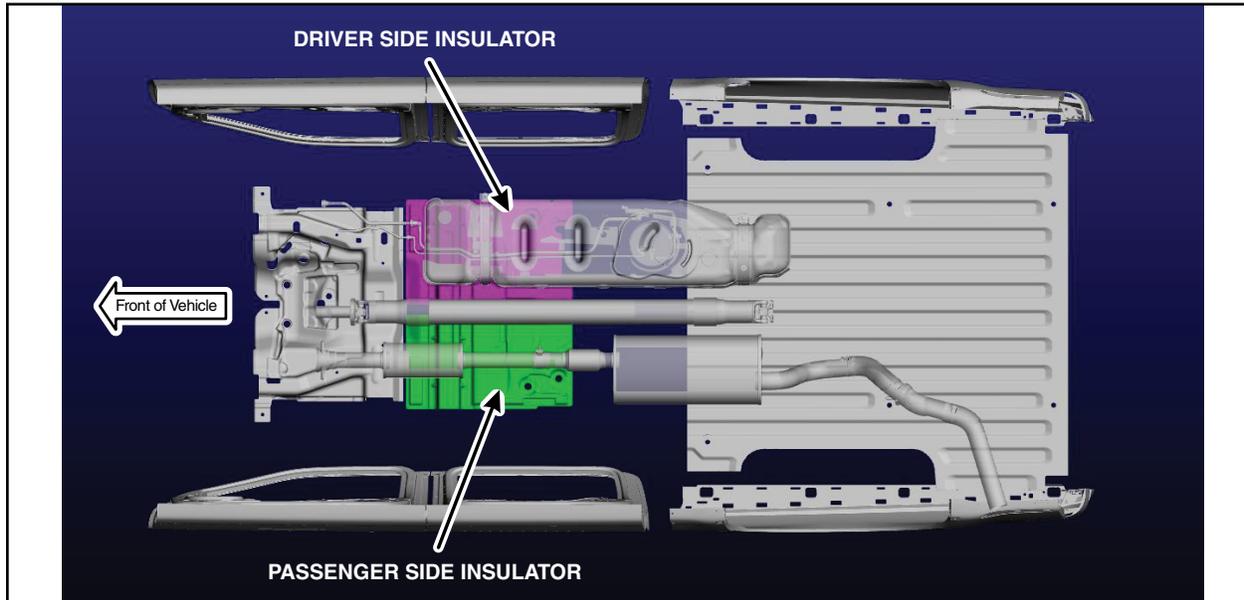
FIGURE 1

1. With the vehicle in NEUTRAL, position it on a hoist. Please follow Workshop Manual (WSM) procedures in Section 100-02.
2. Are either one or both of the underbody insulators present on the vehicle? See Figure 1.

NOTE: The passenger side insulator is located directly above the exhaust.

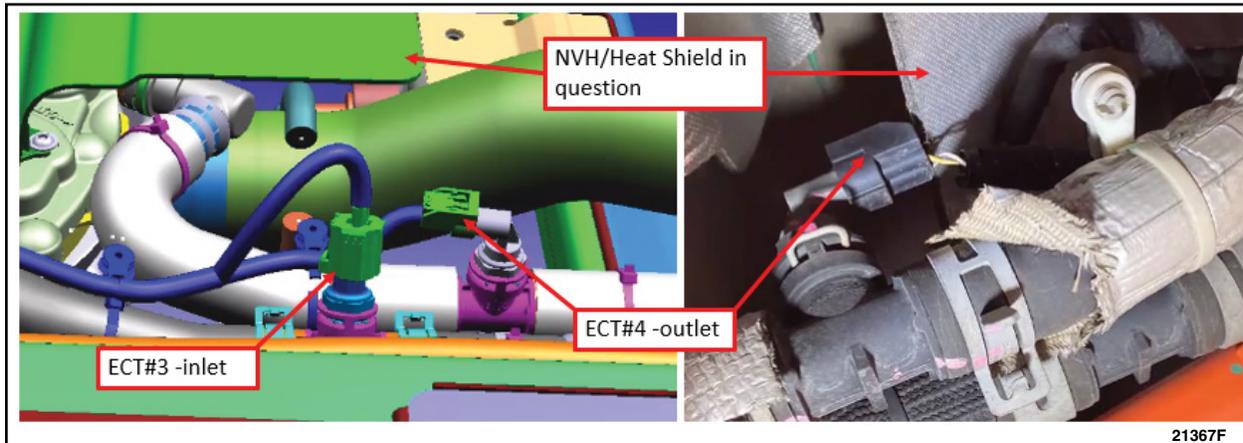
FIGURE 10

9. Inspect the front Engine Coolant Temperature (ECT) sensor connectors for any damage caused by the passenger side insulator. Is there any damage? See Figure 10.

Yes – Does not pass inspection. Contact the SSSC and provide a picture of the damage for proper technical instructions and part numbers, then proceed to step 10.

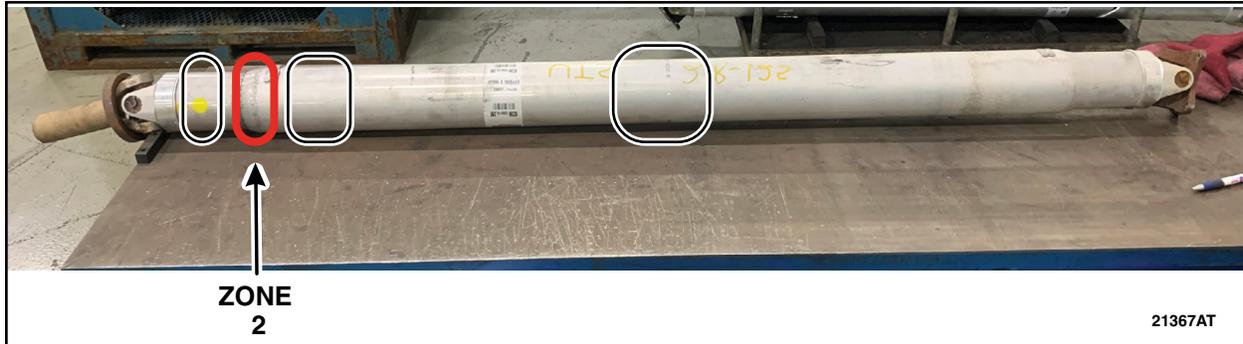
FIGURE 5

8. Inspect Zone 2 (transition from larger tube diameter to smaller diameter section) of the driveshaft tube for any marks caused by the front edge of the passenger side insulator. Are there any marks present? See Figure 5.

Yes – Does not pass inspection. Proceed to step 9.

No – Passes inspection. Driveshaft may be reused. Proceed to step 10.

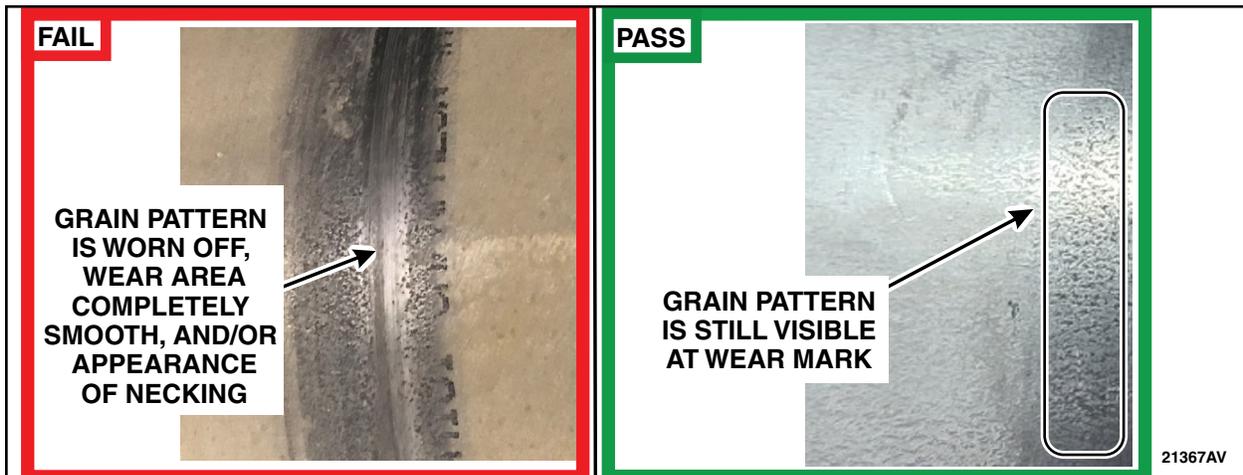
FIGURE 9

9. Inspect the marks found on Zone 2. Is the aluminum tube surface grain pattern worn off, completely smooth, or have an appearance of necking? See Figures 6 through 9.
