David J. Johnson
 Director
 Service Engineering Operations
 Ford Customer Service Division

**SUBJECT: NEW VEHICLE DEMONSTRATION / DELIVERY HOLD -
 Safety Recall 22S53**

Certain 2021-2022 Model Year F-150 Vehicles Equipped with Crew Cab, 145" Wheelbase, 4x4, One-Piece Aluminum Driveshaft, and MFAL BHDAA (Less Sound Insulation Packs)* Loose/Sagging Underbody Insulators

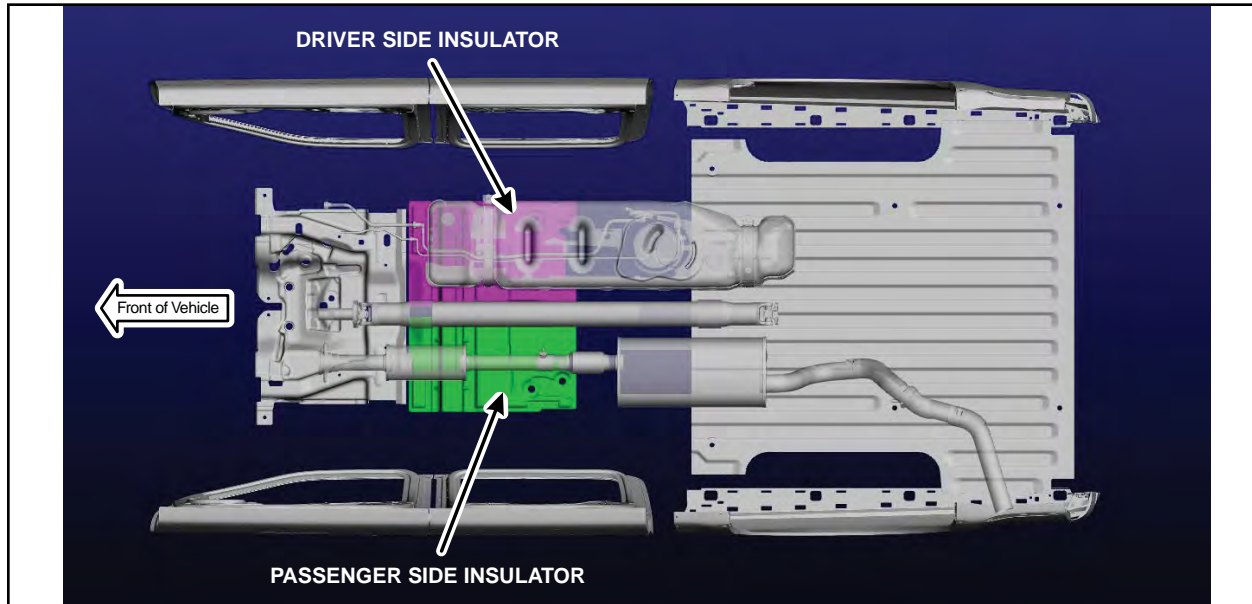
FIGURE 1

1. With the vehicle in NEUTRAL, position it on a hoist. Please follow Workshop Manual (WSM) procedures in Section 100-02.
2. Are either one or both of the underbody insulators present on the vehicle? See Figure 1.

NOTE: The passenger side insulator is located directly above the exhaust.

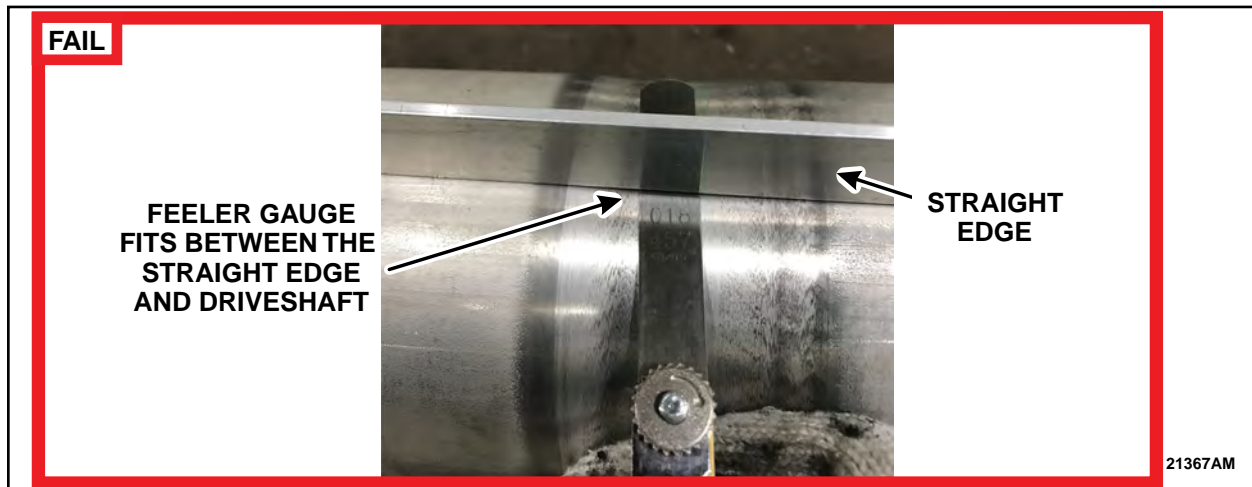
FIGURE 4

7. Place a straight edge along the driveshaft over the wear mark and attempt to fit a 0.018in (0.45mm) feeler gauge between the flat edge and the wear mark. Can the feeler gauge fit between the straight edge and anywhere along the wear mark? See Figures 3 and 4.

Yes – Does not pass inspection. Contact the SSSC and provide a picture of the driveshaft with the feeler gauge fitting between the straight edge and wear mark. Once approved, rear driveshaft replacement will be required, but do not install at this time. Proceed to step 10.

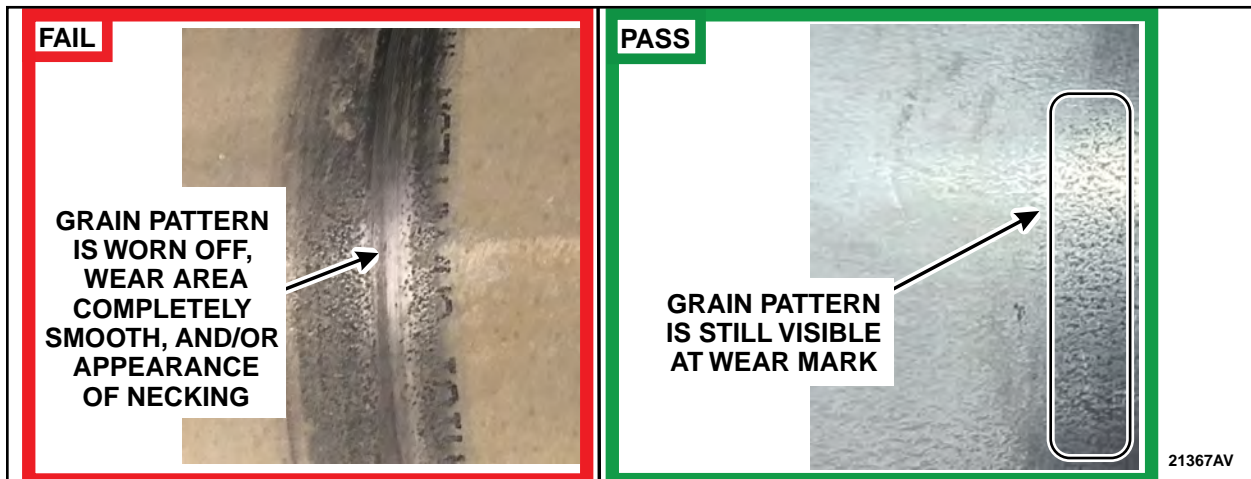
FIGURE 9

9. Inspect the marks found on Zone 2. Is the aluminum tube surface grain pattern worn off, completely smooth, or have an appearance of necking? See Figures 6 through 9.

Yes – Does not pass inspection. Contact the SSSC and provide a picture of the driveshaft with the grain pattern worn off. Be sure to show a clear image of the grain pattern missing. Once approved, rear driveshaft replacement will be required, but do not install at this time. Proceed to step 10.

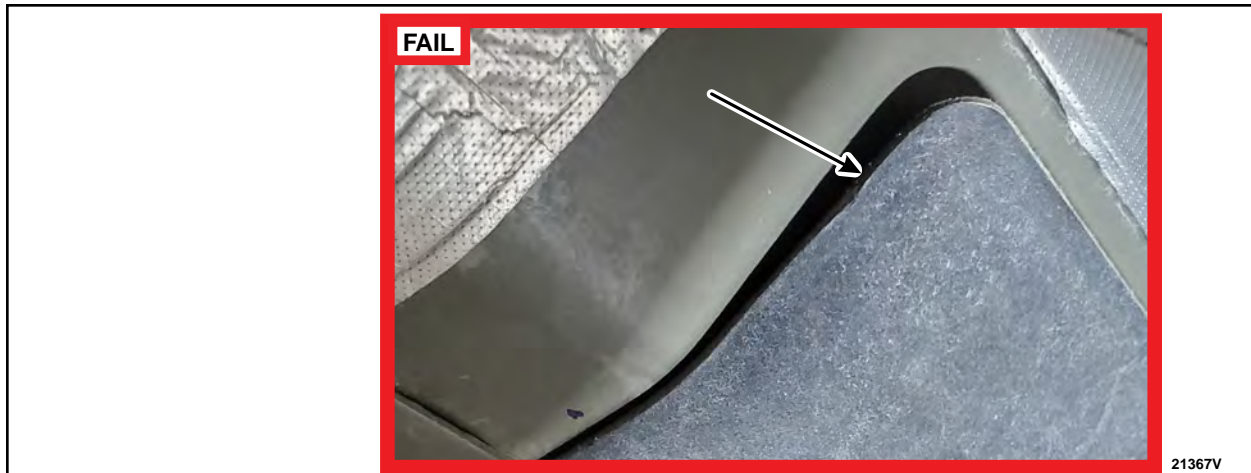
FIGURE 10

10. Inspect the driver side insulator for any edges hanging down or touching the fuel tank. Is the insulator hanging down or touching the fuel tank? See Figure 10.

Yes – Does not pass inspection. Proceed to step 11.

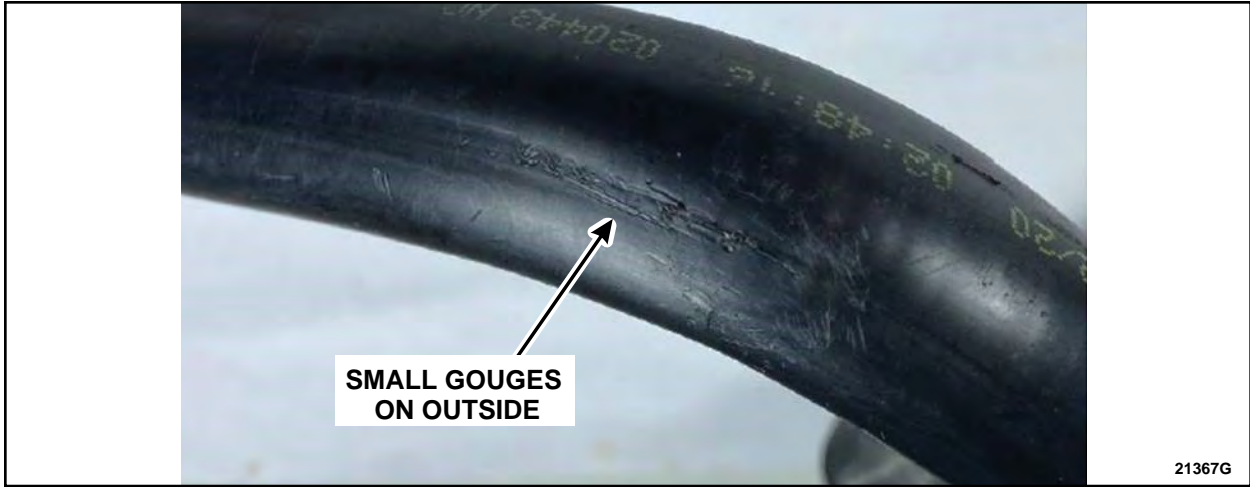
FIGURE 12

12. Inspect the vapor line for any damage caused by the driver side insulator. Is there any damage to the line? See Figures 11 through 13.

Yes – Does not pass inspection. Replace the damaged line. Please follow WSM procedures in Section 310-01, then proceed to step 13.

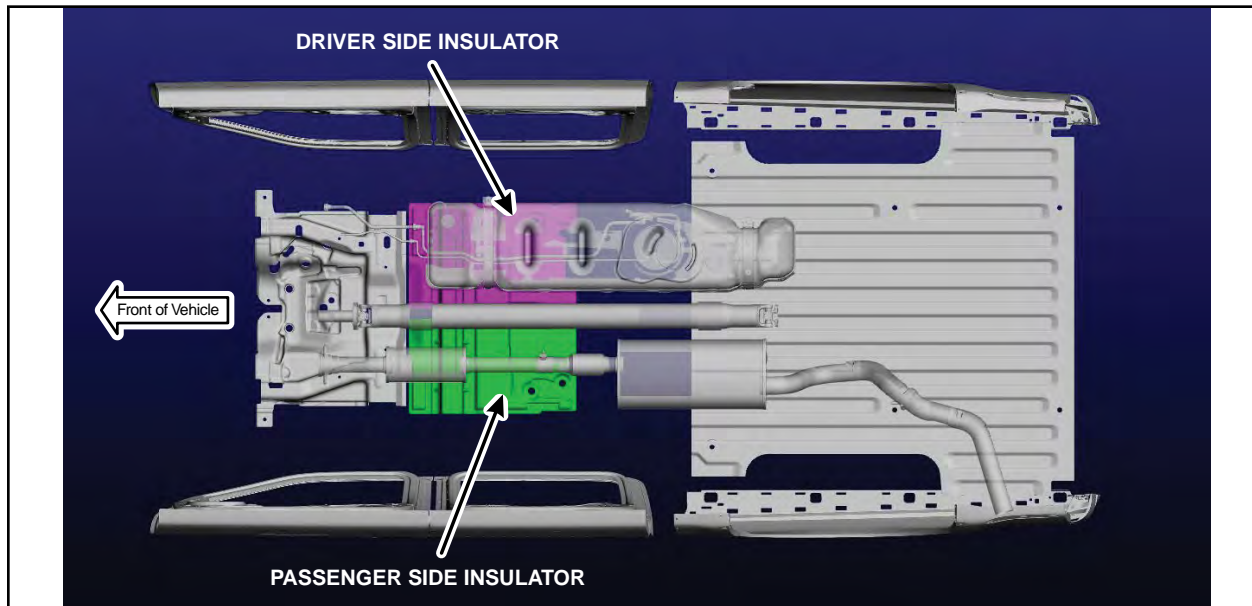
FIGURE 1

1. With the vehicle in NEUTRAL, position it on a hoist. Please follow Workshop Manual (WSM) procedures in Section 100-02.
2. Are either one or both of the underbody insulators present on the vehicle? See Figure 1.

NOTE: The passenger side insulator is located directly above the exhaust.

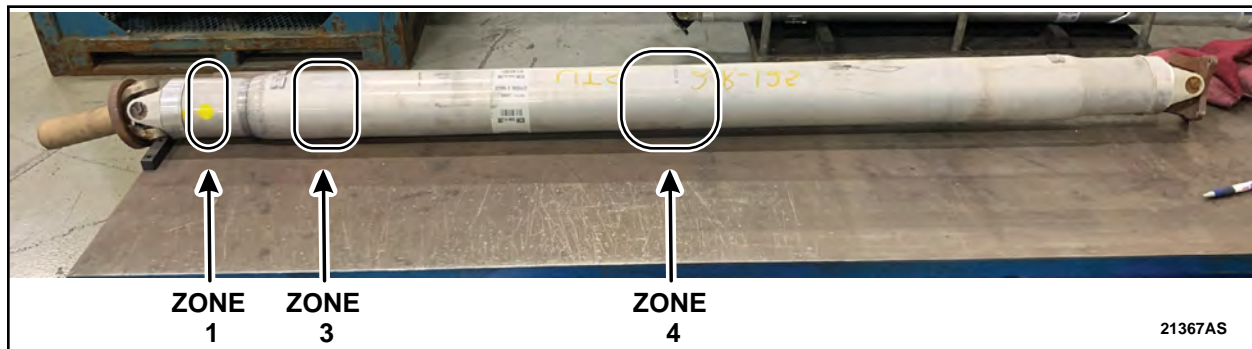
FIGURE 2

4. Inspect Zones 1, 3 and 4 of the rear driveshaft for any marks caused by the front and/or rear edges of the passenger side insulator. Are there any marks present in Zones 1, 3 or 4?
See Figure 2.

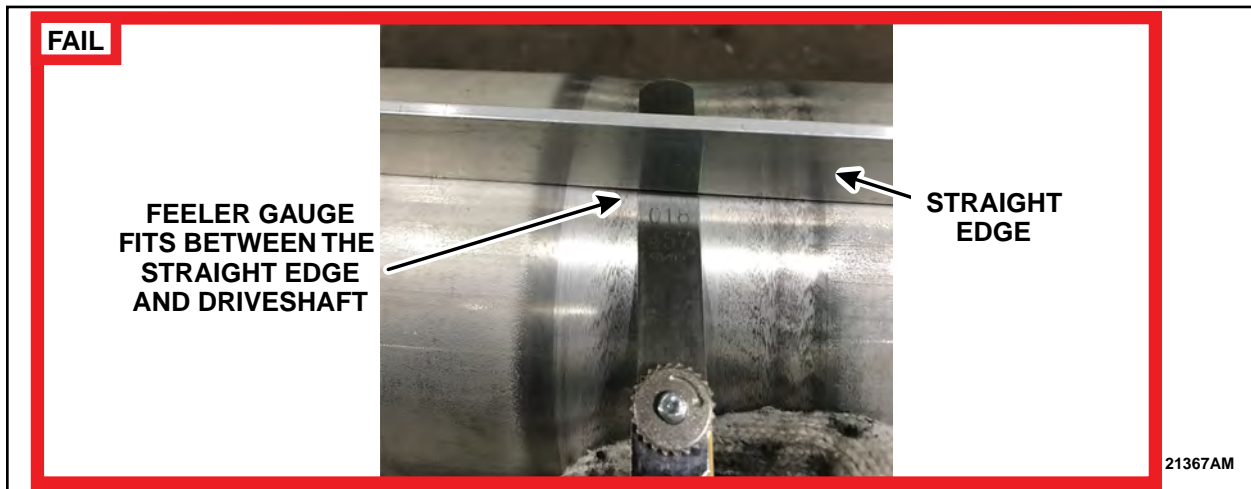
FIGURE 4

6. Place a straight edge along the driveshaft over the wear mark and attempt to fit a 0.018in (0.45mm) feeler gauge between the flat edge and the wear mark. Can the feeler gauge fit between the straight edge and anywhere along the wear mark? See Figures 3 and 4.

Yes – Does not pass inspection. Contact the SSSC and provide a picture of the driveshaft with the feeler gauge fitting between the straight edge and wear mark. Once approved, rear driveshaft replacement will be required, but do not install at this time. Proceed to step 9.

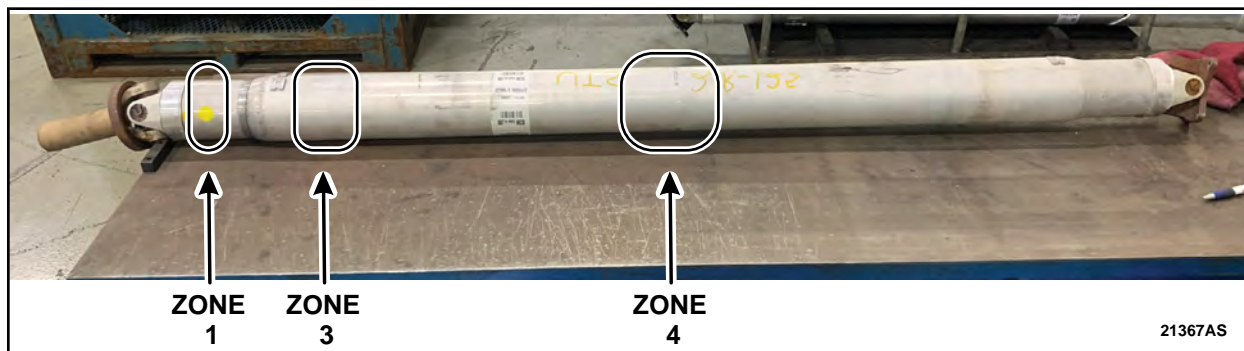
FIGURE 2

4. Inspect Zones 1, 3 and 4 of the rear driveshaft for any marks caused by the front and/or rear edges of the passenger side insulator. Are there any marks present in Zones 1, 3 or 4?
See Figure 2.

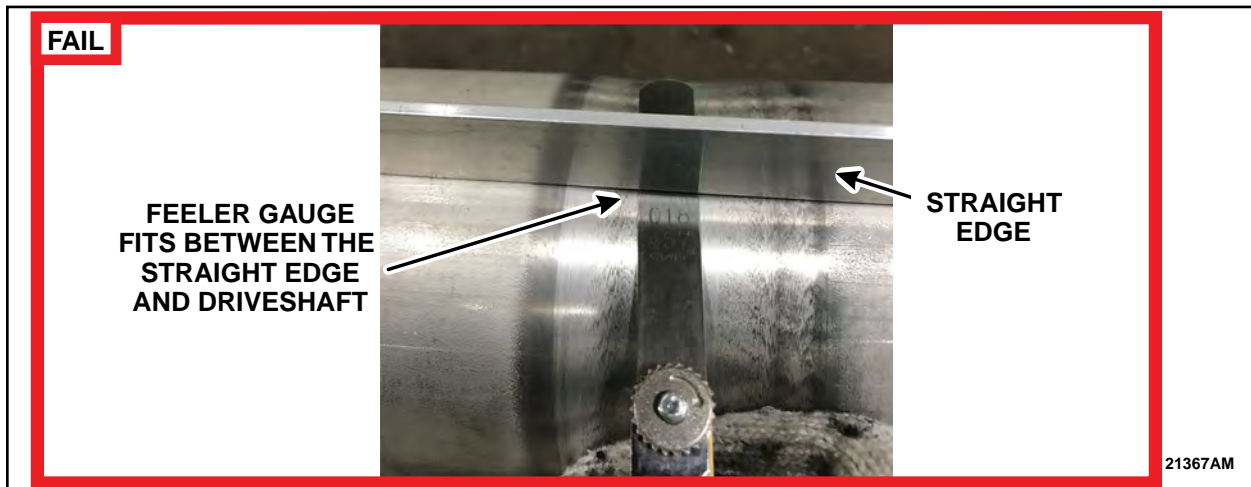
FIGURE 4

6. Place a straight edge along the driveshaft over the wear mark and attempt to fit a 0.018in (0.45mm) feeler gauge between the flat edge and the wear mark. Can the feeler gauge fit between the straight edge and anywhere along the wear mark? See Figures 3 and 4.

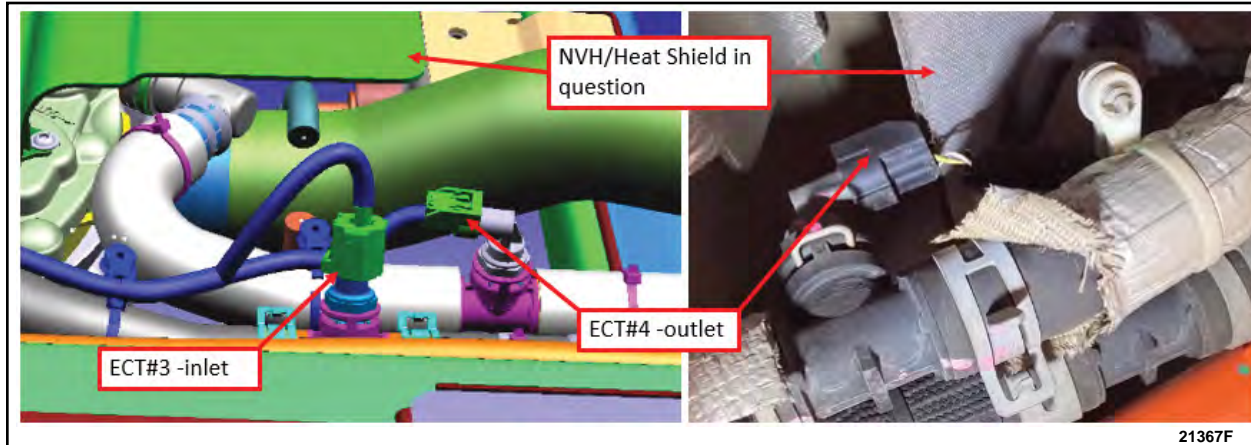
FIGURE 10

9. Inspect the front Engine Coolant Temperature (ECT) sensor connectors for any damage caused by the passenger side insulator. Is there any damage? See Figure 10.

Yes – Does not pass inspection. Contact the SSSC and provide a picture of the damage for proper technical instructions and part numbers, then proceed to step 10.
