**SUBJECT:** **NEW VEHICLE DEMONSTRATION / DELIVERY HOLD**  
**Compliance Recall 22C22 - Supplement #1**  
 Certain 2022 Model Year Bronco Sport and F-150 Vehicles  
 Front Park Lamp Flicker

**NEW VEHICLE DEMONSTRATION / DELIVERY HOLD**  
**Compliance Recall 22C22 - Supplement #1**  
Certain 2022 Model Year Bronco Sport and F-150 Vehicles  
Front Park Lamp Flicker

## CERTAIN 2022 MODEL YEAR BRONCO SPORT AND F-150 VEHICLES — PARK LAMP FLICKER

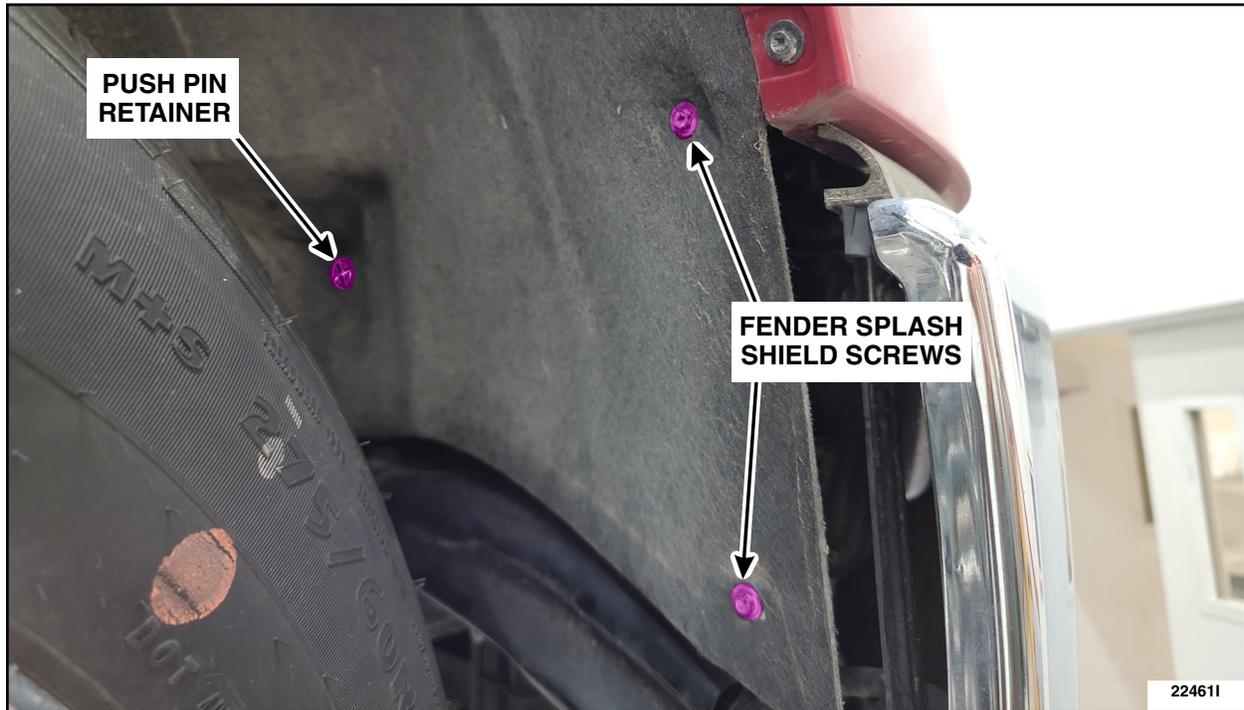
**FIGURE 2**

2. *Position the vehicle on a hoist.*
3. *On both sides of the vehicle, remove the two fender splash shield screws and the push pin retainer.*  
*See Figure 2.*

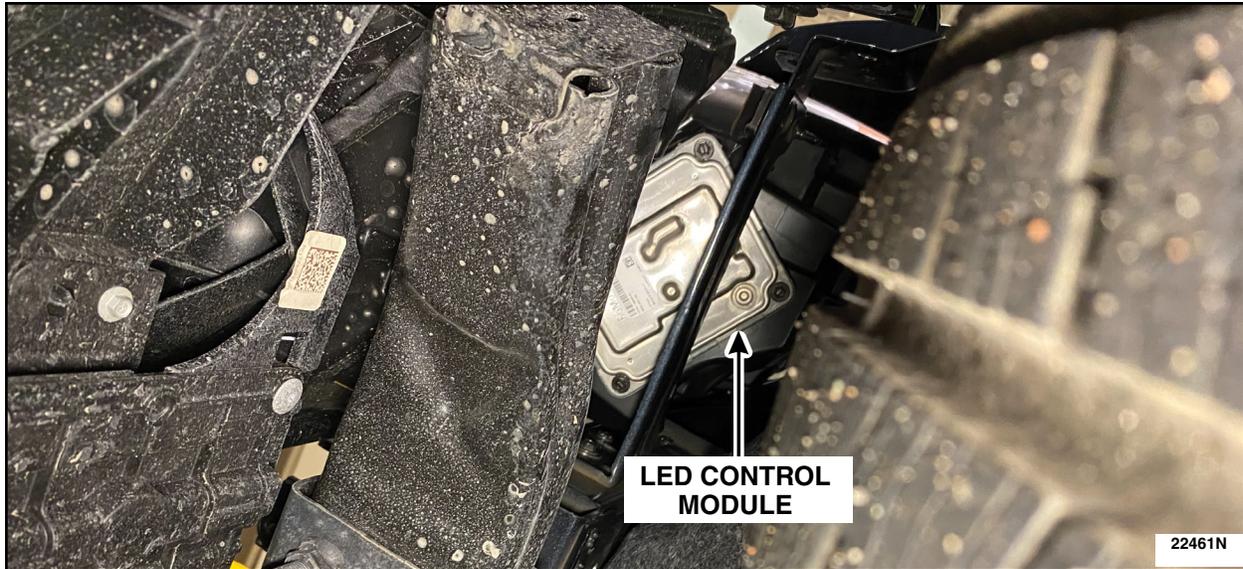
FIGURE 3

5. Look up at the bottom of the headlamp so the LED module label is visible. See Figures 3, 4 and 5.

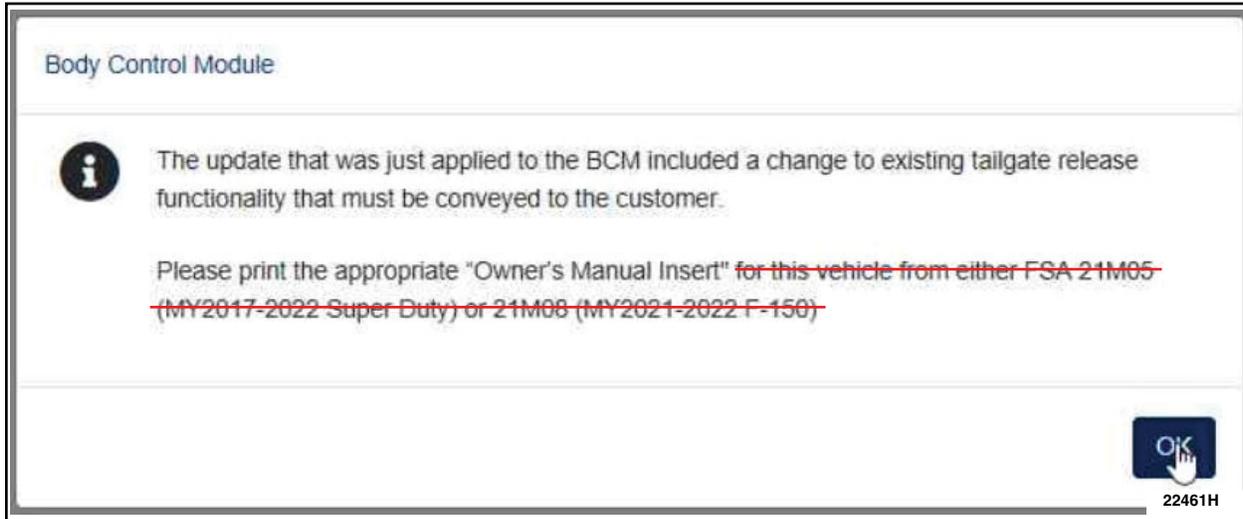
FIGURE 8

(Do **NOT** print the 21M08 addendum as called out in the FDRS pop-up as shown in Figure 8.)

**NO** - Print 22C22 specific owner manual addendum and continue on to Step 9.

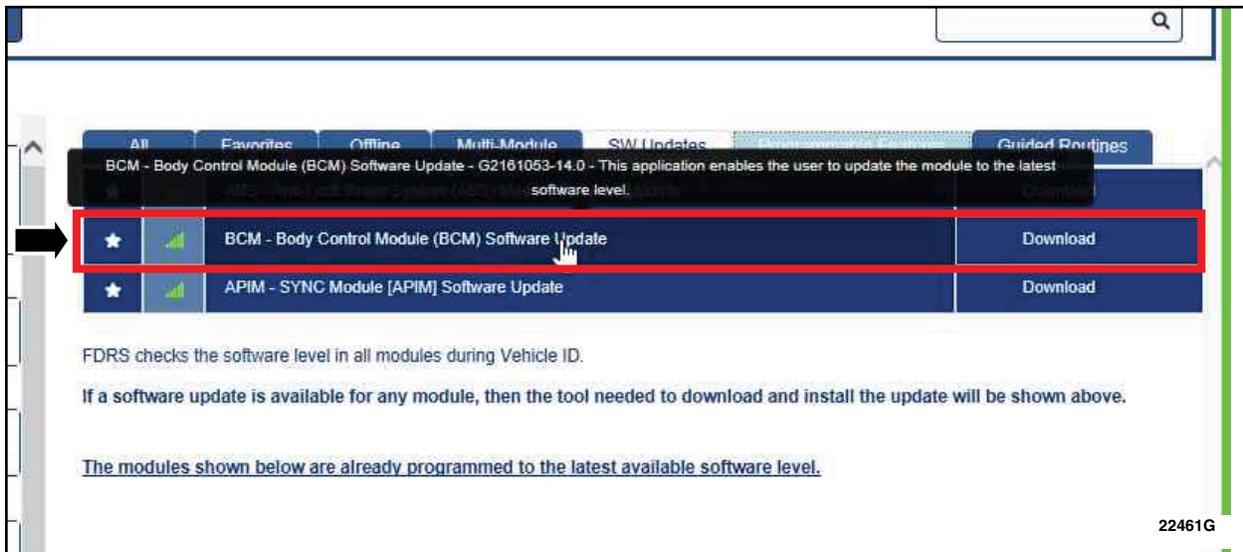
FIGURE 9

10. From the list on the RH side of the screen, select **BCM - Body Control Module (BCM) Software Update** again. See Figure 9.
