TO: Mercedes-Benz Dealer Principals, General Managers, Sales Managers, Service Managers, Parts Managers	FROM: Gregory Gunther, Department Manager, Vehicle Compliance and Analysis, Engineering Services
RE: <b>Recall Campaign Launch Notification</b> <b>Install 12 Volt Battery Support</b> <b>MY19-22 CLS-Class and E-Class</b> <b>(257 and 213 platform)</b>	DATE: December 21, 2022

Campaign No. 2022100009, December 2022

SUBJECT: **Model CLS-Class and E-Class (257 and 213 platform)**  
**Model Year 2019-2022**

## **Install 12 Volt Battery Support**

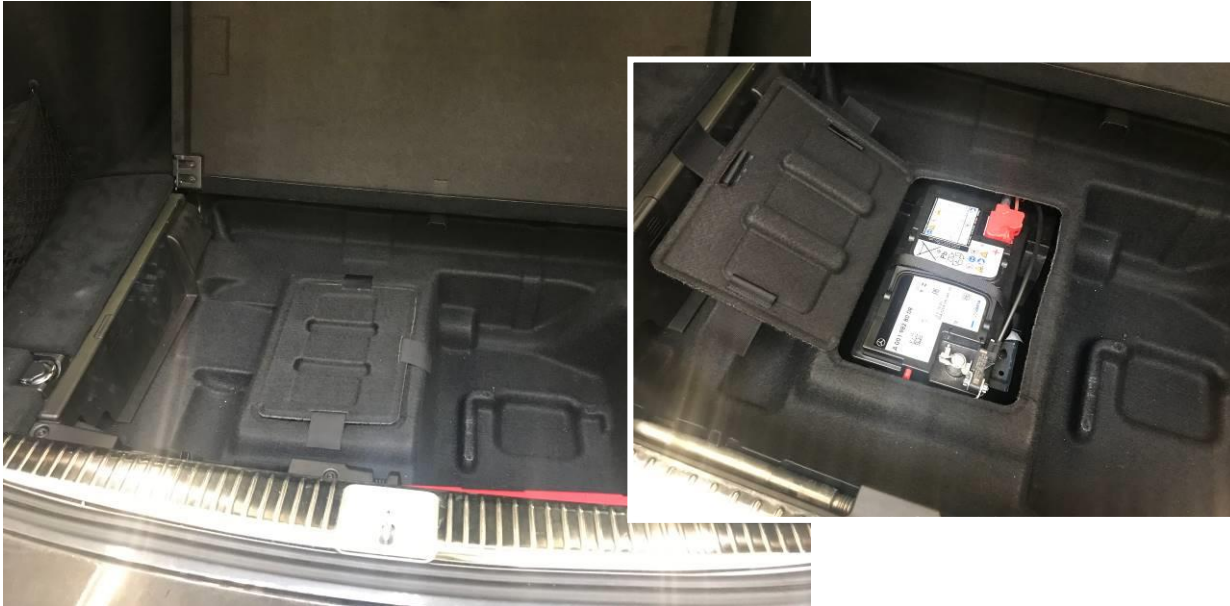
Figure 2

3. Check whether there is an opening with cap (figure 2) behind the battery in the spare wheel well.

- i** If an opening with cap exists, the replacement part must be adapted as described in **work procedure C!**
- i** If **no** opening with cap exists, continue with operation step 4.
