**PRODUCT CAMPAIGN BULLETIN**

**APPLICABILITY:** 2019-2022MY Ascent

**NUMBER:** WRL-22R

**SUBJECT:** PTC Heater Ground Bolt

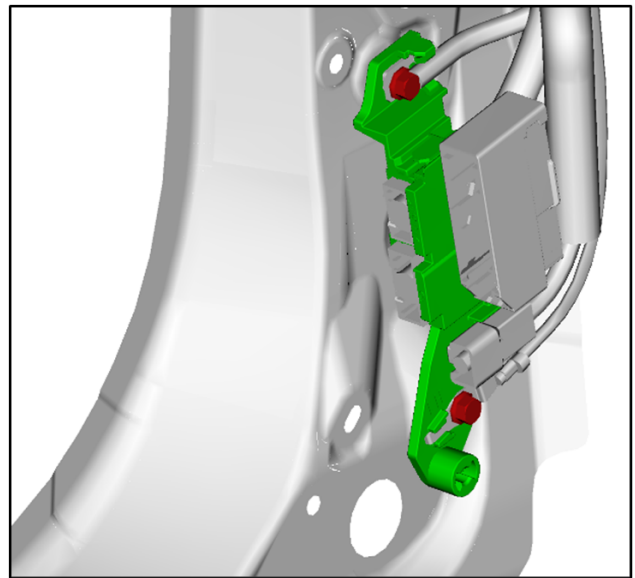
**STEP 6:** Remove the two heater ground bolts.

The ground bolt that secures the ground terminal of the Positive Temperature Coefficient (PTC) heater may have been improperly fastened during vehicle production. This potential condition may result in the melting of the ground terminal and surrounding components when the PTC heater is in operation, increasing the risk of a fire.

**STEP 25:** Install the new ground bolts and torque to 13Nm.
