Vehicle Compliance & Analysis

IMPORTANT RECALL CAMPAIGN UPDATE

Campaign No. 2023010004, January 2023

Check Sliding Roof Bonding

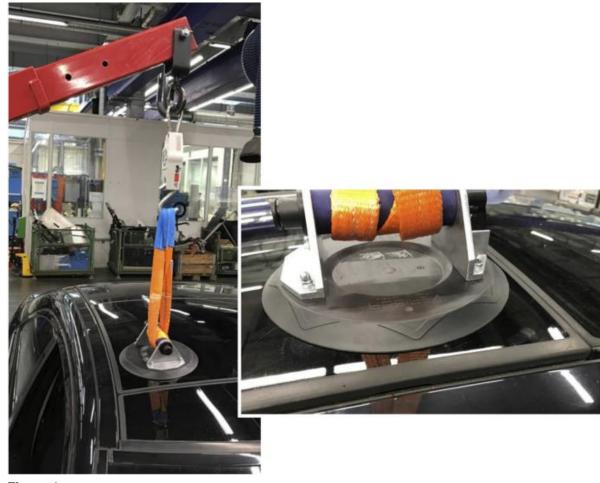
Figure 1

Attention, danger: Wear safety glasses and stay clear of the area above the suction cup tool (head/face) during the check.

i If the panoramic sliding sunroof panel is detached from the padding of the sliding sunroof/ tilting roof frame at one of the test points (see Figure 3), replace the sliding sunroof panel.
