IMPORTANT SAFETY RECALL
See enclosed VIN list

**August 2022
FL937A
NHTSA #22V-394**

Subject: Freightliner Steering Assembly U-Joint Pinch Bolts

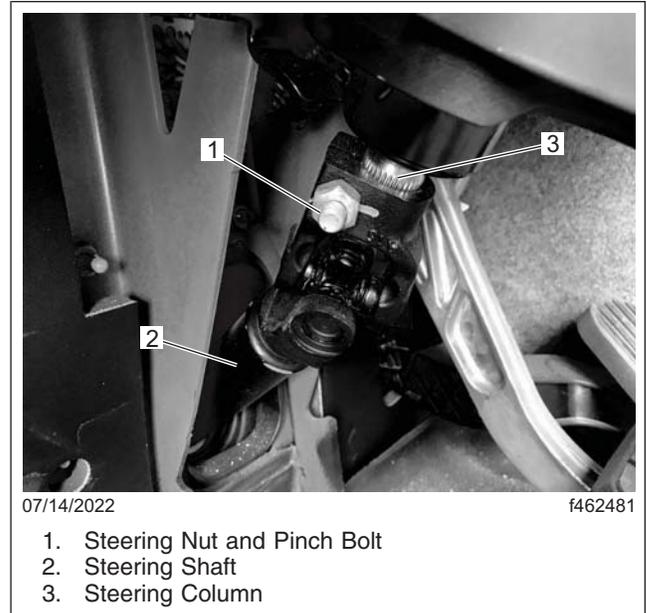
Fig. 1, Steering Pinch Bolt Location

1. Park the vehicle on a level surface, shut down the engine, and set the parking brake. Chock the rear tires.
2. Locate the steering shaft inside the cab, as shown in [Fig. 1](#).
3. Check the connections between the steering column and steering shaft, and the nut to pinch bolt connection, as shown in [Fig. 1](#). Remove the steering column cover to see the bolt.
4. Inspect the nut to pinch bolt connection. There must be bolt threads exposed beyond the nut as shown in [Fig. 1](#).

4. Inspect the nut to pinch bolt connection. There must be bolt threads exposed beyond the nut as shown in [Fig. 1](#).
Are the bolt threads visible?
YES → Go to the next step.
NO → **DO NOT** drive the vehicle. Have it immediately towed to the nearest DTNA dealership for repair.
5. Inspect the exposed splines of the steering shaft connection as shown in [Fig. 2](#). It may be necessary to turn the steering wheel to gain adequate visibility of the splines.
If the steering shaft splines are not visible on both sides of the bolted connection, **DO NOT** drive the vehicle. Have it immediately towed to the nearest DTNA dealership for repair.
If the steering shaft splines are exposed on both sides of the bolted connection, go to the next inspection.

NO → **DO NOT** drive the vehicle. Have it immediately towed to the nearest DTNA dealership for repair.

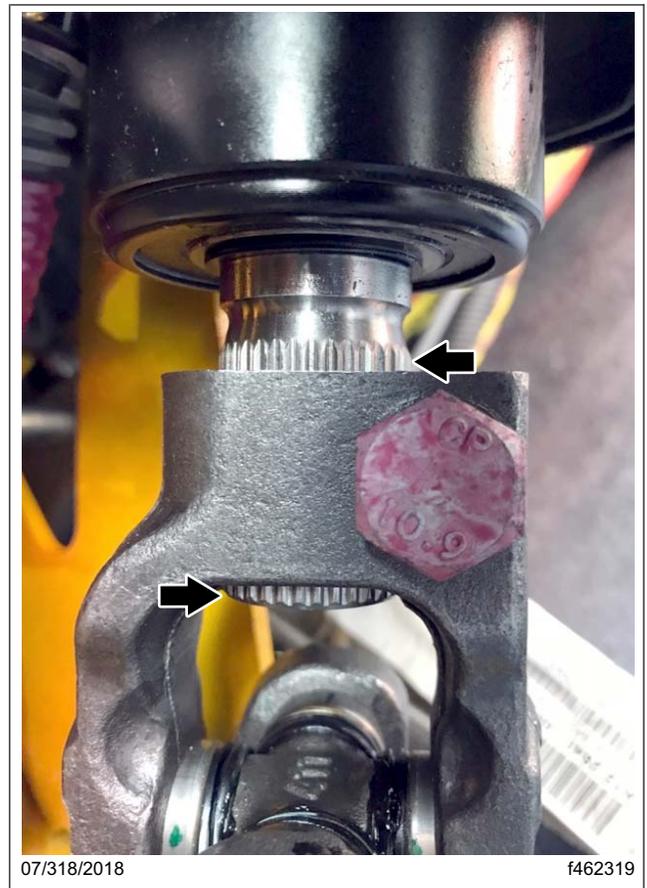
Fig. 2, Steering Shaft Splines

5. Inspect the exposed splines of the steering shaft connection as shown in **Fig. 2**. It may be necessary to turn the steering wheel to gain adequate visibility of the splines.

If the steering shaft splines are not visible on both sides of the bolted connection, **DO NOT** drive the vehicle. Have it immediately towed to the nearest DTNA dealership for repair.
