VOLUNTARY RECALL CAMPAIGN

Classification: EL22-014	Reference: NTB22-086	Date: September 28, 2022
-----------------------------	-------------------------	-----------------------------

VOLUNTARY SAFETY RECALL CAMPAIGN 2017 ROGUE; WIRE HARNESS INSPECTION

CAMPAIGN ID #: PC918
APPLIED VEHICLES: 2017 Rogue (T32)

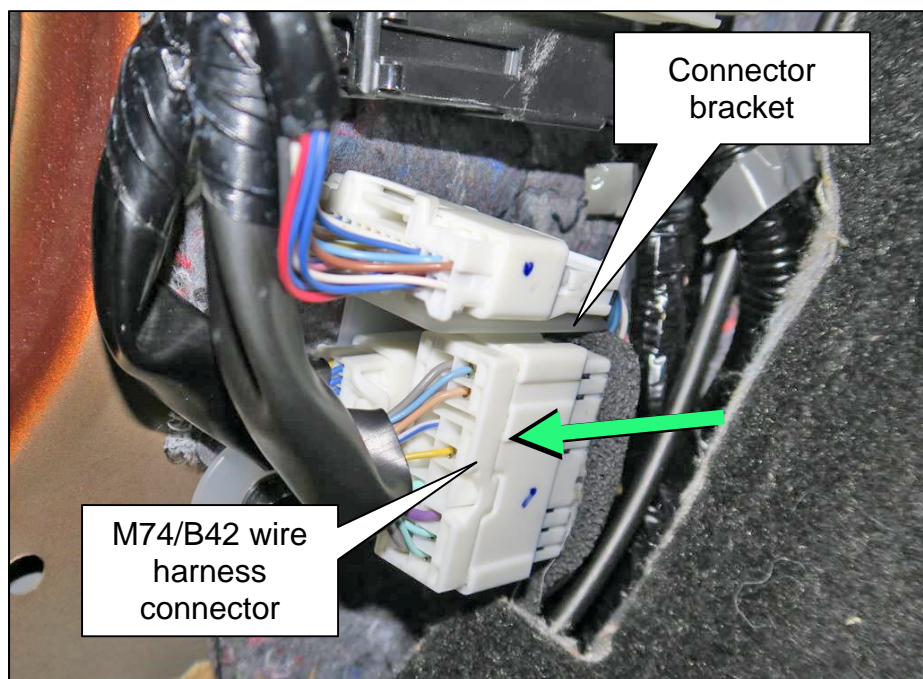
Figure 1

3. While leaving the M74/B42 wire harness connectors connected, disengage the connectors from the connector bracket by pulling in the direction shown (Figure 1).

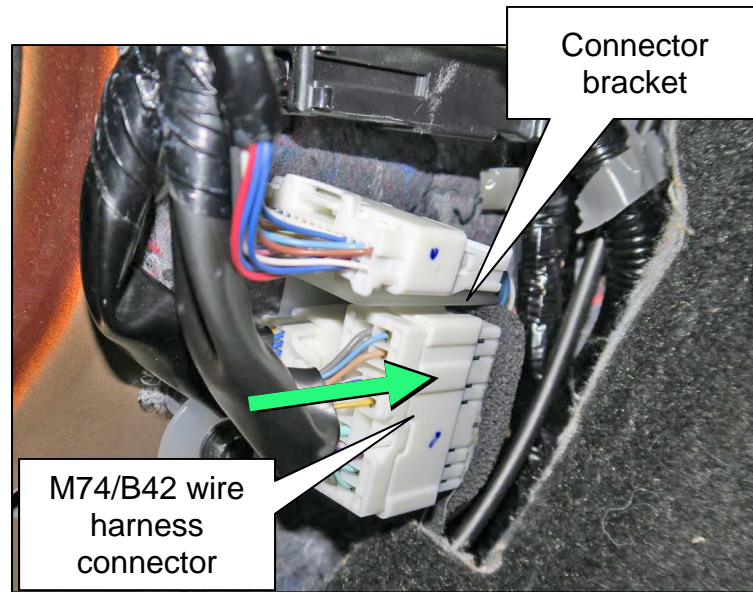
Figure 4

6. While leaving the M74/B42 wire harness connectors connected, engage the connectors into the connector bracket by pushing in the direction shown (Figure 4).
