RECALL INSPECTION AND REPAIR INSTRUCTIONS

NHTSA Recall #: 22V-068

Tiffin #: TIF-120

Models Involved: 2018-2022 Allegro & Breeze units with the 2000W inverter option

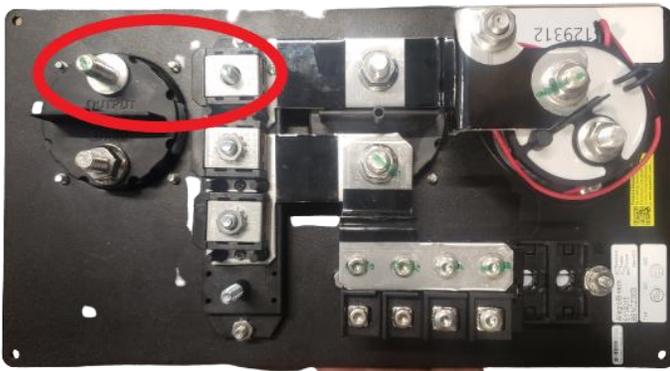
8. If any damage or signs of overheating, contact **Tiffin Service** at **(256) 356-8661** or service@tiffinmotorhomes.com

9. Using the cable provided, connect one end of the cable to the stud for the inverter switch. This will require using the torque wrench set on 100 in lbs.
