RECALL INSPECTION AND REPAIR INSTRUCTIONS

NHTSA Recall #: 22V-068

Models Involved: 2018-2022 Allegro & Breeze units with the 1200W inverter option

Purpose: To correct the torque on the DCD panel and update torque label.

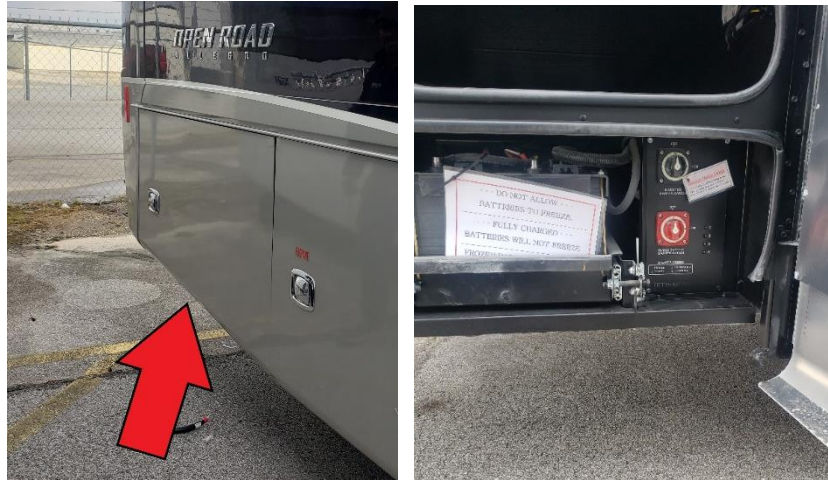
- For the 32FA, 32SA, 34PA, & 36 UA, the DCD panel is located in the rear most cargo compartment on the passenger side of the coach.

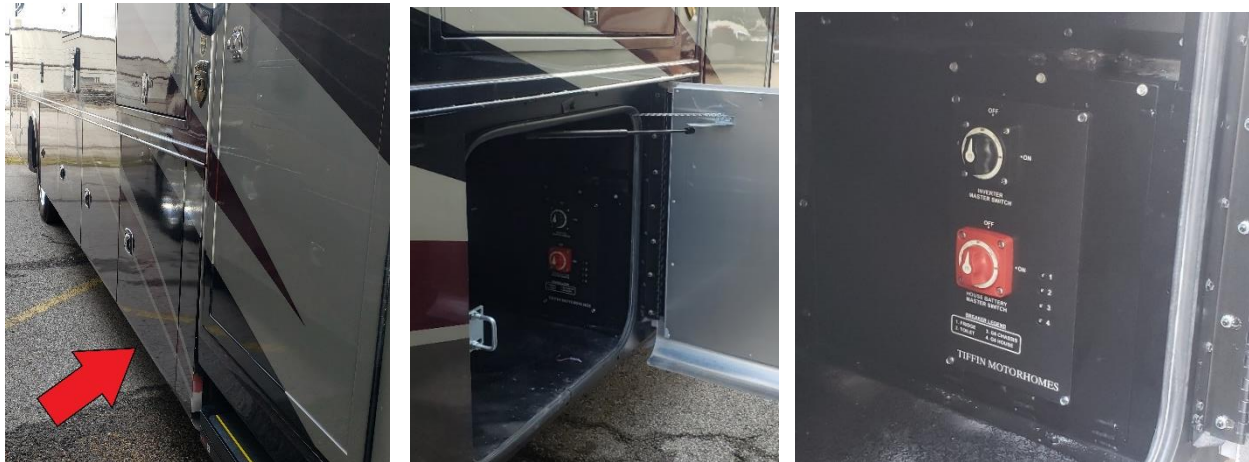
- For the 36LA, the DCD panel is located in the cargo compartment behind (to the rear of the coach) the entry door on the passenger side of the coach.

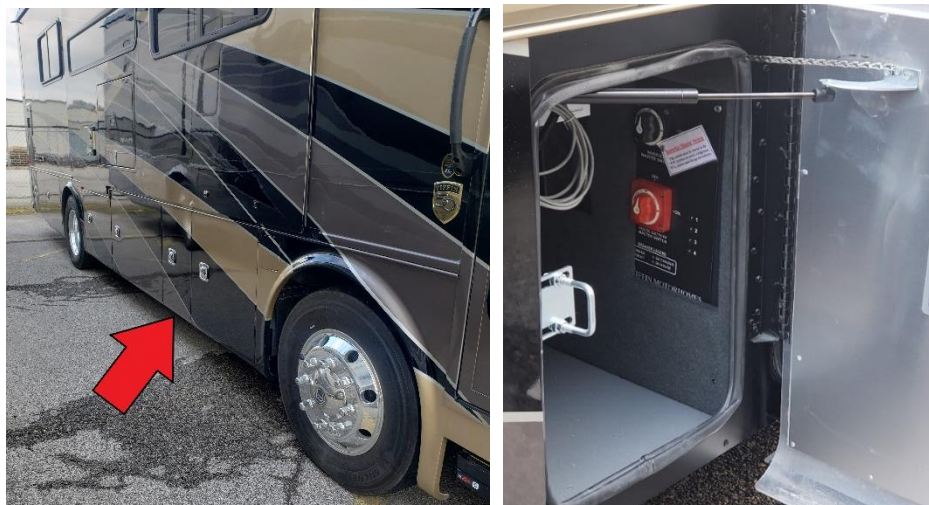
- For all Breeze units, the DCD panel is located on the passenger side of the coach in the second compartment to the rear of the entry door
