SIB 11 01 22

## RECALL 22V-119: POSITIVE CRANKCASE VENTILATION (PCV) BLOW-BY HEATER

This Service Information Bulletin (Revision 3) replaces SI B11 01 22 **dated June 2022**.

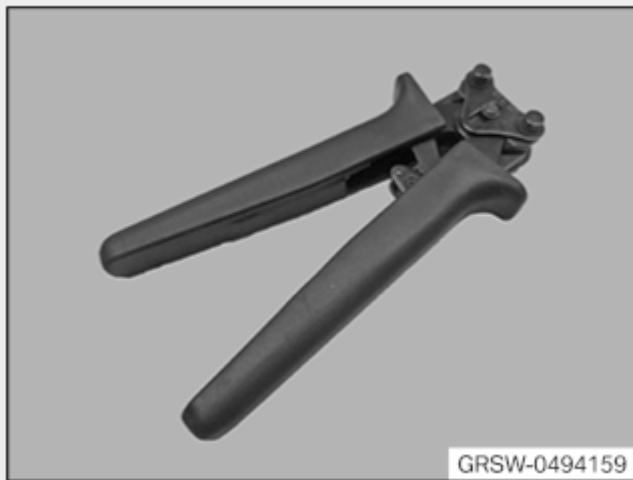
0 494 159 (61 4 321) Handle

Handle 83 30 0 494 159 (61 4 321) was distributed in the Crimping Set P/N 83 30 0 494 158 via the Automatic Tool Shipment Program in 2001.

The Handle P/N 83 30 0 494 159 can also be purchased separately.

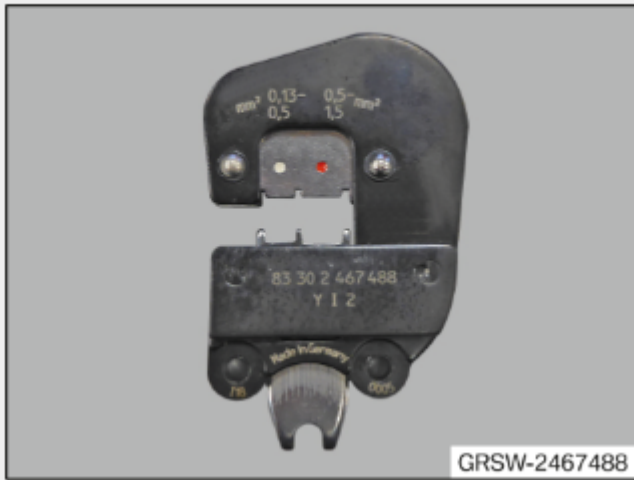
**2 467 488 Crimping tool**

Crimping tool 2 467 488 was shipped via Automatic Tool Shipment in late June 2022.
