Safety Recall

Code: 20DN

Fuel Level Sender

February 08, 2023

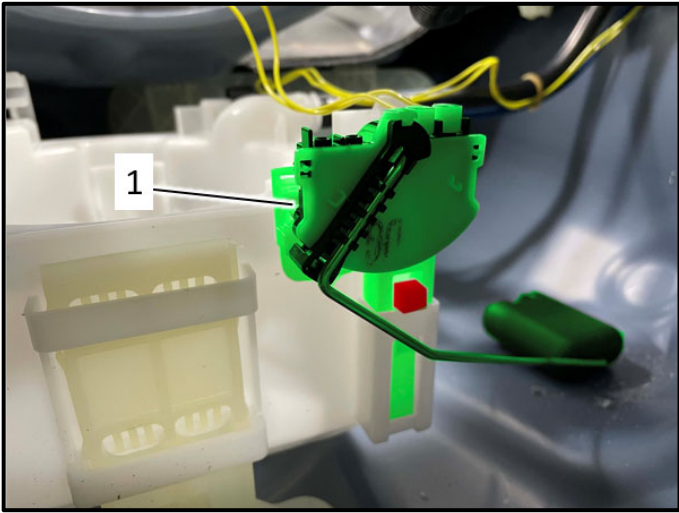
Repair Overview

Due to tolerance deviations, the distance between the fuel level sender and a ventilation pipe in the tank may be too small. As a result, the fuel level sender may get stuck on the ventilation pipe which will lead to a drop in the fuel level not being detected and therefore to an incorrect fuel level and remaining range being displayed in the instrument cluster. This may cause the vehicle to run out of fuel even though the indicator shows that there is still fuel in the tank. Inaccurate fuel indication may lead to an engine stall due to fuel starvation, increasing the risk of a crash.

In order to create a sufficient distance between the fuel level sender and the ventilation pipe, a sensor with tighter geometric tolerances will be installed within the fuel tank.

- Replace fuel level sender
