GROUP	MODEL
Safety Recall Campaign	2014-2016MY Cadenza (VG)
NUMBER	DATE
SC232 (Rev 2, 11/10/2022)	May 2022

SAFETY RECALL CAMPAIGN

SUBJECT: **WINDSHIELD INSPECTION & REATTACHMENT (SC232)**

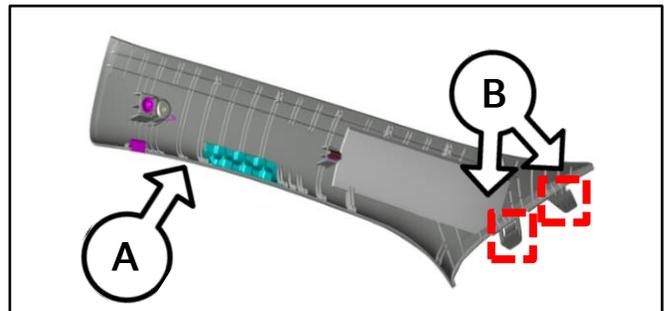
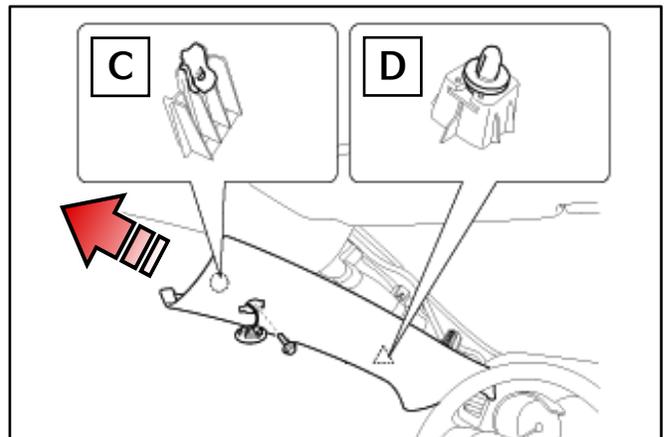
- When removing the front pillar trim, be careful not to break the two (2) keys (B) at the bottom.
- After removing the screw and detaching clip (C) and fastener (D) lift the front pillar trim in the direction of the headlining to remove it.

1. Before inspecting for leakage, remove the front pillar trim (A) on both sides of the vehicle by referring to the "Body (Interior and Exterior) → Interior → Interior Trim → Repair procedures" chapter in the applicable Shop Manual on KGIS.

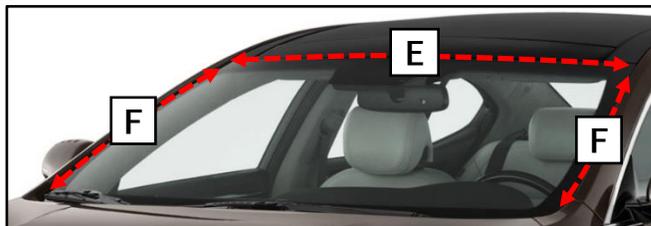
3. Inside the vehicle, inspect for water leakage along the top (E) and side pillar (F) areas of the windshield.
