# Safety Recall

## Code: 42L8

**Subject** Rear Suspension Knuckles  
**Release Date** June 10, 2022

**Subject: Safety Recall 42L8 – Rear Suspension Knuckles**

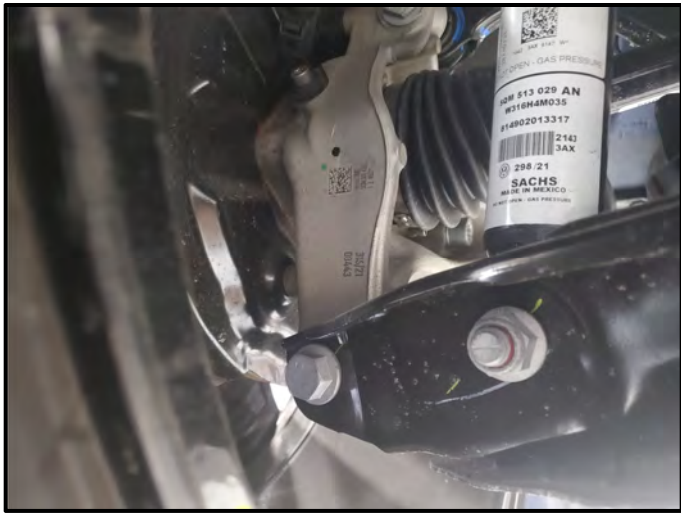
**Problem Description** Vehicles included in this recall may have been assembled with incorrectly manufactured rear knuckles. In the event of a rear knuckle breakage, the stability in the rear suspension will be compromised. Depending on the traffic/driving circumstances and driver behavior, this situation could pose a risk of a crash.

- Inspect rear wheel bearing housings and replace, if necessary.
