# Recall Campaign Bulletin

Campaign No. 2022050015, May 2022

SUBJECT: **Model GL-Class, ML-Class, and R-Class (X164, W164 and 251 platform)  
Model Year 2006-2012**

## **Inspect Brake Booster – without Pedal Rework**

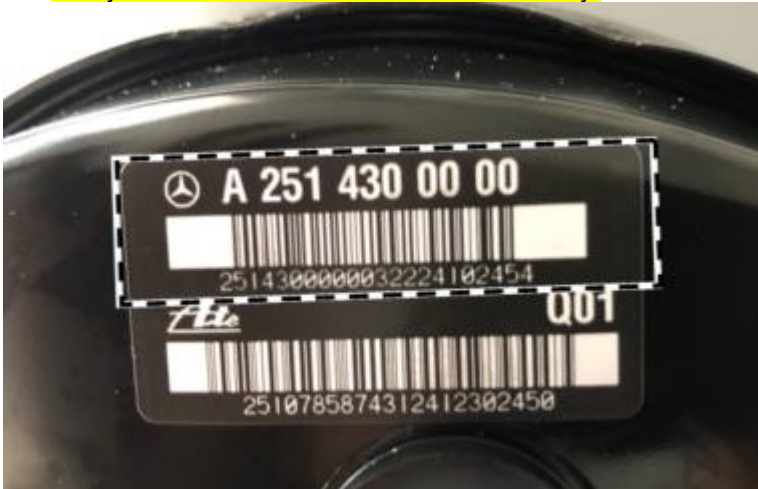
**Figure 12**

4. Read out serial number (**Figure 12**) using the **Mercedes-Benz PartScan** app.
