Recall Campaign Launch Notification			May 28, 2022
Campaign No. :	NHTSA ID	Campaign Desc. :	<b>Inspect Brake Booster Without Pedal Rework</b>
2022050015	22V315	22P4290005	
<p>This is to notify you of the Recall Campaign Launch to inspect the brake booster on <b>278,173</b> Model Year (“MY”) 2006-2012 GL-Class, ML-Class, and R-Class (X164, W164 and 251 platform) vehicles. The recall campaign will be visible on the <a href="http://www.safercar.gov">www.safercar.gov</a> website and may generate questions from customers. Affected VINs will be flagged in VMI as “OPEN” on <b>May 28, 2022</b>.</p>			
<b>Background</b>			
<b>Issue</b>	<p>Mercedes-Benz AG (“MBAG”), the manufacturer of Mercedes-Benz vehicles, has determined that on certain Model Year (“MY”) 2006-2012 ML-Class, GL-Class (W164/X164 platform) and R-Class (251 platform) vehicles, the function of the brake booster might be affected due to advanced corrosion in the joint area of its housing. After extended time in the field and in conjunction with prolonged water exposure, this corrosion might lead to a vacuum leak at the brake booster. If this were to occur, the brake force support might be reduced, leading to an increase in the

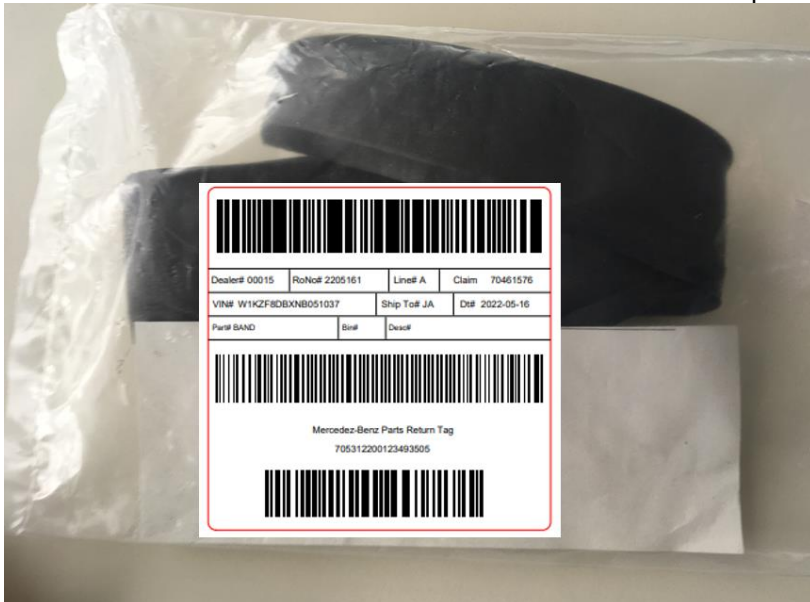
- For each vehicle processed, print out the part return barcode from the NetStar Parts Disposition application
- Pack the rubber sleeve with the part return barcode in a plastic bag and seal securely with barcode **visible from the outside** (see figure 1).
- For Dedicated Delivery Service (DDS) dealers, please forward parts in bulk (10-20 pcs per Load List unless time does not permit) to your facing PDC using the normal DDS warranty parts return process. Please ensure you include a Dealer Return slip marked for Warranty.
- For non-DDS dealers, please forward parts in bulk (10-20 pcs per Load List unless time does not permit) directly to the QEC using the normal FedEx Ground warranty parts return process.

All rubber sleeves should be individually tagged with a warranty parts return barcode and bagged. Recommend that bulk sleeve shipments are placed into a single overpack bag and then packaged in a small box with a copy of the Load List affixed to the box. Failure to return the rubber sleeve within the pre-defined time period will result in a non-return part debit.
