TO: Mercedes-Benz Dealer Principals, General Managers, Sales Managers, Service Managers, Parts Managers	FROM: Gregory Gunther, Department Manager, Vehicle Compliance and Analysis, Engineering Services
RE: <b>Recall Campaign Launch Notification – STOP DRIVE</b> <b>Inspect Brake Booster with Pedal Rework</b> <b>MY07-08 GL-Class, ML-Class, R-Class</b> <b>(X164, W164, 251 platform)</b>	DATE: May 28, 2022

Recall Campaign Launch Notification			May 28, 2022
Campaign No. :	NHTSA ID	Campaign Desc. :	<b>Inspect Brake Booster With Pedal Rework</b>
2022050014	22V315	22P4290006	
<p>This is to notify you of the Recall Campaign Launch to inspect the brake booster on <b>14,123</b> Model Year (“MY”) 2007-2008 GL-Class, ML-Class, and R-Class (X164, W164 and 251 platform) vehicles. The recall campaign will be visible on the <a href="http://www.safercar.gov">www.safercar.gov</a> website and may generate questions from customers. Affected VINs will be flagged in VMI as “OPEN” on <b>May 28, 2022</b>.</p>			
Background			
Issue	<p>Mercedes-Benz AG (“MBAG”), the manufacturer of Mercedes-Benz vehicles, has determined that on certain Model Year (“MY”) 2007-2008 ML-Class, GL-Class (W164/X164 platform) and R

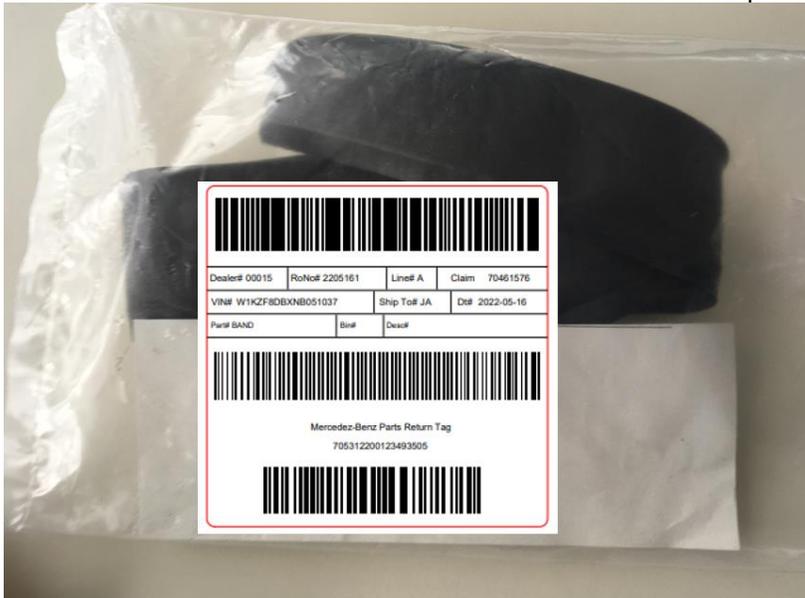
- For each vehicle processed, print out the part return barcode from the NetStar Parts Disposition application
- Pack the rubber sleeve with the part return barcode in a plastic bag and seal securely with barcode **visible from the outside** (see figure 1).
- For Dedicated Delivery Service (DDS) dealers, please forward parts in bulk (10-20 pcs per Load List unless time does not permit) to your facing PDC using the normal DDS warranty parts return process. Please ensure you include a Dealer Return slip marked for Warranty.
- For non-DDS dealers, please forward parts in bulk (10-20 pcs per Load List unless time does not permit) directly to the QEC using the normal FedEx Ground warranty parts return process.

All rubber sleeves should be individually tagged with a warranty parts return barcode and bagged. Recommend that bulk sleeve shipments are placed into a single overpack bag and then packaged in a small box with a copy of the Load List affixed to the box. Failure to return the rubber sleeve within the pre-defined time period will result in a non-return part debit.
