TO: Mercedes-Benz Dealer Principals, General Managers, Sales Managers, Service Managers, Parts Managers	FROM: Gregory Gunther, Department Manager, Vehicle Compliance and Analysis, Engineering Services
RE: Updated Recall Campaign Launch Notification – STOP DRIVE Inspect Brake Booster with Pedal Rework MY07-08 GL-Class, ML-Class, R-Class (X164, W164, 251 platform)	UPDATE: July 22, 2022

IMPORTANT RECALL CAMPAIGN UPDATE

Campaign No. 2022050014, May 2022

Inspect Brake Booster – with Pedal Rework

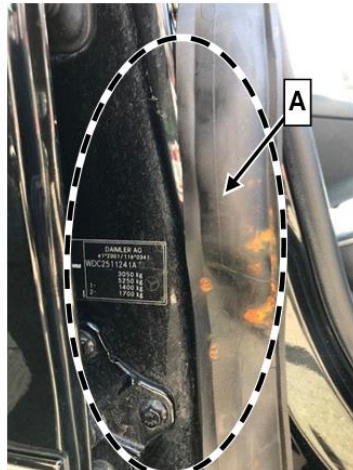
Figure 4

3. Take a photo of the rubber sleeve with the VIN label of the B-pillar (**A, figures 3 and 4**) and store to a local HDD/computer storage location with the vehicle service file and attach it to the warranty claim in EVA.

i These pictures serve as documentation of the current condition of the brake booster.
