# Recall Campaign Bulletin

Campaign No. 2022050015, May 2022

SUBJECT: **Model GL-Class, ML-Class, and R-Class (X164, W164 and 251 platform)**  
**Model Year 2006-2012**

## **Inspect Brake Booster – without Pedal Rework**

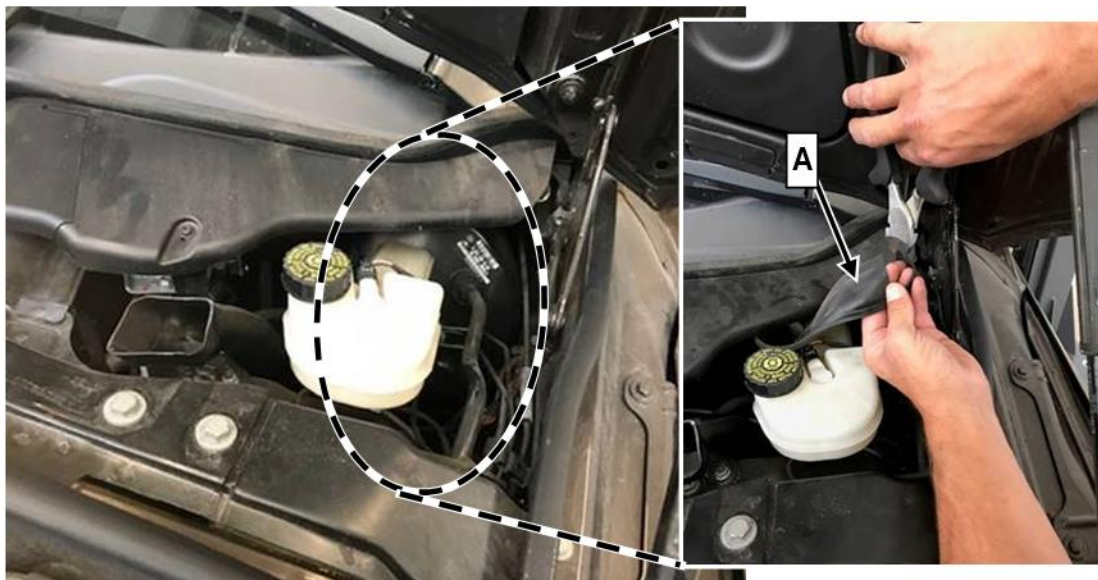
Figure 2

2. Remove the rubber sleeve wrapped around the brake booster (A, figure 2) with a suitable tool (hook and side cutting pliers). If the rubber sleeve is not present, please proceed to check/test procedure A1.  
**i** The rubber sleeve should be separated above the barcode label on the brake booster as seen in (A, figure 2 and B, figure 4.1).

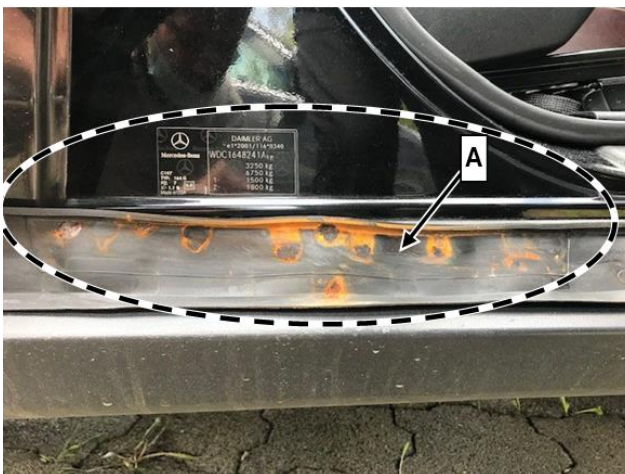
Figure 3

3. Take a photo of the rubber sleeve with the VIN label of the B-pillar (A, figures 3 and 4) and store to a local HDD/computer storage location with the vehicle service file and attach it to the warranty claim in EVA.  
**i** These pictures serve as documentation of the current condition of the brake booster.
