# Recall Campaign Bulletin

Rev. E: February 27, 2026

CAMPAIGN NO.	2023110006
CAMPAIGN DESC.	23P5497319
NHTSA ID	22V365
SUBJECT	<b>SIM Card Communication Module – Wave 7</b>
MODEL(S)	A-Class, C-Class, CLA, CLS, E-Class, G-Class, GLA, GLB, GLC, GLE/GLS, AMG GT 4-door, S-Class, and SLC vehicles (177, 205, 117, 118, 257, 213, 238, 463, 247, 156, 253, 166, 292, 167, 290, 217, 222 and 172 platform)
MODEL YEAR(S)	2017 – 2022
CAMPAIGN POPULATION	<b>23,699</b>

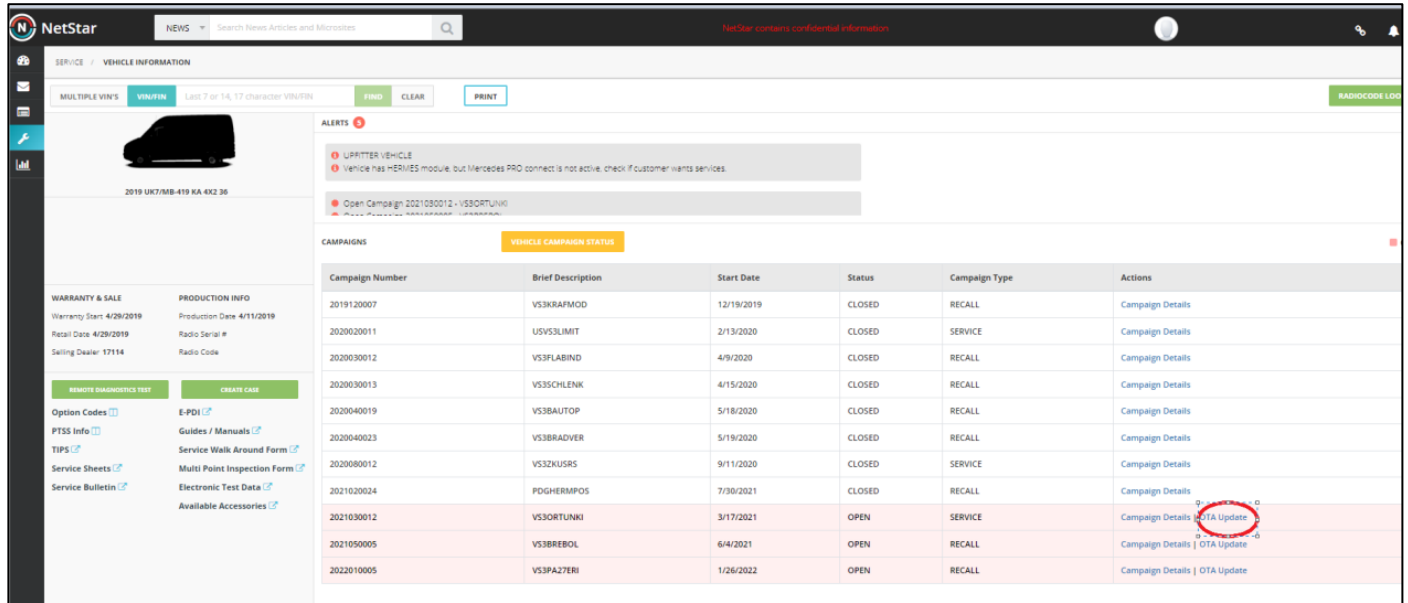
Figure 4 – In the “Actions” column, “OTA Update” is available, listed next to Campaign Number 2023110006

1. Log in to “NetStar” and call up the Vehicle Master Inquiry (VMI) screen.
2. Search for the vehicle identification number (VIN) (Figure 4).  
 [i] The “OTA Update” link becomes visible in the campaign table (next to Campaign Number 2023110006) in the VMI screen when the campaign is open for the selected vehicle.

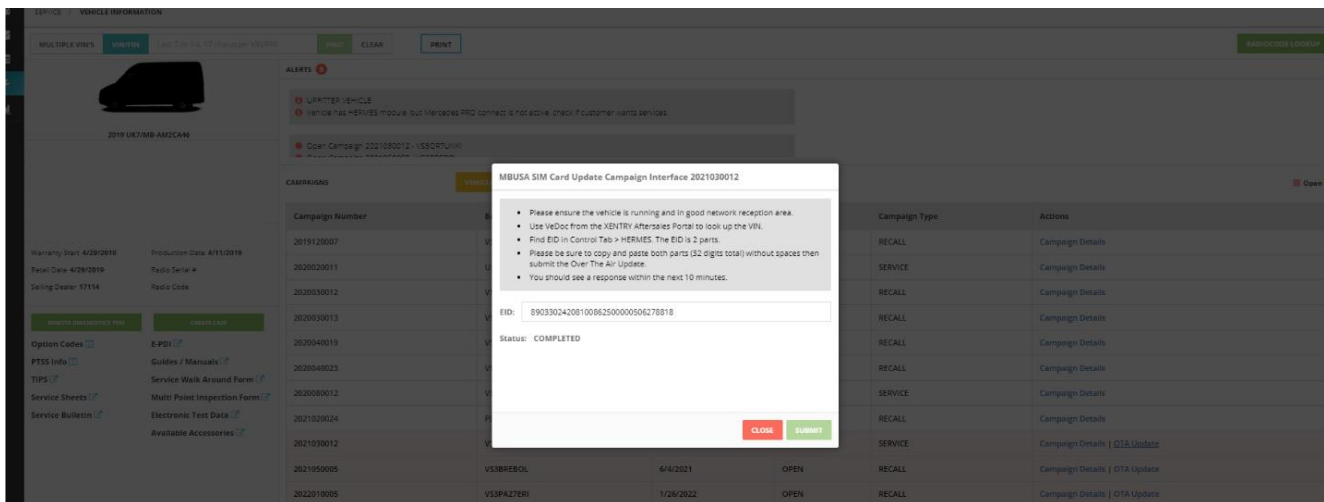
**Figure 10** (screen on “NetStar” if the OTA update was successful)  
*Status: Completed*
