VOLUNTARY RECALL CAMPAIGN

Classification: AT22-007A	Reference: NTB22-064A	Date: February 9, 2023
------------------------------	--------------------------	---------------------------

VOLUNTARY SAFETY RECALL CAMPAIGN 2020-2022 FRONTIER, TITAN/TITAN XD 4WD; TRANSMISSION PARKING PAWL PIN

CAMPAIGN ID #: R22A1
APPLIED VEHICLES: 2020-2021 Frontier (D40) 4WD
2022 Frontier (D41) 4WD
2020-2022 Titan and Titan XD (A61) 4WD

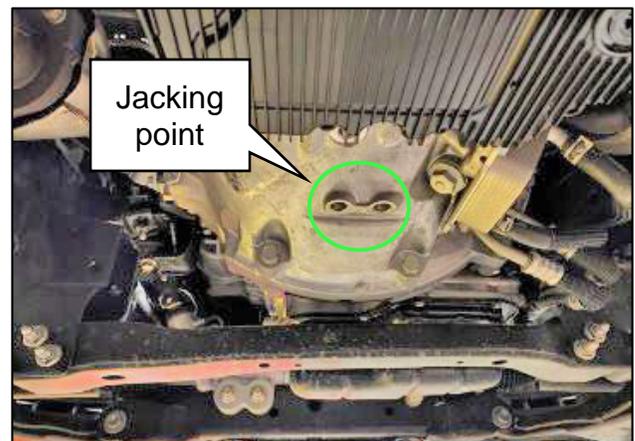
Figure 8

To avoid damage to the Transmission Assembly, do NOT support or lift the Transmission with the Transmission Pan.

- If it is necessary to support the Transmission Assembly during this procedure, use a suitable jack and a block of wood at the jacking point shown in Figure 8.

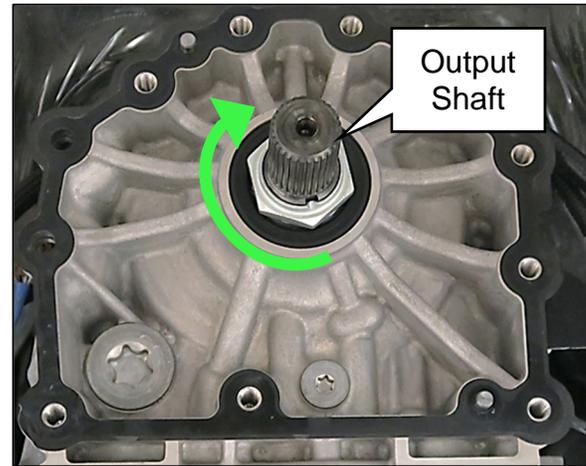
Figure 9

IMPORTANT: To help prevent the Parking Pawl from moving out of position after performing step 10, do **NOT** touch or move the Output Shaft **AFTER** removing the Parking Pawl Pin.

- Rotate the Output Shaft **clockwise** to seat the Parking Pawl against the Parking Gear, then release the output shaft.

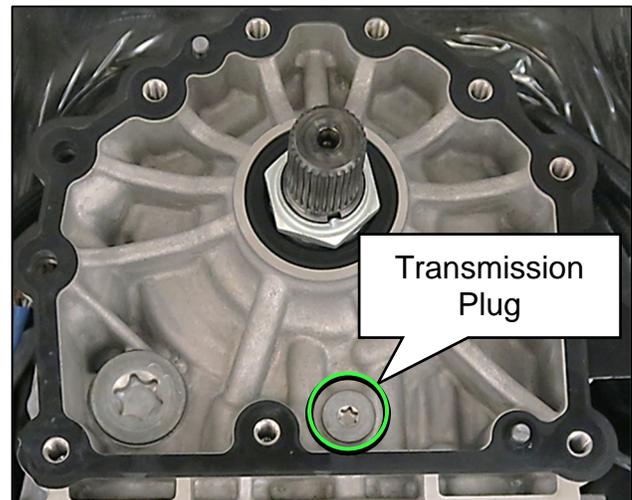
Figure 10

To prevent sealant entry and possible damage to the Transmission, ensure to remove **ALL** residual sealant from the Transmission Case threads after removing the Transmission Plug in step 12.

- Remove the Transmission Plug shown in Figure 10.

- During removal, loosen and tighten the Transmission Plug several times to remove sealant from the Transmission Case threads.
- Discard the removed Transmission Plug.
- Using a clean shop towel, remove the residual sealant from the Transmission Case threads.
