SAFETY RECALL BULLETIN

SUBJECT:			No: SR-22-003
IMPROPER OPERATION OF AUDIO UNIT – SAFETY RECALL CAMPAIGN			DATE: July 2022
			MODEL: 2022 Outlander
CIRCULATE TO:	<input checked="" type="checkbox"/> GENERAL MANAGER	<input checked="" type="checkbox"/> PARTS MANAGER	<input checked="" type="checkbox"/> TECHNICIAN
<input checked="" type="checkbox"/> SERVICE ADVISOR	<input checked="" type="checkbox"/> SERVICE MANAGER	<input checked="" type="checkbox"/> WARRANTY PROCESSOR	<input checked="" type="checkbox"/> SALES MANAGER

This Campaign Bulletin provides instructions to reprogram the In Vehicle Infotainment (IVI) system with modified software.

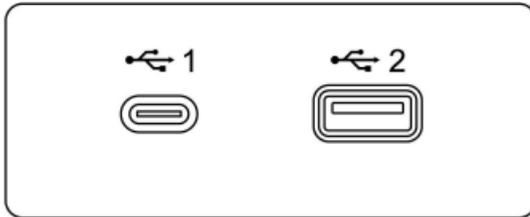
- Before proceeding with the update, remove any USB devices that may be inserted such as charging cables and memory sticks.
- IVI unit may fail and USB port (Type-C) may become unusable if you begin the update before removing USB devices.

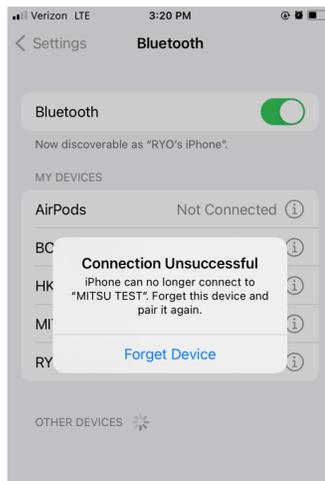
15. The following information and images (shown below and on the next page) are being provided to further clarify the Bluetooth information lost after the software update.
- Item #1 - Bluetooth devices/Wi-Fi stored will be lost - Bluetooth device name stored on the customers phone will need to be removed by using the Forget Device function:
