PRODUCT CAMPAIGN BULLETIN

APPLICABILITY: 2015-2021 MY WRX STI

NUMBER: WRE-22

SUBJECT: Safety Recall – Back-Up Lamp Switch Failure

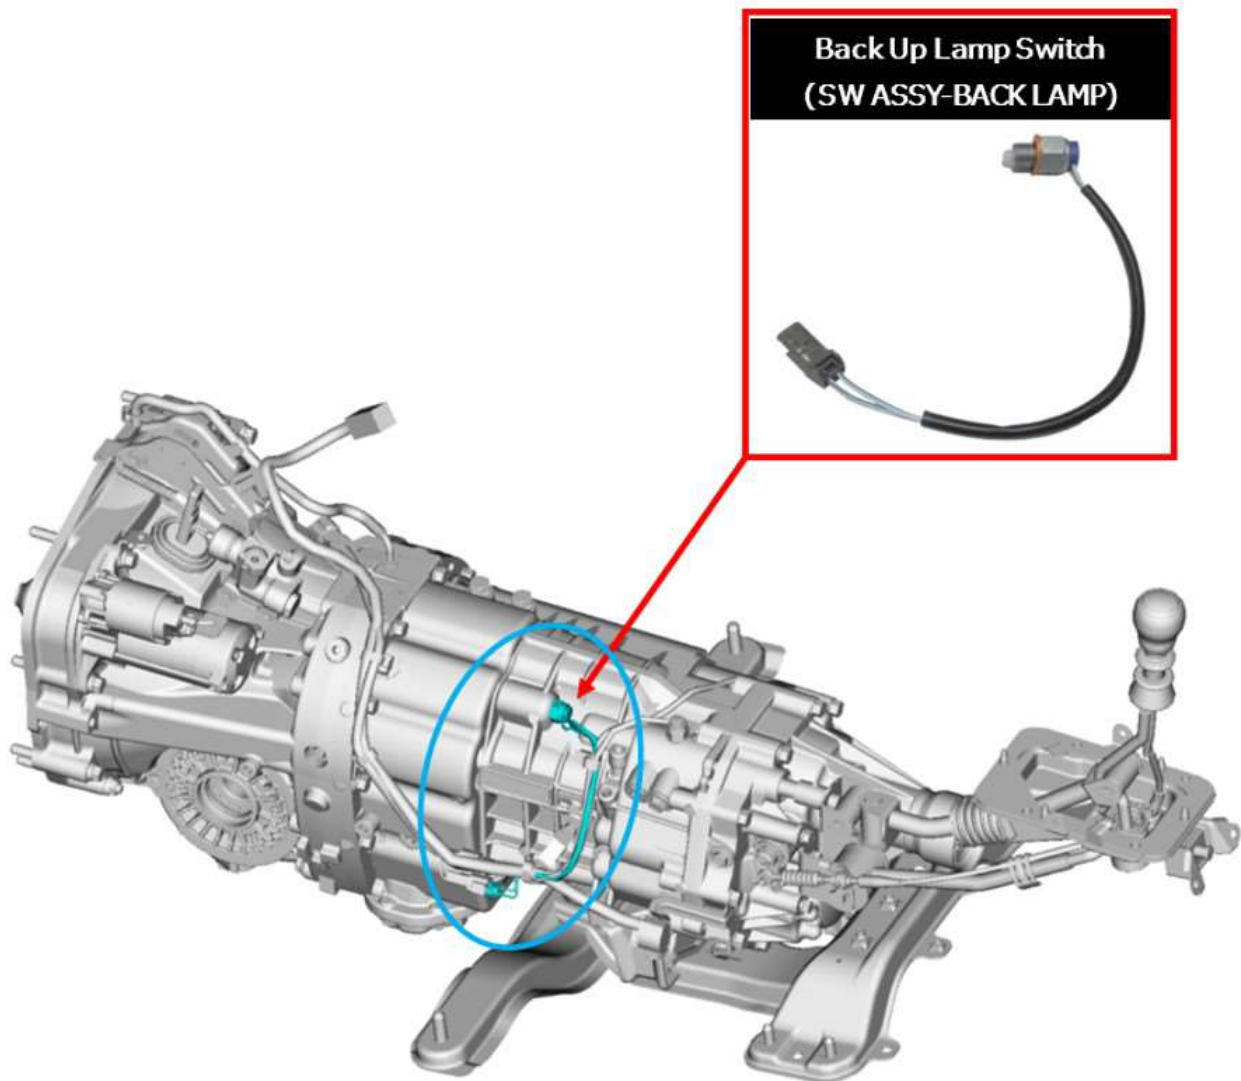
COMPONENT DESCRIPTION:

The operating environment of the back-up lamp switch may expose the internal switch contacts to heated oil. When heated, sulfur in the oil may cause a chemical reaction with the materials used on the switch terminal contact surfaces and plate spring. This chemical reaction may cause corrosion and a non-conductive film to form on the contacts resulting in poor electrical conductivity.

Over time, the back-up lamp switch may become inoperative which may result in the back-up lamps not illuminating when in reverse gear, the rear-view camera (if equipped) not displaying an image, and the select lever/gear position indicator in the combination meter not displaying ‘R’ for reverse gear.

For all potentially affected vehicles, Subaru retailers will conduct an inspection and replace the back-up lamp switch with improved one, if necessary, at no cost to the customer.
