Recall Campaign Bulletin

Campaign No. 2022080010, September 2022

SUBJECT: **Various Models**
Model Year 2019-2022

Check Transmission Wiring Harness Connector

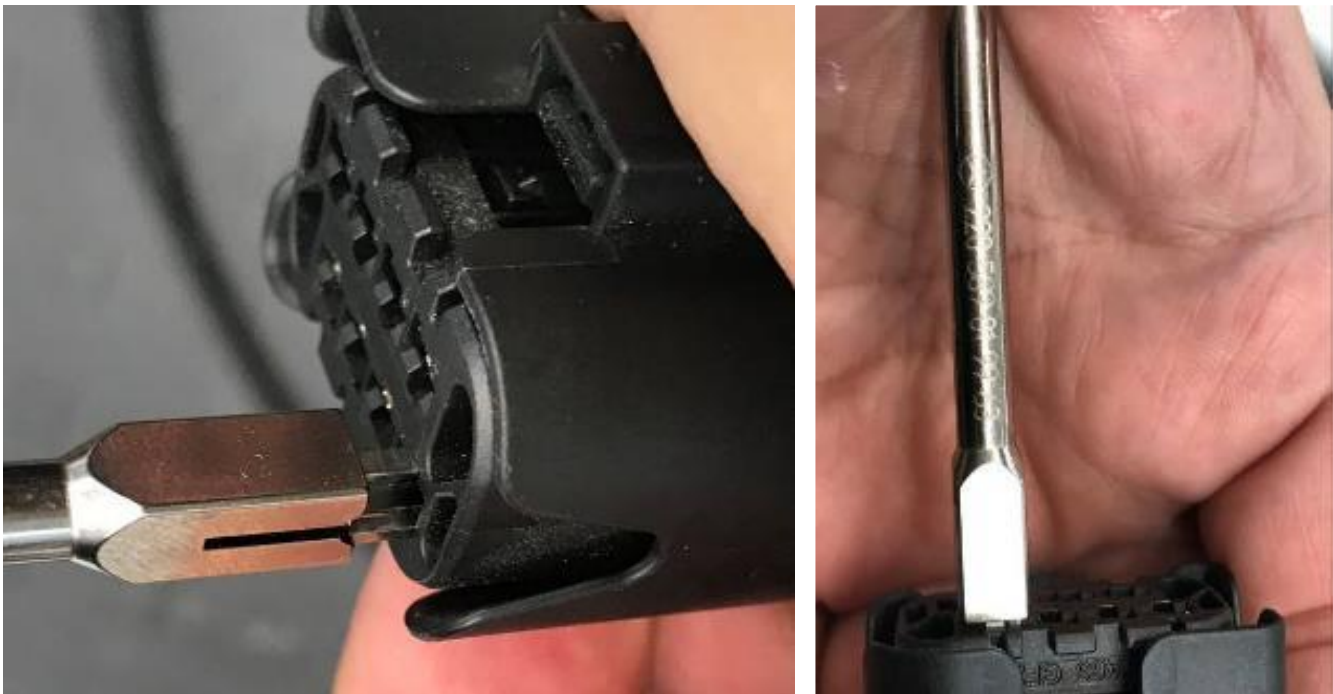
Figure 3

- a. If corrosion or moisture is detected, the vehicle-side wiring harness (A 290 540 99 14) must be repaired and the transfer case wiring harness (A 213 540 32 69) **must always be replaced**.
- b. If OK, **remove pins** from **vehicle-side** wiring harness (B, Figure 2) using special tool **W 220 589 01 99 63** (Figure 3) individually and **one after the other**, check for corrosion and damage, **and reinsert pins**.
