| Safety Recall Campaign | 2023MY Sportage (NQ5a) |
| SC248 | September 2022 |

ALTERNATOR B+ TERMINAL NUT INSPECTION AND TIGHTENING (SC248)

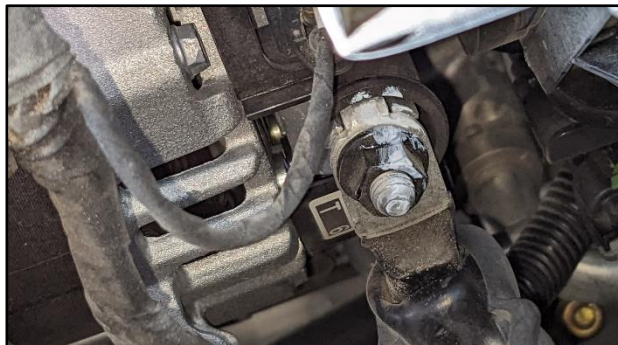
This bulletin provides information to inspect and, if necessary, tighten the alternator battery positive (B+) terminal nut on certain 2023MY Kia Sportage (NQ5a) vehicles equipped with 2.5L Theta III engine, produced from January 12, 2022 through August 8, 2022. The alternator B+ terminal nut ensures that the electrical connection is maintained between the battery wire harness terminal plate and the alternator B+ terminal. The alternator B+ terminal nut in the affected vehicles may not have been properly tightened during the assembly. If the terminal nut is not properly tightened, it can loosen over time and may result in an engine stall while driving or a fire may occur while driving due to electrical arcing at the B+ terminal. An engine stall increases the risk of a crash, and a fire increases the risk of injury. Follow the procedure outlined in this publication to inspect and, if necessary, tighten the alternator nut to specifications. Before conducting the procedure, verify that the vehicle is included in the list of affected VINs.
