# Safety Recall

## Code: 13i5

**Subject** Engine Connecting Rod

**Release Date** November 18, 2022

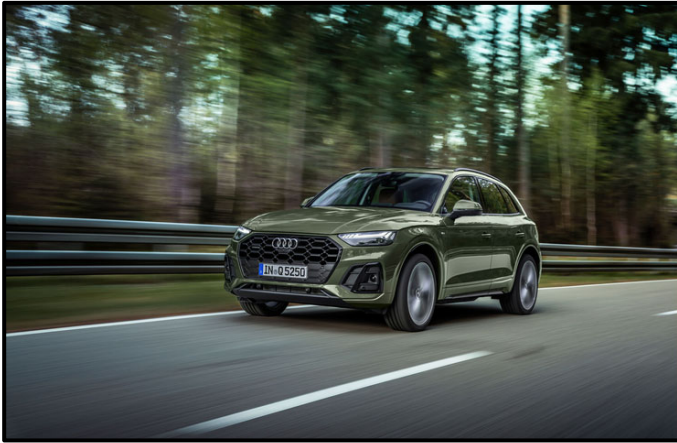
## Section B – Test Procedure: Oil Filter Replacement + Road Test (connecting rod stress test) + Oil Filter Inspection

- Turn engine off.
- Remove oil filter.
- See examples of OK and NOT OK oil filter and housing on the following pages.
- If no excessive metal particles are found:

- The engine requires replacement.
  - Take clear photos of oil filter and housing.
  - Proceed to Section C

- Remove oil filter.
- **Install a new oil filter and seal.**
- Run engine at idle until it reaches operating temperature of 90°C.
- Turn on air-conditioning and all other engine loads.

- Activate Sport mode.
- Following all traffic laws, perform a road test, quickly accelerating from 1<sup>st</sup> to 2<sup>nd</sup> gear, bringing engine RPM up to 4500 RPM each time.

- Engine does not require replacement.
  - **Replace oil filter and seal again.**
  - Torque housing to 25 Nm.
  - Proceed to Section D.
- If excessive metal particles are found:
