Recall campaign 5622K – Headlight Adjustment Prevention Caps

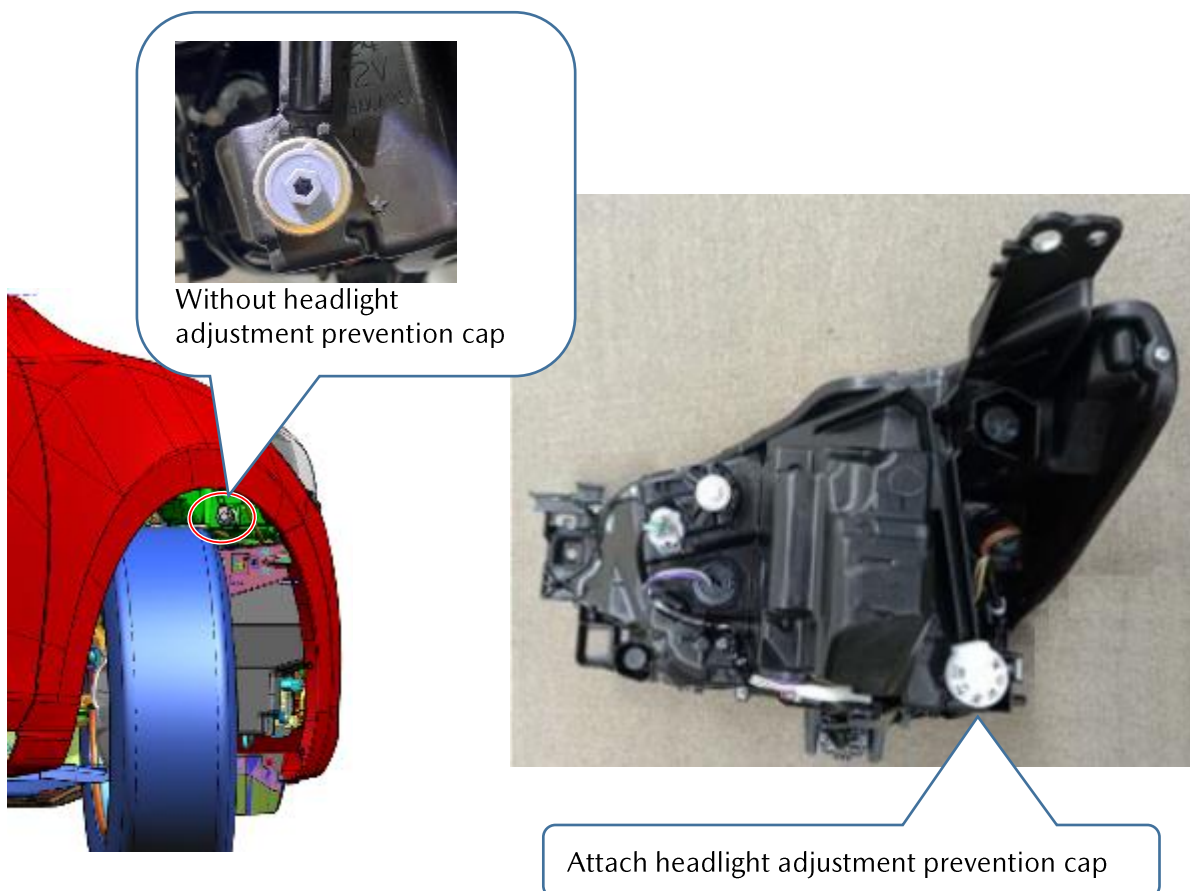
The photos below are of the RH side of the vehicle. Please perform the repair to both sides, RH and LH on the vehicle. The repair is the same for both sides of the car.

Removal of the Fender Well (LH Side shown below)

1. Turn the steering wheel completely to the right
2. Remove 6 fasteners using a standard body pry tool.
