# Product Safety Recall

## N212352530 Windshield Wiper Failure

**Release Date:** October 2022

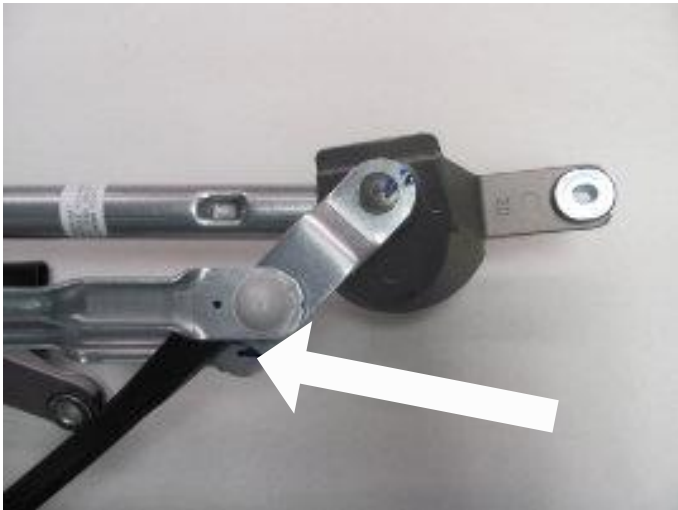
6055974

2. Place the assembly on the work bench or carefully secure it in a bench vise with non-marring inserts.

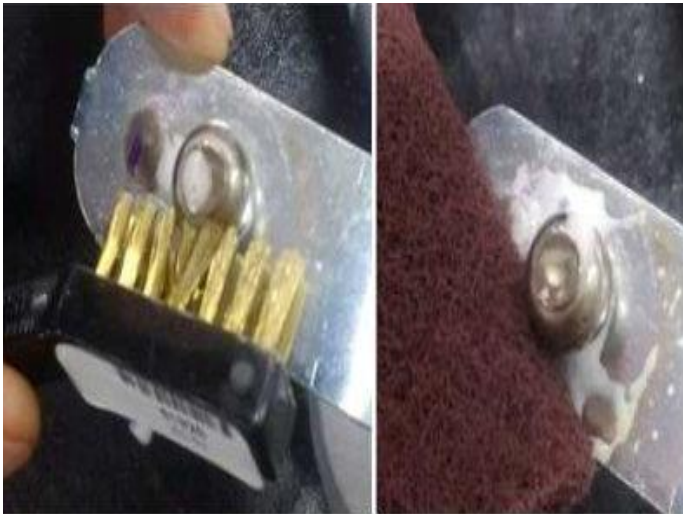
6055977

5. Using a suitable aerosol solvent and a small wire brush or abrasive pad, clean the old grease and debris from the ball joints. Wipe the ball joints clean with a suitable disposable towel.
6. With the ball joints cleaned, inspect the surface for severe damage (material missing).

**The below examples are acceptable levels pitting, flaking and rust residue.**

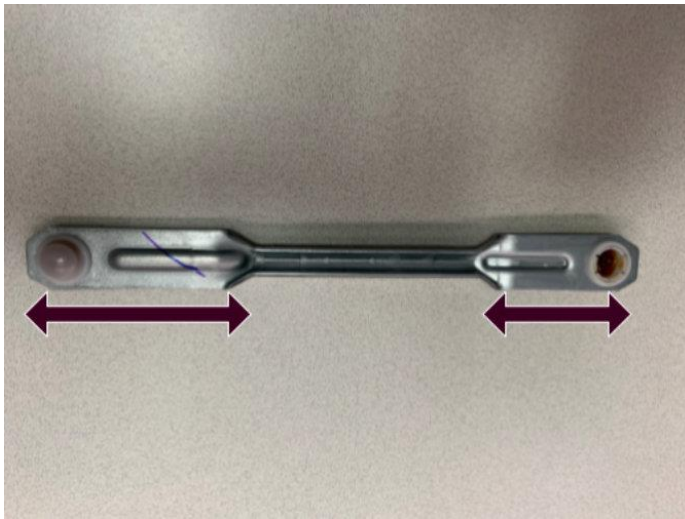
6055987

**IMPORTANT:** The short link rod has a long side and a short side. The long side is marked by a blue paint stripe. Ensure the long side is installed onto the motor pivot ball. Improper installation of this link will cause interference with the rotating assembly.

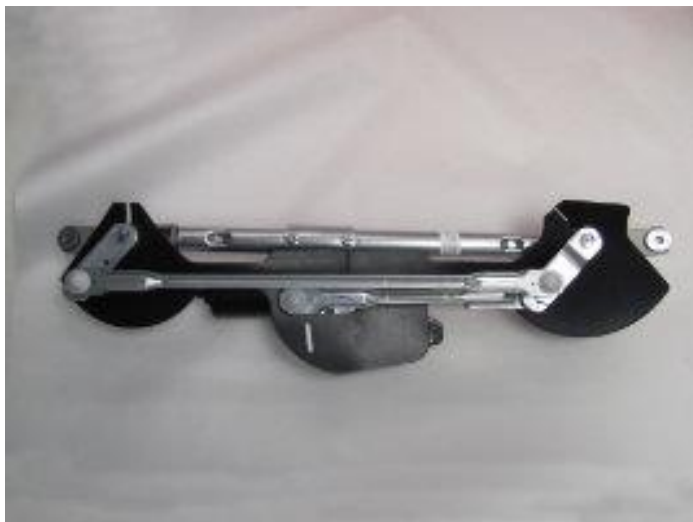
6055986

**NOTE:** The rain shield may have a curve to the material causing the rotating linkage to rub, this is an expected condition, it will not affect the performance of the assembly.
