August 4, 2023

SUBJECT: **NEW VEHICLE DEMONSTRATION / DELIVERY HOLD –
 Safety Recall 23S06 – *Supplement #2***

Certain 2022-2023 Model Year Bronco, Explorer, F-150, Mustang and 2023 Aviator
 Vehicles Equipped With 10 Speed Automatic Transmission
 Transmission Assembly Inspection

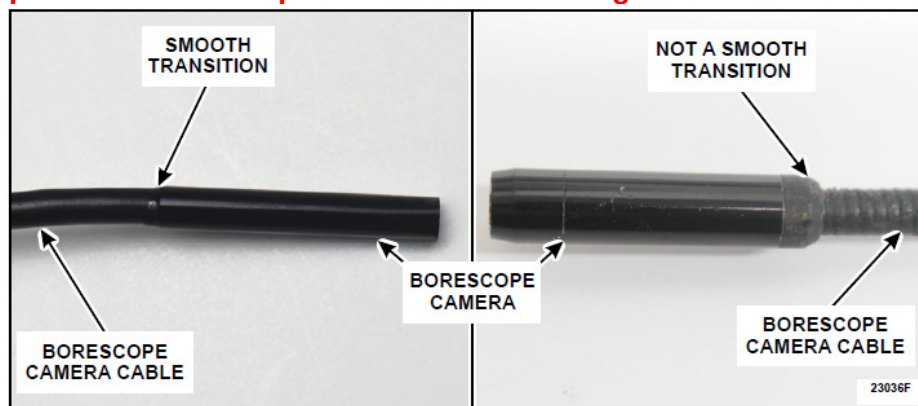
NOTE: The camera attachment to the cable end must be a smooth transition with no raised lip/edge. A raised edge or lip at the camera connection could cause it to get stuck in the transmission and require complete disassembly. **A metal braided cable is highly recommended.**

DO NOT attempt to use a borescope that has a camera larger than 6.0 mm diameter.

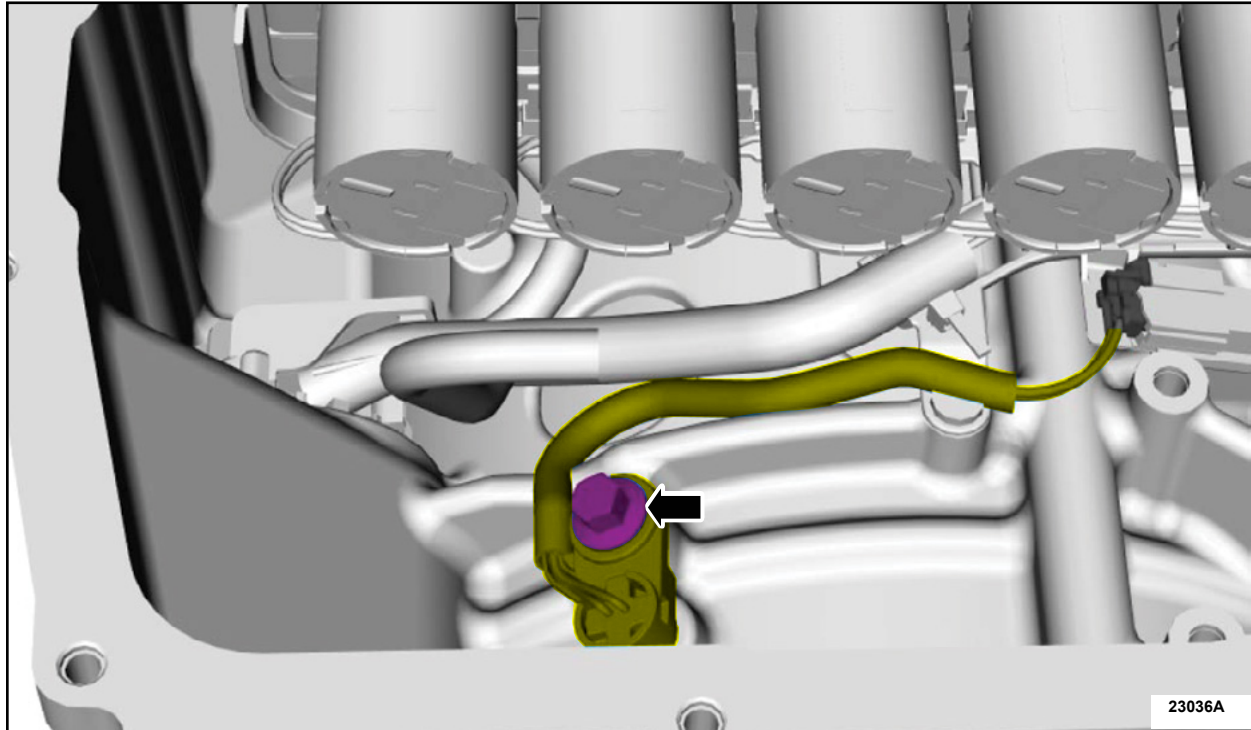
FIGURE 2

4. Remove the bolt and position aside the output shaft speed sensor. See Figure 2.

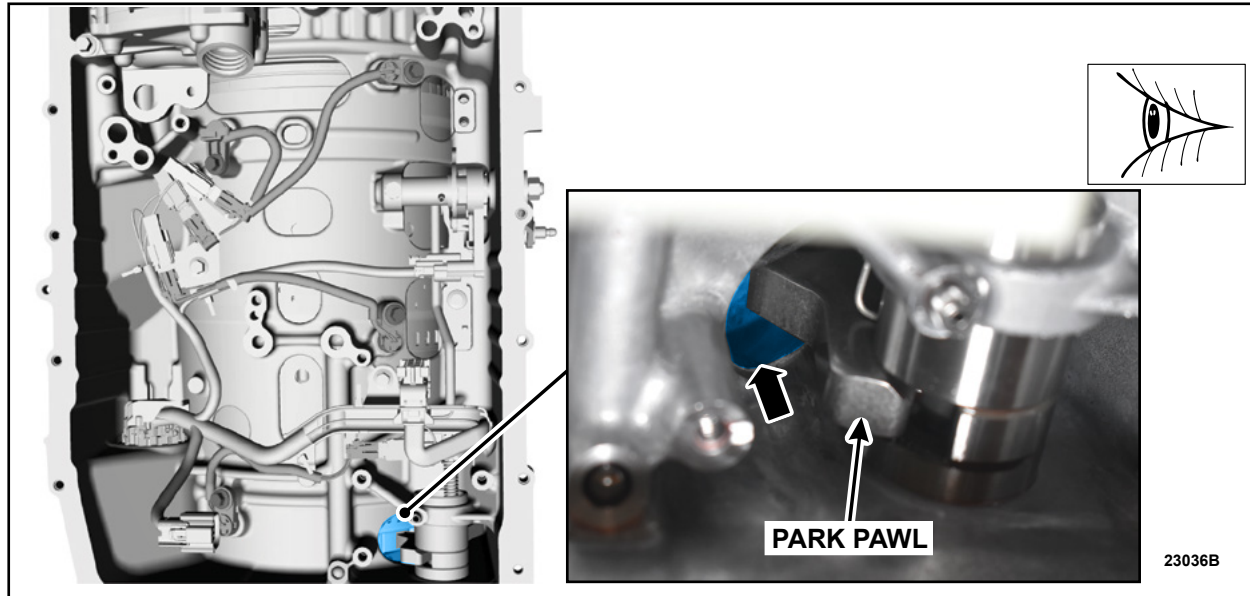
FIGURE 3

5. Visually inspect the park pawl area for a bolt. See Figure 3. Is a bolt present?

YES - Submit a photo of the bolt found in the transmission assembly, the VIN, and the transmission oil pan removed. Replace the transmission. Follow the WSM procedures in Section 307-01. This completes the FSA.
