SUBJECT: **NEW VEHICLE DEMONSTRATION / DELIVERY HOLD –
 Safety Recall 23S06 – *Supplement #1***

Certain 2022-2023 Model Year Bronco, Explorer, F-150, Mustang and 2023 Aviator
 Vehicles Equipped With 10 Speed Automatic Transmission
 Transmission Assembly Inspection

REF: **NEW VEHICLE DEMONSTRATION / DELIVERY HOLD –
 Safety Recall 23S06**

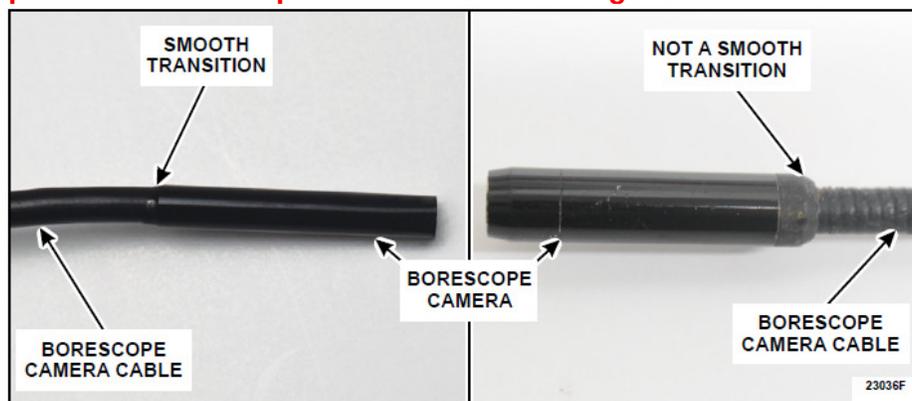
NOTE: The camera attachment to the cable end must be a smooth transition with no raised lip/edge. A raised edge or lip at the camera connection could cause it to get stuck in the transmission and require complete disassembly. **A metal braided cable is highly recommended.**

DO NOT attempt to use a borescope that has a camera larger than 6.0 mm diameter.

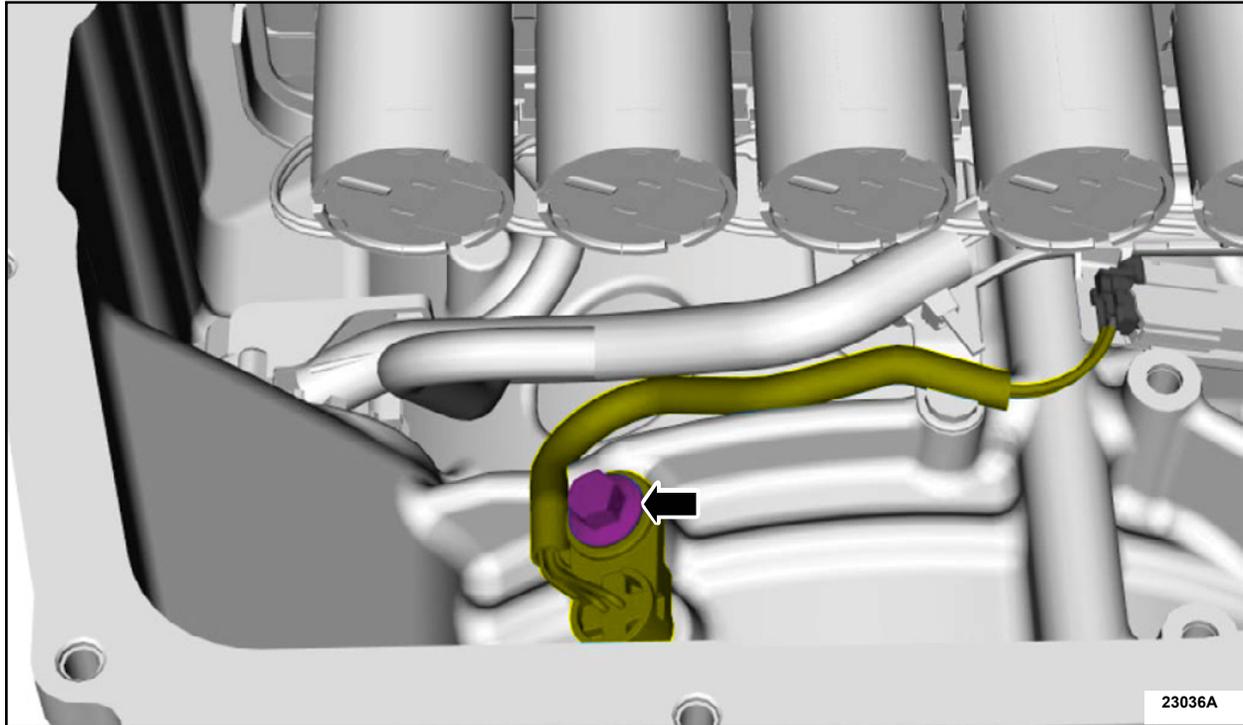
FIGURE 2

4. Remove the bolt and position aside the output shaft speed sensor. See Figure 2.

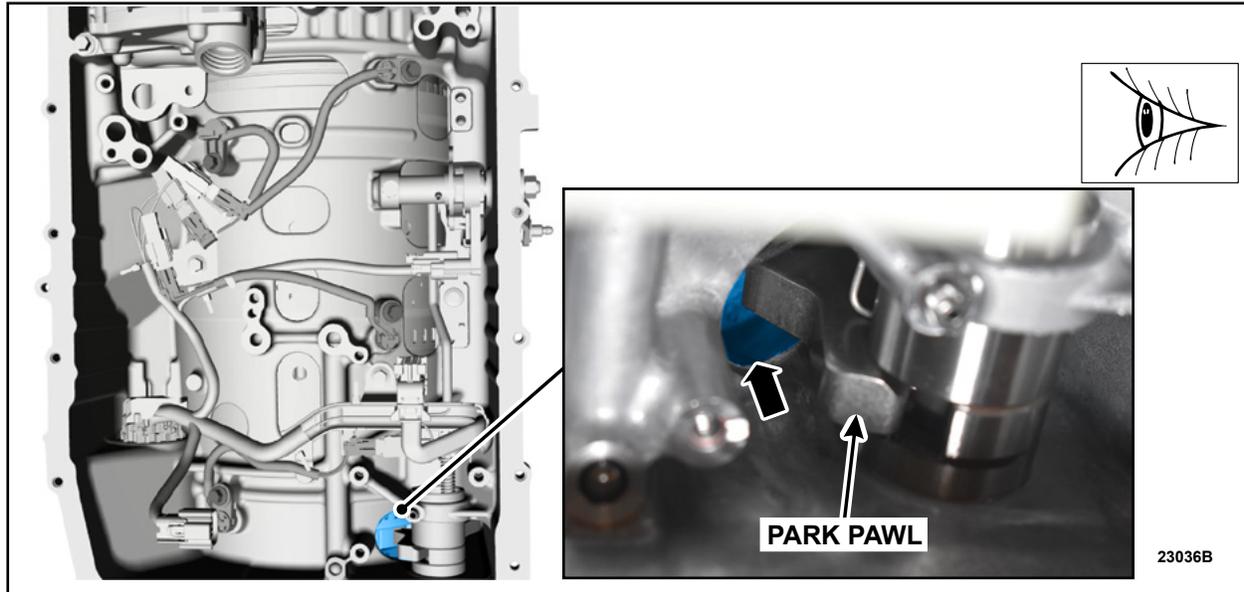
FIGURE 3

5. Visually inspect the park pawl area for a bolt. See Figure 3. Is a bolt present?

YES - Submit a photo of the bolt found in the transmission assembly, the VIN, and the transmission oil pan removed. Replace the transmission. Follow the WSM procedures in Section 307-01. This completes the FSA.
