Bentley Bulletin

23-023

Subject: NON COMPLIANCE RECALL - SEAT AIR BAG MAY TEAR (RE23/03)

New Continental GTC and Bacalar

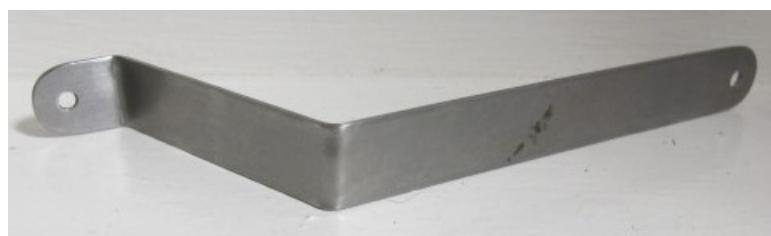
Figure 6

- Mandrel tool - WT10662 (Figure 6)

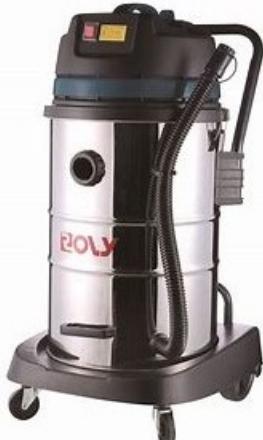
Figure 8

An industrial vacuum cleaner for removing swarf when conducting the rework process is also required and must also be sourced locally (Figure 8)

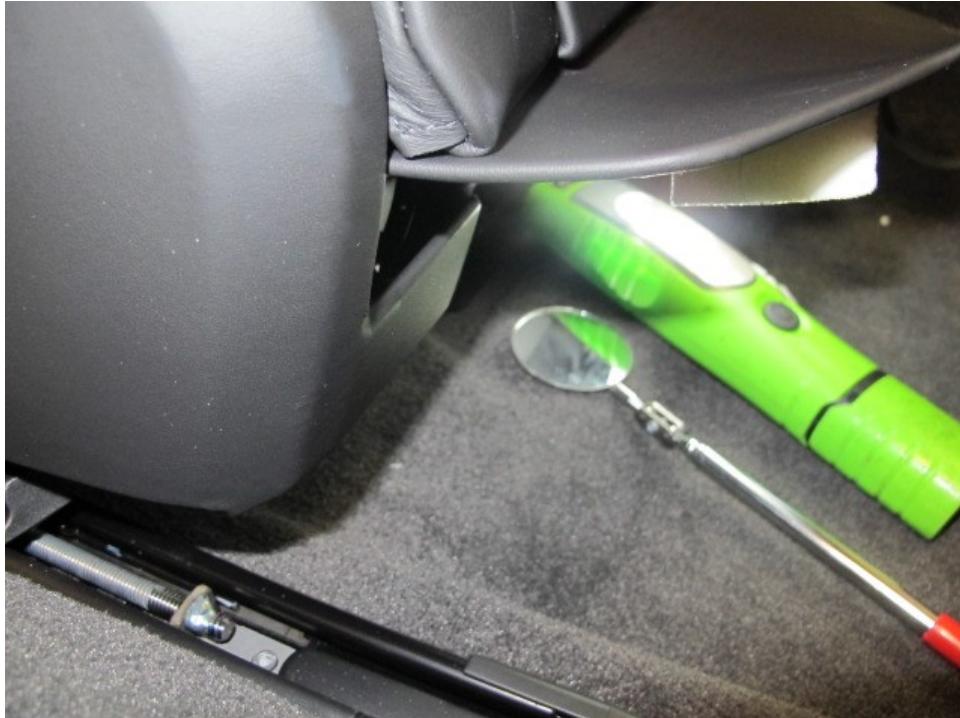
Figure 9

TIP: To ease removal and refitting of the straps/fixings it is recommended to use an inspection mirror and a suitable inspection lamp to assist with locating the straps/fixings (Figure 9)

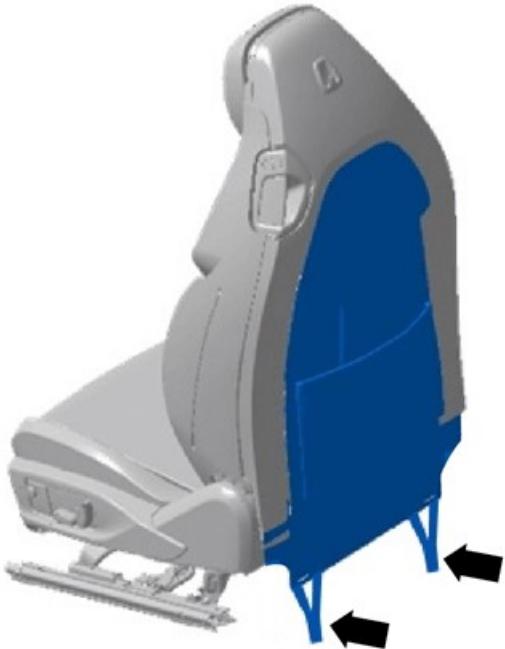
- Referring to Figure 10 - Release the straps from the points on the underside of the cushion frame

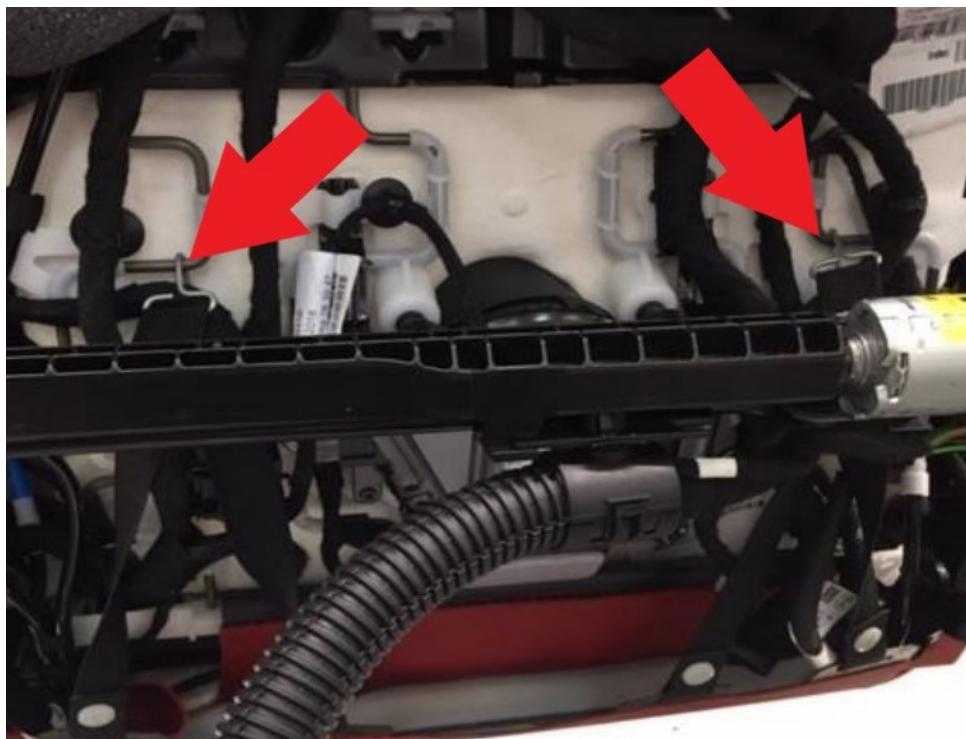
HINT: Take note of the points before removal to ensure the straps are refitted in the same location on completion, see the example shown in Figure 11

THE STRAPS MUST ONLY BE ATTACHED TO THE SEAT CUSHION SPRINGS AS SHOWN IN FIGURE 11

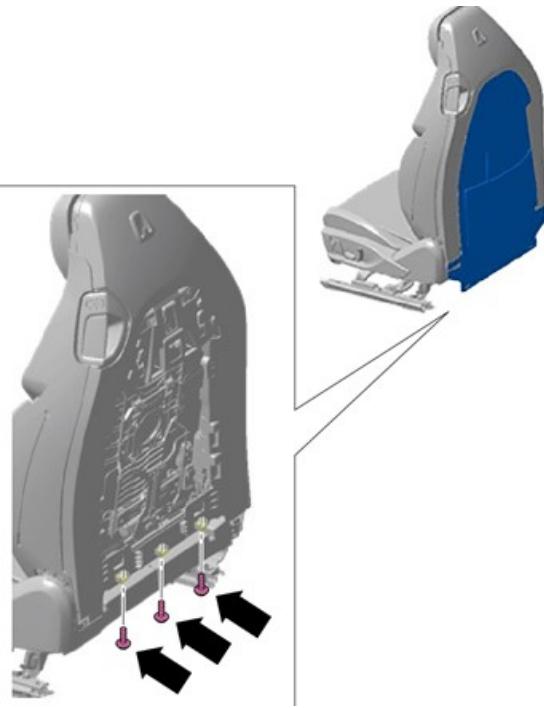
Figure 12

3) Remove the (x3) fixings (3.5 Nm) at the base of the back panel (Figure 12)

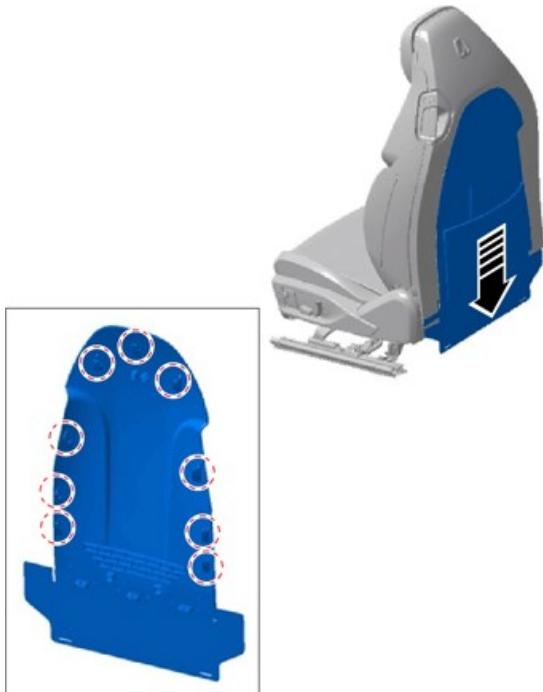
Figure 13

4) Slide the back panel downwards and remove (Figure 13)

Once removed, the back panel should be stored in a safe and clean environment

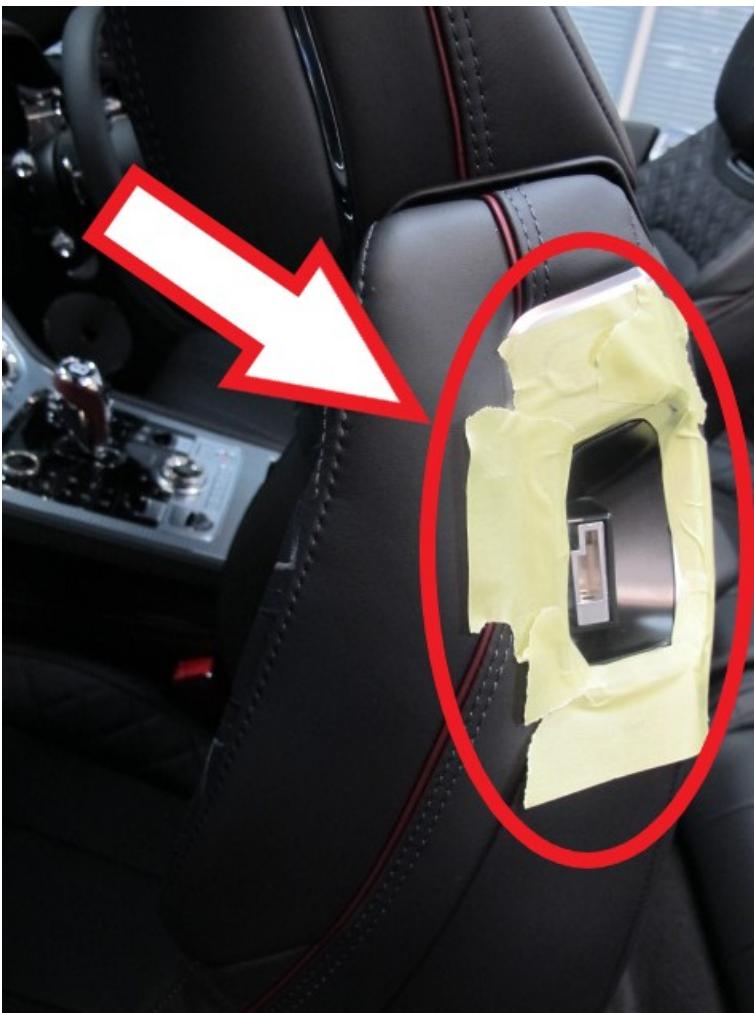
Figure 14

Ensure the surround is suitably protected during the process (Figure 14) as any damage will not be covered under Warranty

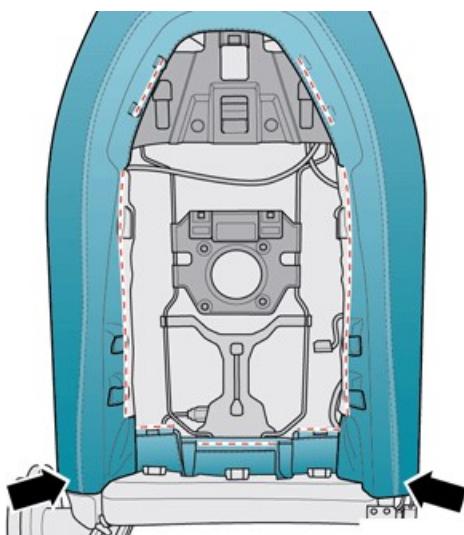
Referring to Figure 15 - Release the squab cover from the clipping points -dotted lines- at the rear

Take extreme care when removing the squab clamshell at the lower corners as damage can easily be caused, any damage caused within this area will not be covered under Warranty

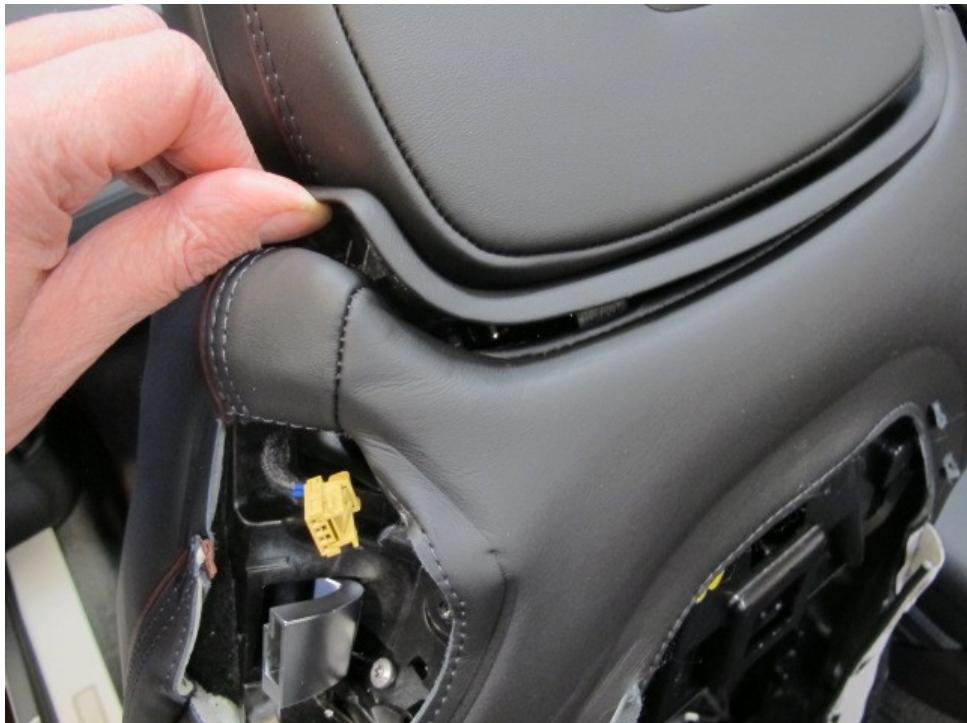
Figure 17

- Referring to Figure 16 - Use a non-metallic trim tool, release the squab finisher -1- which is secured by four clips
- The trim does not require removing completely, the trim requires releasing from the clipping points to allow the squab cover to relax (Figure 17) during the next part of the procedure

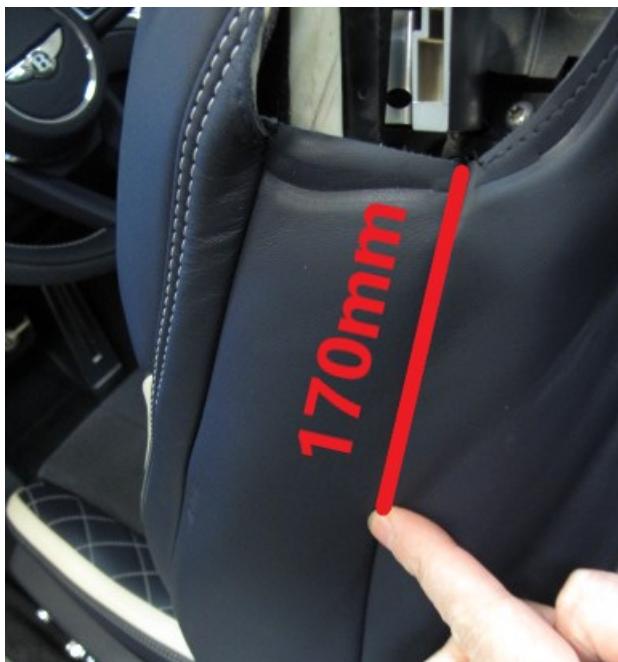
- For guidance - The side rivet is located at the approximate point shown in Figure 18 (approximately 170mm downwards from the release handle)

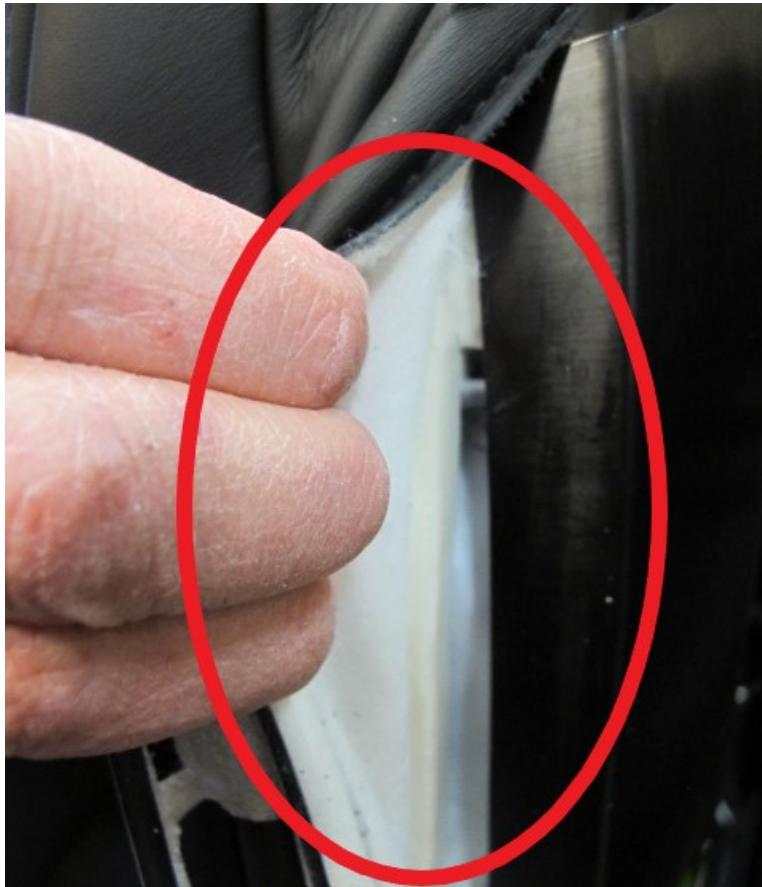
The operative **MUST** ensure the position of the foam and front seat airbag sock is as shown within Figure 19 (Not damaged or twisted)

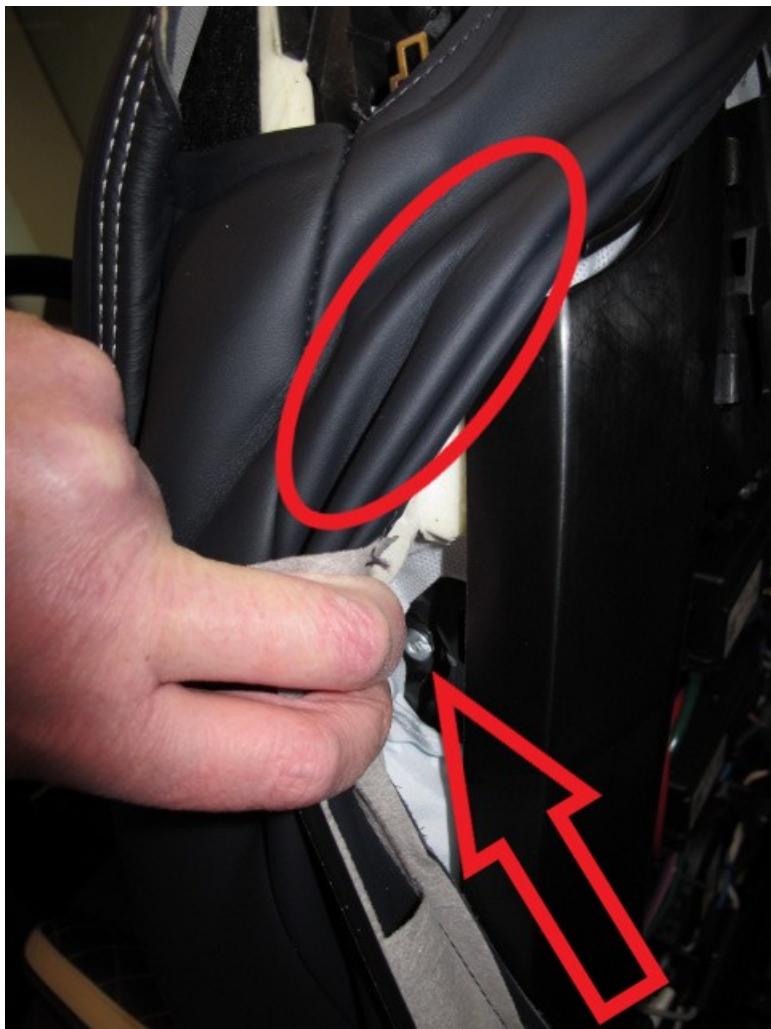
6) Referring to Figure 20 - With extreme care the operative should manoeuvre the front seat squab cover as shown

Take care not to stretch or damage the seat squab cover when conducting the onward check, the location shown in Figure 20 (upper corner of the seat clam) has a pointed edge, in the event care is not taken, damage can be caused to the seat squab cover, any damage caused within this area will not be covered under Warranty

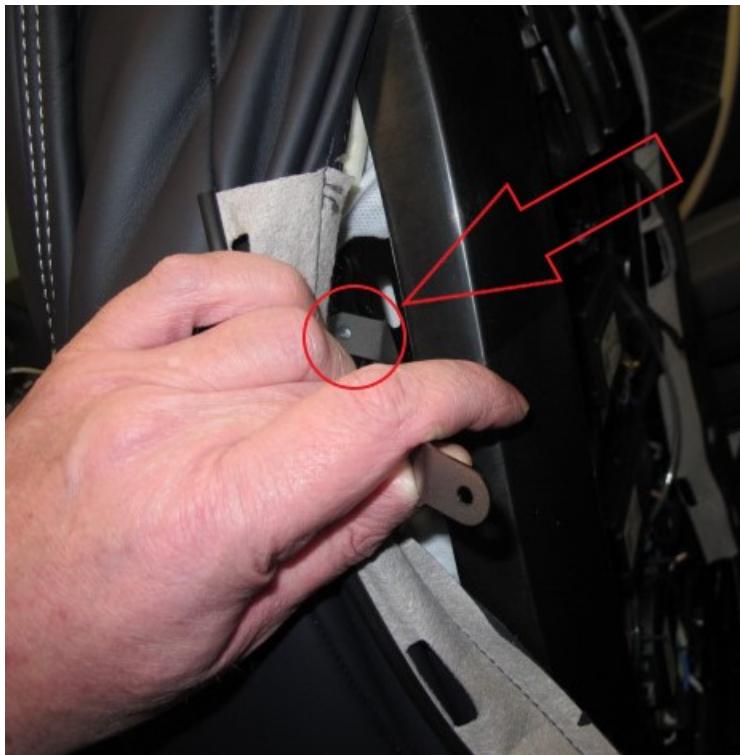
7) Referring to Figure 21 - Using WT10662 the operative should measure the protrusion of the rivet mandrel as follows:

- Position WT10662 over the rivet head/mandrel as shown

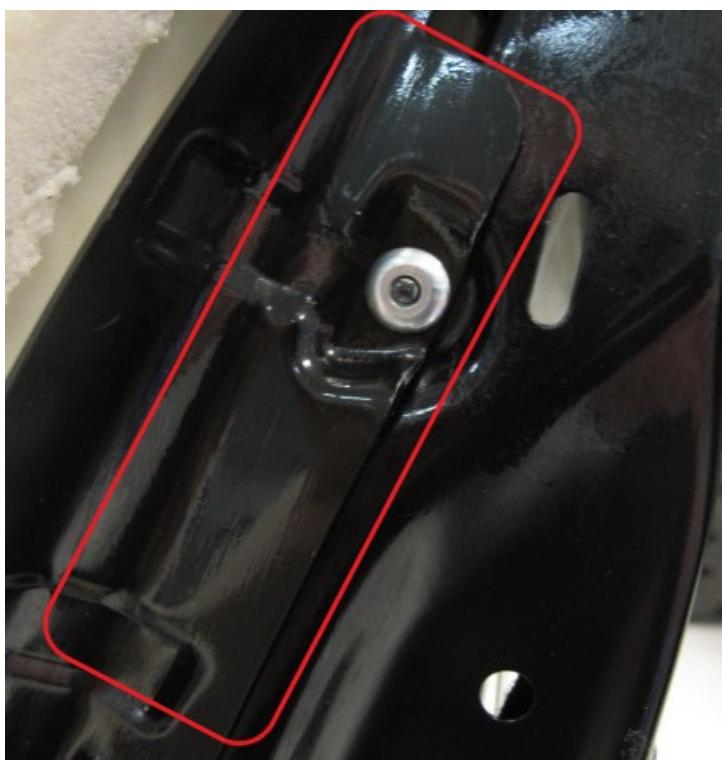
Figure 25

- Using a suitable degreasing agent for example MYKAL high performance wipes - De-grease the area shown within in Figures 25 and 26

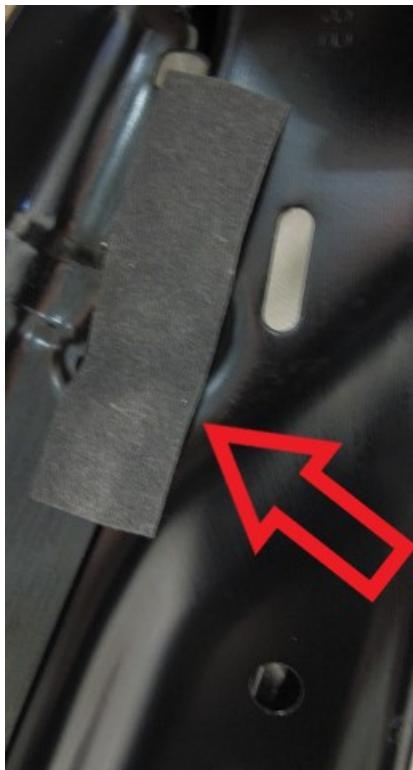
- 9) Referring to Figure 27 - Apply the first Paraskin strip at the location shown

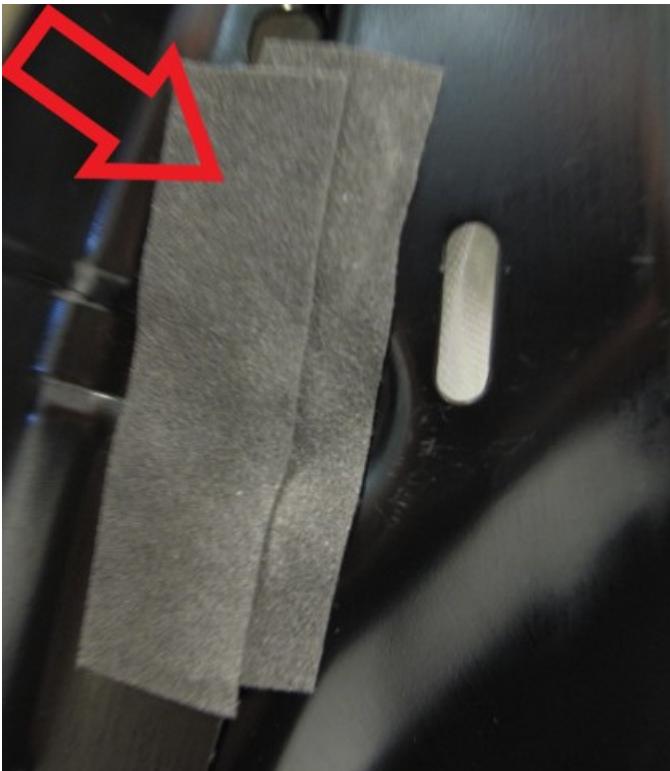
- Referring to Figure 28 - Apply the second Paraskin strip at the location shown

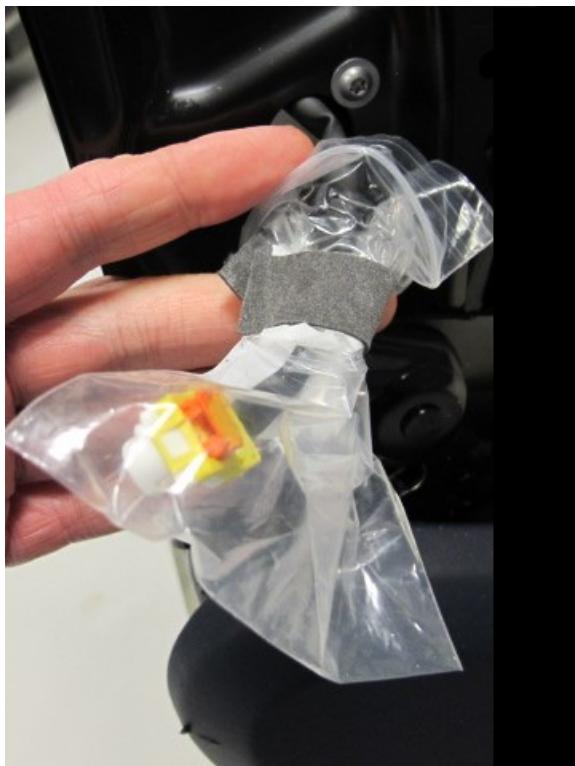
Figure 30

- Ensure the airbag connection is suitably protected to ensure swarf cannot enter the airbag plug (Figure 30)

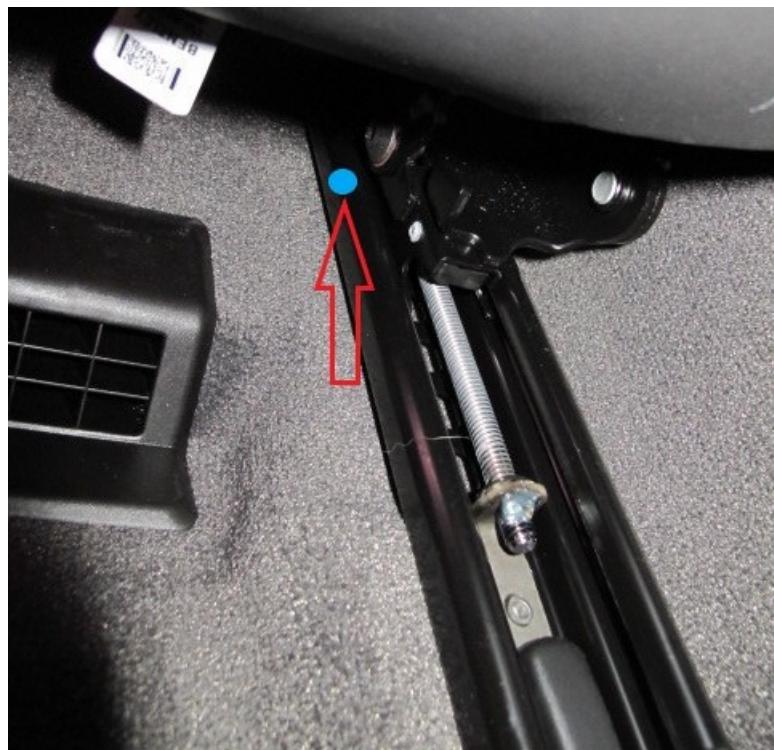
Figure 33

Blue paint completion mark on the left side inner seat rail (Figure 33)
