Service Engineering Operations
Ford Customer Service Division

SUBJECT: **NEW VEHICLE DEMONSTRATION / DELIVERY HOLD –
Safety Recall 23S55 - *Supplement # 4***
Certain 2020-2022 Model Year Explorer Vehicles
Rear Axle Bolt Fractures

CERTAIN 2020-2022 MODEL YEAR EXPLORER VEHICLES — REAR AXLE BOLT FRACTURES

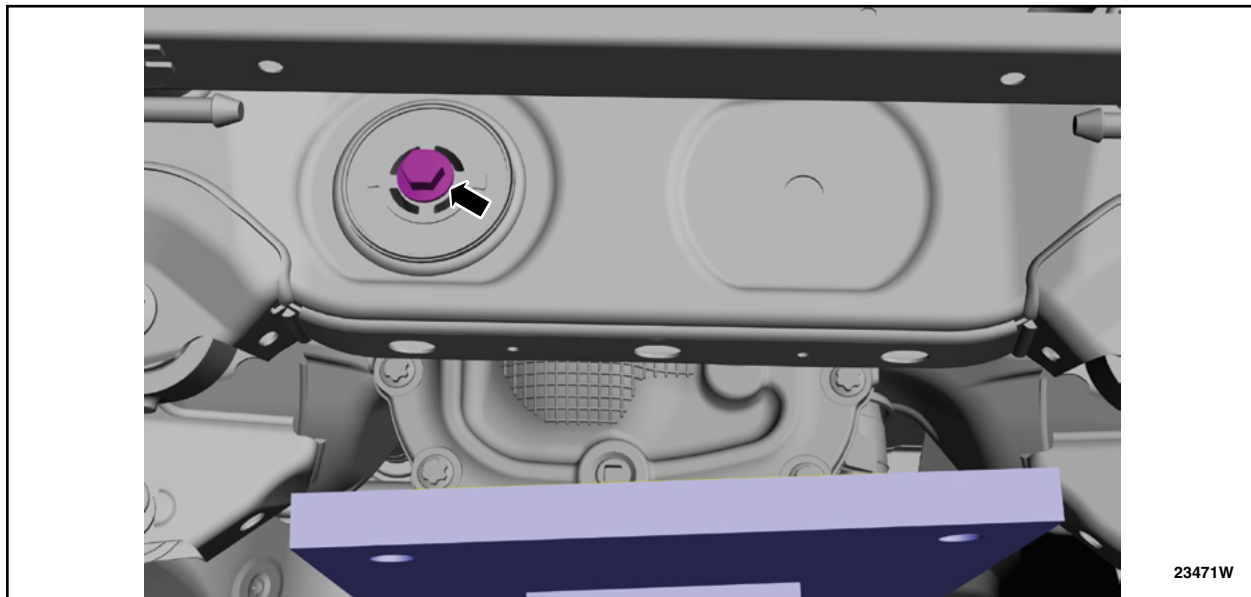
FIGURE 1

1. With the vehicle in NEUTRAL, position it on a hoist. Follow the WSM procedures in Section 100-02.
2. Does the Rear Differential Unit (RDU) contains One or Two RDU axle cover to subframe mounting bolts? See Figures 1 and 2.
 - A. The RDU only contains ONE (1) axle cover to subframe mounting bolt. Proceed to Step 3.
 - B. The RDU contains TWO (2) axle cover to subframe mounting bolts. This Recall is complete and no further repairs are required. Refer to the Dealer Bulletin for RDU claiming instructions.
