Stacy L. Balzer
 Director
 Service Engineering Operations
 Ford Customer Service Division

SUBJECT: **NEW VEHICLE DEMONSTRATION / DELIVERY HOLD – *Supplement # 1***
Safety Recall 23S55

Certain 2020-2022 Model Year Explorer Vehicles
 Rear Axle Bolt Fractures

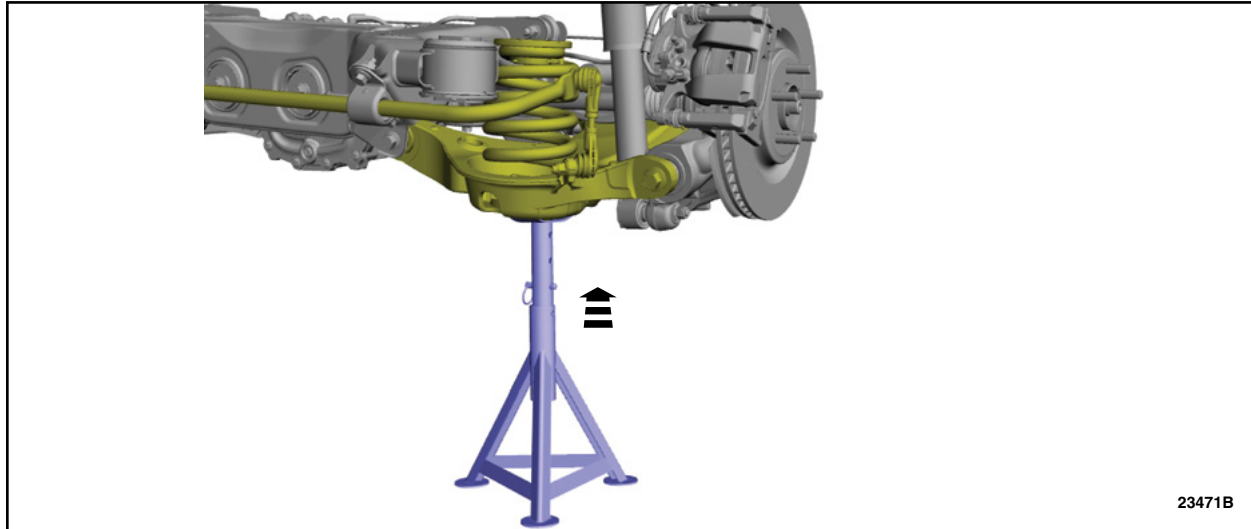
FIGURE 1

4. Use a suitable jack to raise the suspension until the distance between the center of the hub and the lip of the fender is equal to the measurement taken during removal (curb height). See Figure 1.

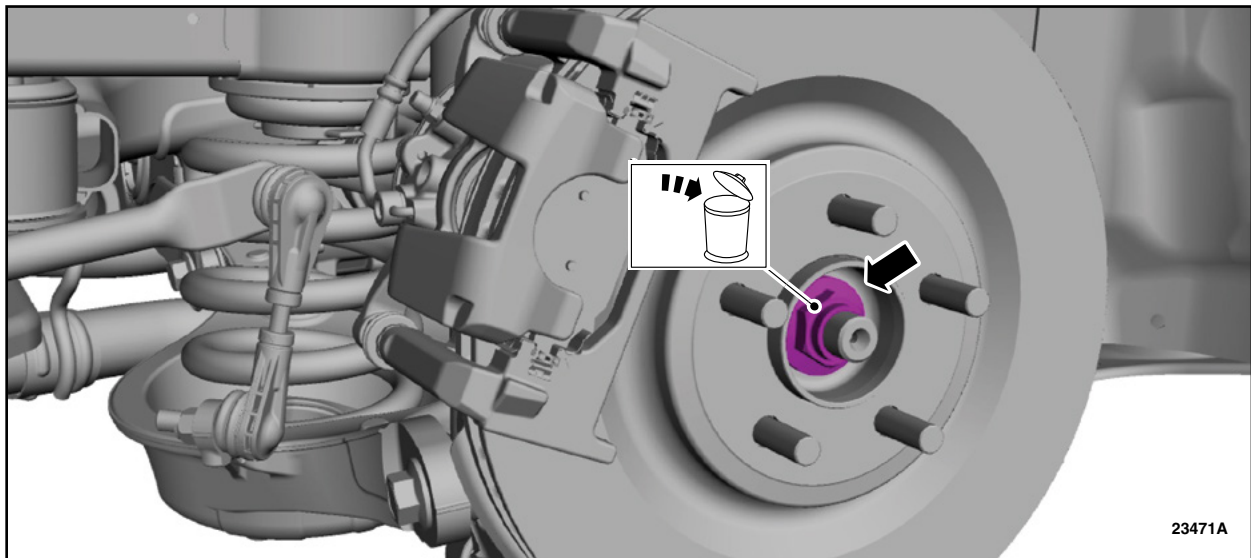
FIGURE 2

5. Remove and discard the LH rear wheel hub nut. See Figure 2.

- Torque: 300 Nm (221 lb.ft).

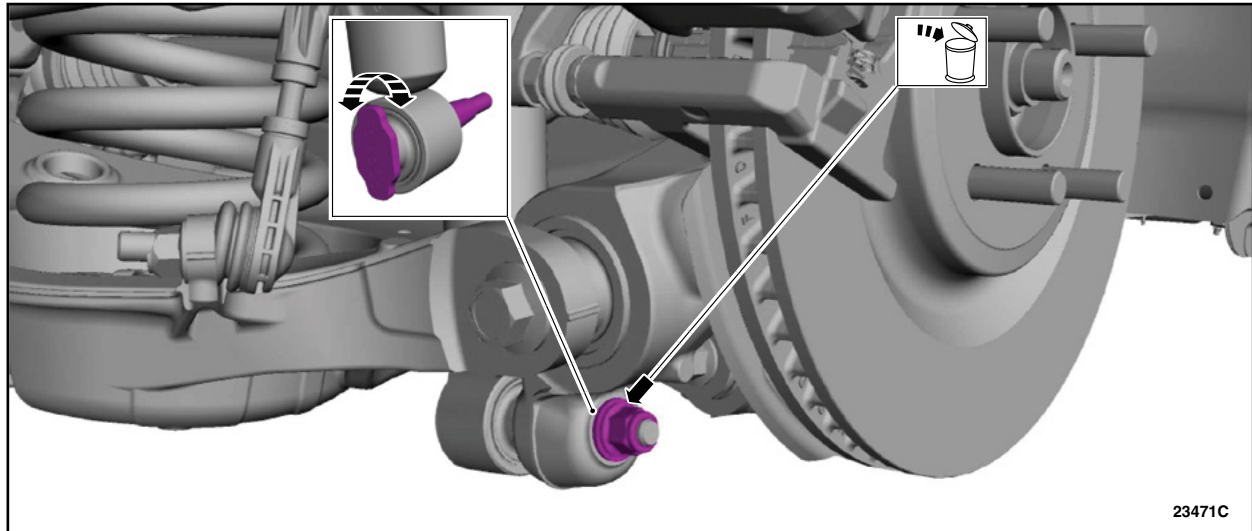
FIGURE 3

7. Remove and discard the rear shock absorber lower nut. See Figure 3.

• *Torque: 80 Nm (59 lb.ft).*

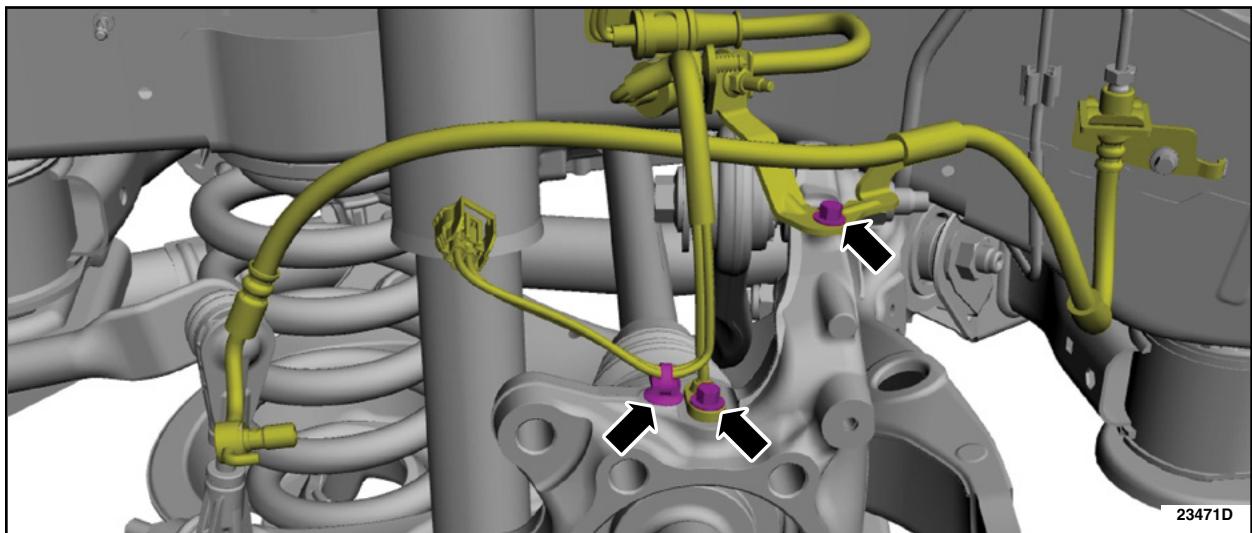
FIGURE 4

8. Remove the wheel speed sensor bolt and position the wheel speed sensor aside. Remove the brake hose bracket bolt and position the brake hose bracket aside. See Figure 4.

- Brake hose bracket bolt torque: 15 Nm (133 lb.in).
- Wheel speed sensor bolt torque: 15 Nm (133 lb.in).

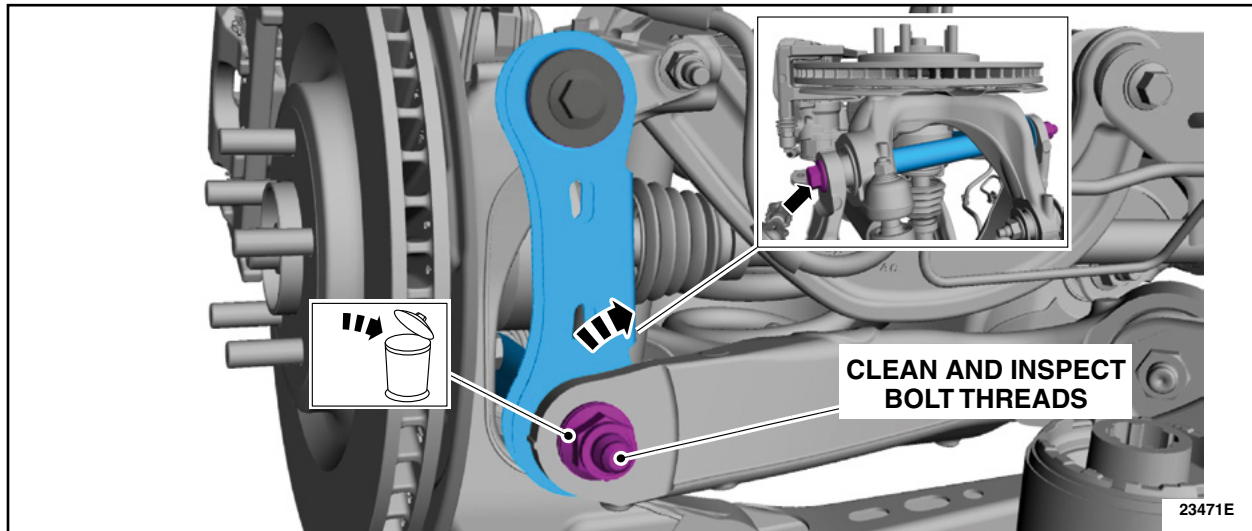
FIGURE 5

9. Remove and discard the lower arm vertical link lower nut. Remove, clean and inspect the lower arm vertical link lower bolt threads. If the threads are not damaged, apply LOCTITE® 263™, or equivalent (Obtain locally), and reuse the bolt and order a *new* nut. If the threads are damaged order a *new* nut and bolt. Position the lower arm vertical link bolt aside. See Figure 5.

• Torque: 350 Nm (258 lb.ft).

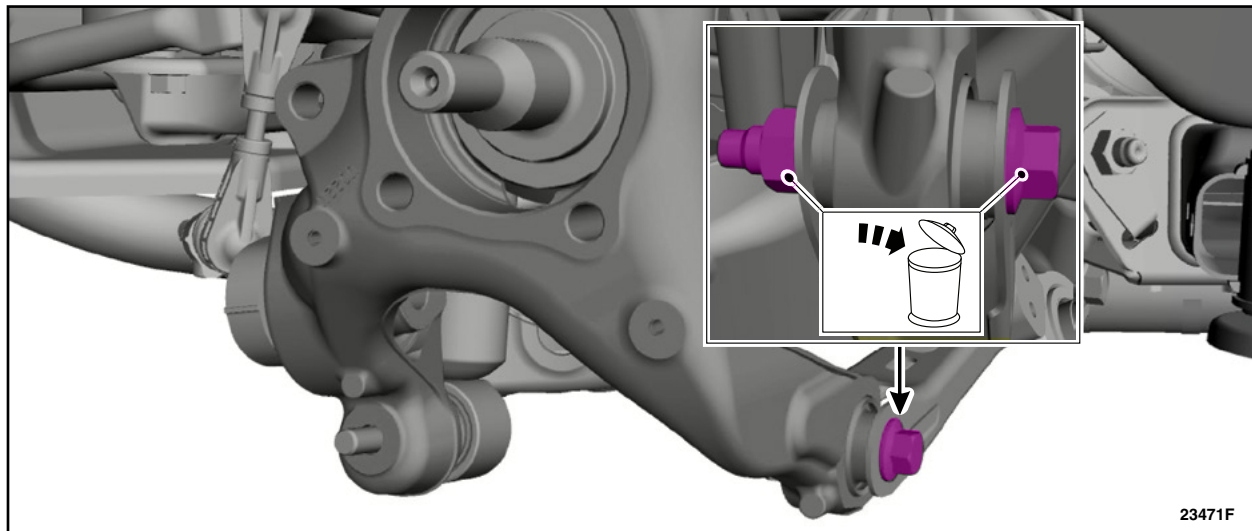
FIGURE 6

10. Remove and discard the toe link-to-wheel knuckle bolt and nut. See Figure 6.

• Torque: 175 Nm (129 lb.ft).

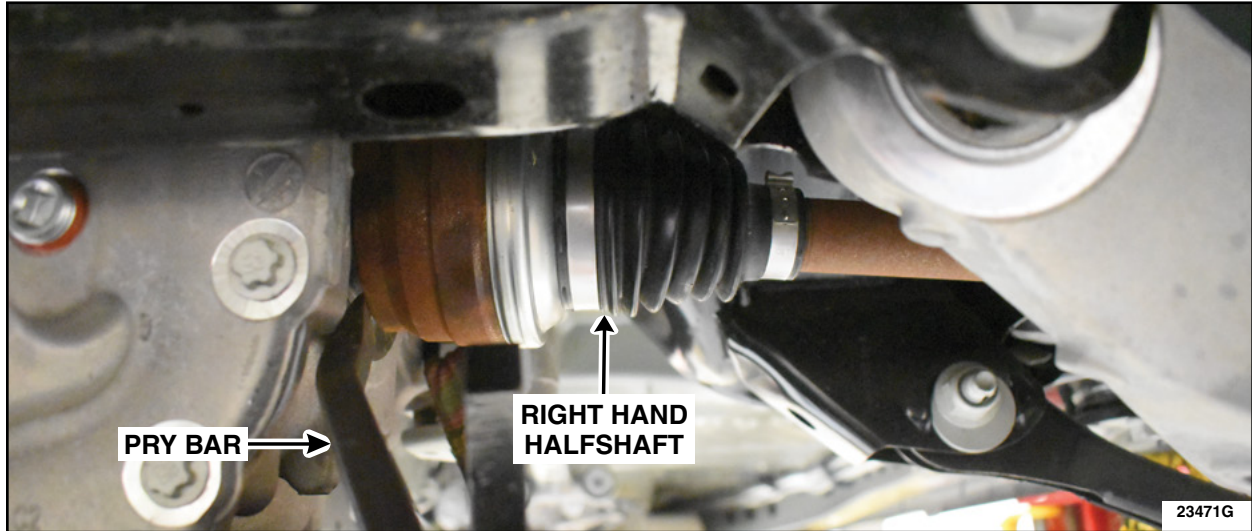
FIGURE 7

13. Using a pry bar, disengage the Right Hand (RH) halfshaft inner halfshaft cir-clip. See Figure 7.

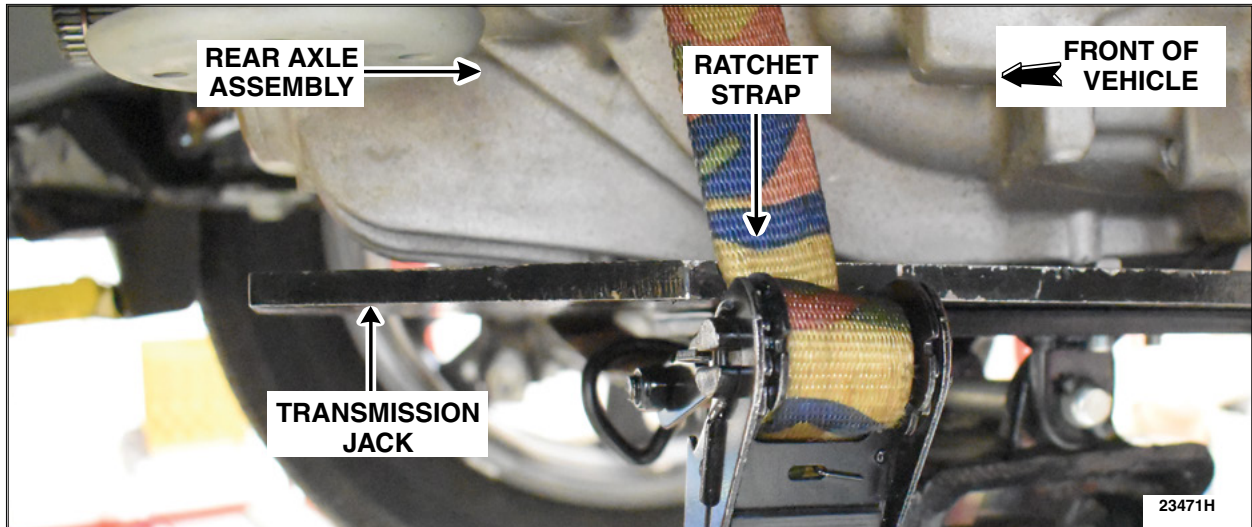
FIGURE 8

14. Secure the rear axle assembly to the transmission jack using a ratchet strap. See Figure 8.

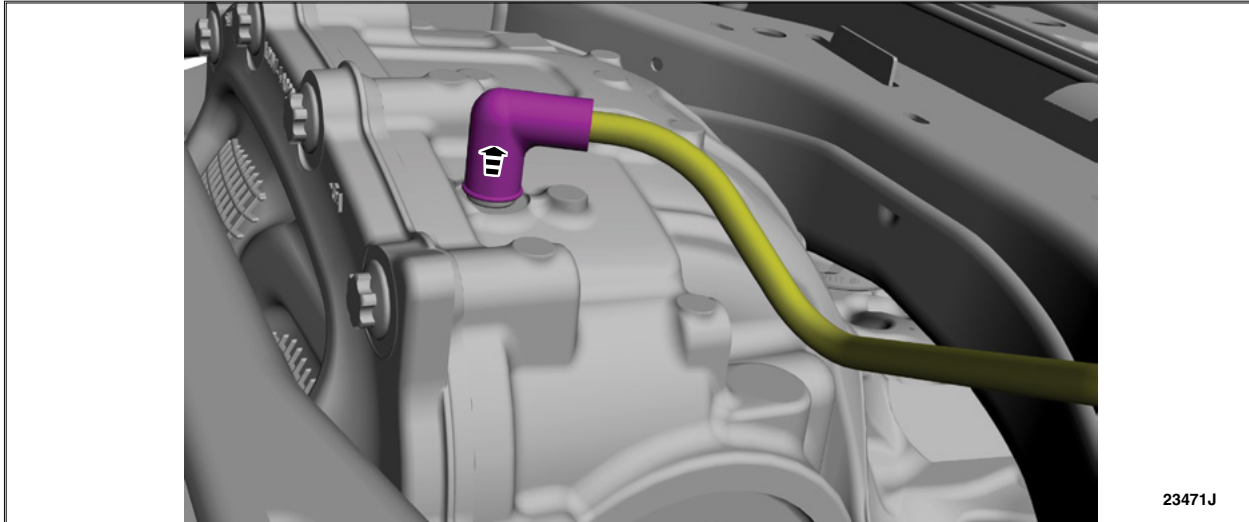
FIGURE 9

16. Disconnect and position the axle assembly vent hose aside. See Figure 9.

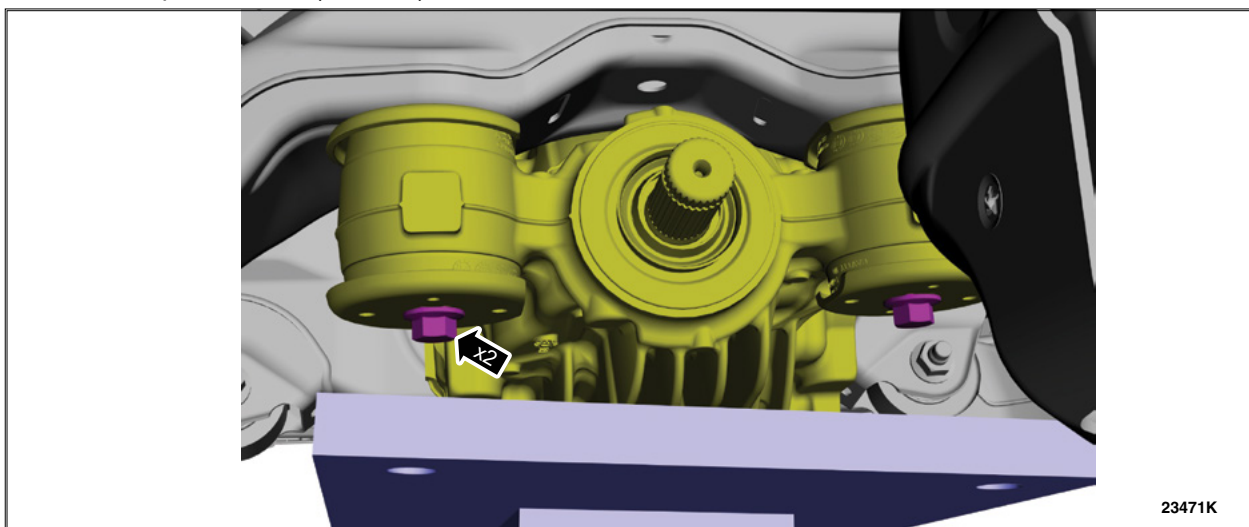
FIGURE 10

NOTE: In the next Step, clean and inspect both of the rear axle housing support bolt threads. If the threads are not damaged, apply LOCTITE®263™, or equivalent (Obtain locally), and reuse both bolts. If the threads are damaged order *new* bolt(s).

17. Remove the rear axle housing support front bolts. See Figure 10.

- Torque: 175 Nm (129 lb.ft).

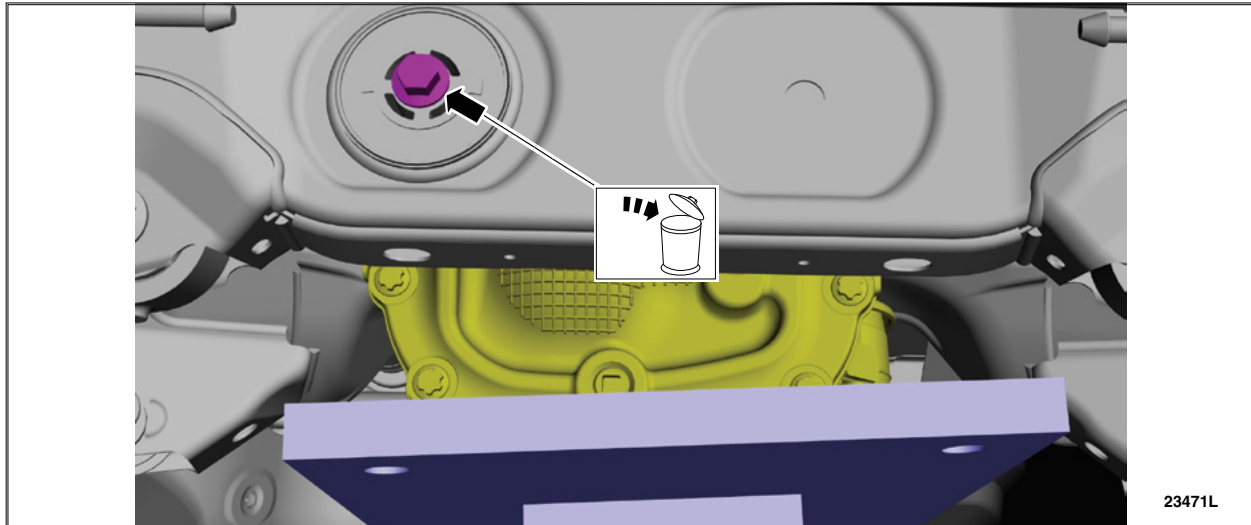
FIGURE 11

18. Remove and discard the rear axle housing support rear bolt. See Figure 11.

Stage 1: Torque to: 100 Nm (74 lb.ft).

Stage 2: Tighten an additional: 100°

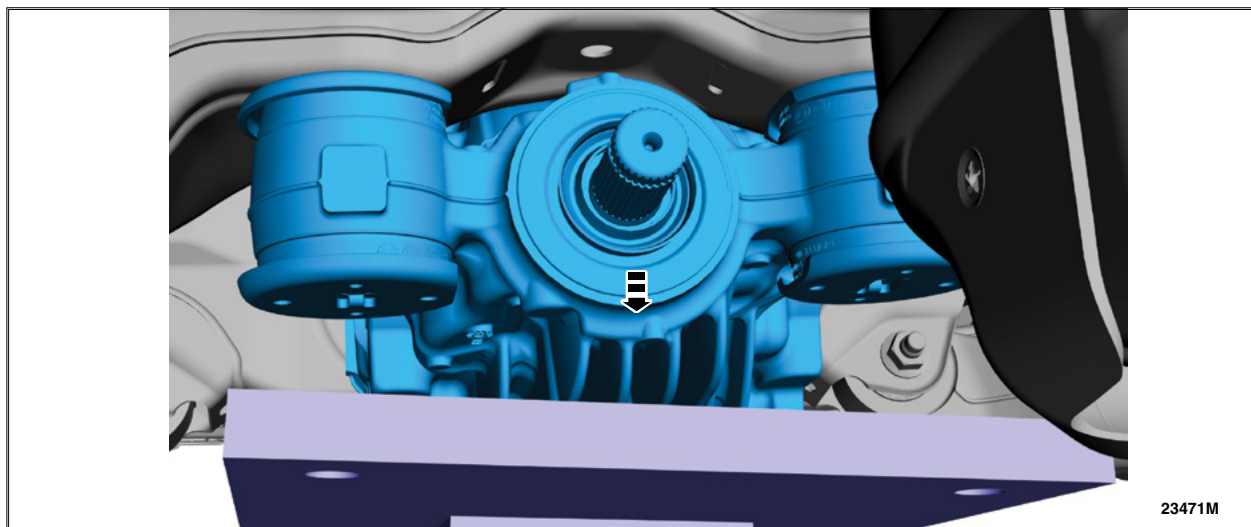
FIGURE 12

19. Gently let down the transmission jack and remove the rear axle assembly. See Figure 12.
Use the General Equipment: Transmission Jack.

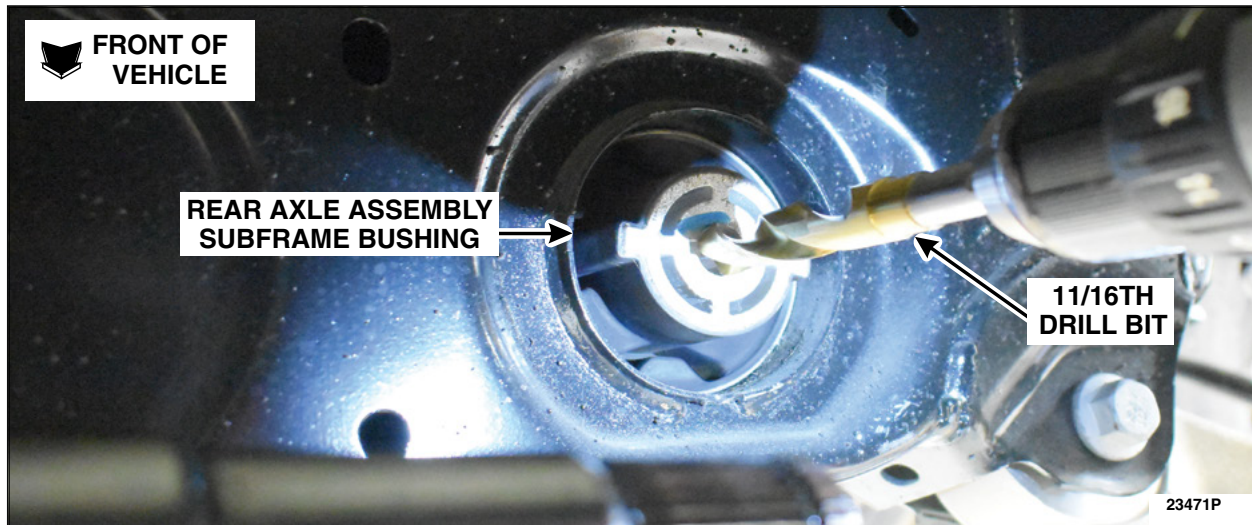
FIGURE 15

23. Using an 11/16th or larger drill bit drill out the rear axle assembly subframe bushing bolt hole. See Figure 15.

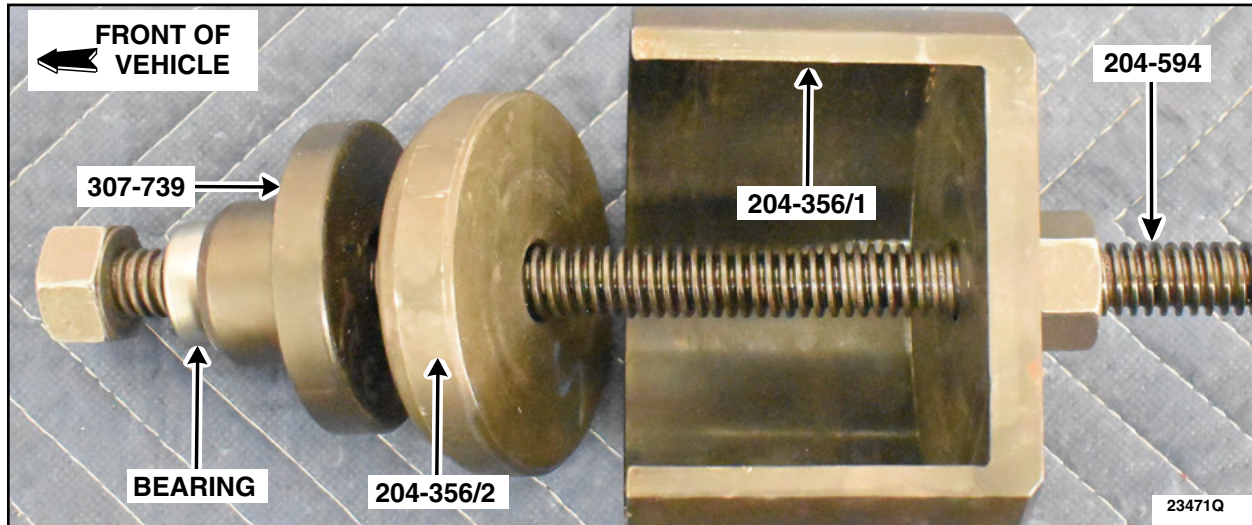
FIGURE 16

24. Using the Special Service Tool: 204-594 Forcing screw, 204-356/1 Remover/Installer, Radius Arm Axle Bushing, 204-356/2 Remover/Installer, Radius Arm Axle Bushing, 307-739 Installer, R3 Bearing, and 205-153 Adapter for 303-224 (Handle) and press out the rear axle assembly subframe bushing. See Figure 16.

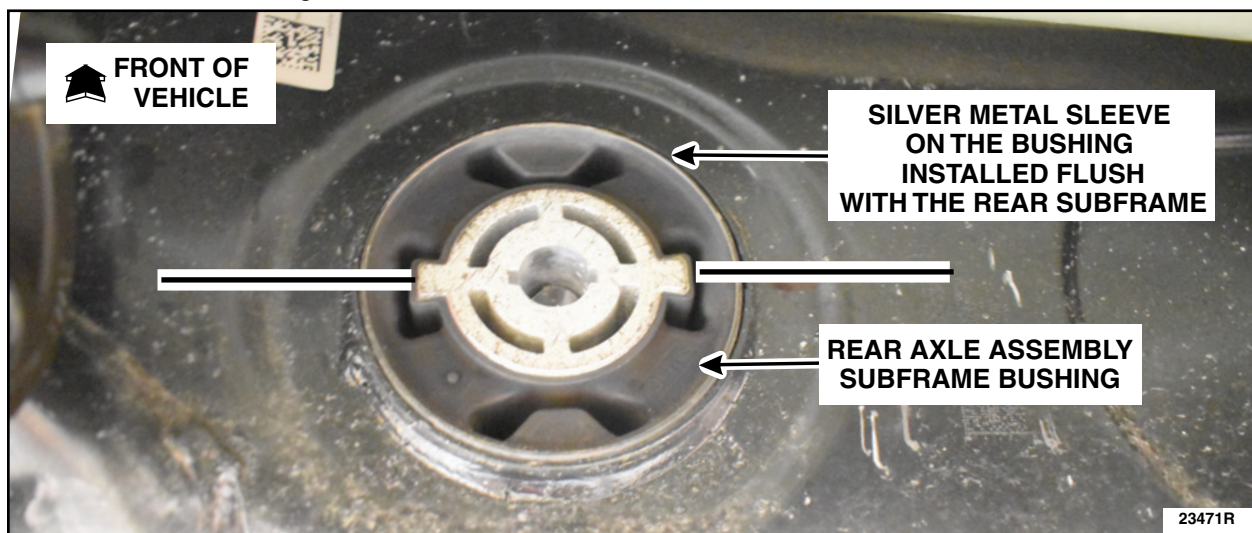
FIGURE 17

NOTE: Make sure the tabs on the *new* rear axle assembly subframe bushing are horizontal with the subframe. See Figure 17.

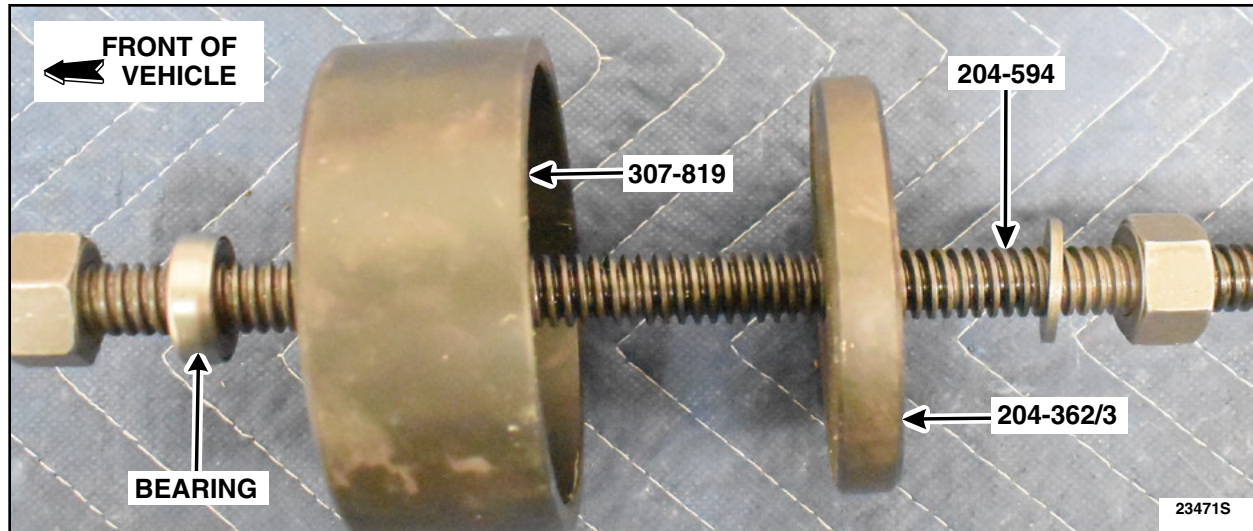
FIGURE 18

25. Install the *new* rear axle assembly subframe bushing using the Special Service Tool: 204-594 Forcing screw, 204-362/3 Remover/Installer, Front Subframe Bushing, and 307-819 Cup, Receiver.
See Figure 18.
