TO: Mercedes-Benz Dealer Principals, General Managers, Sales Managers, Service Managers, Parts Managers	FROM: Gregory Gunther, Senior Manager, Vehicle Compliance and Analysis, Engineering Services
RE: <b>Recall Campaign Launch Notification</b> <b>Inspect 12V Starter/Alternator Wiring Harness</b> <b>MY22-23 SL (232 platform)</b>	DATE: November 3, 2023

Campaign No. 2023100014, November 2023

SUBJECT: **Model SL (232 platform)**  
**Model Year 2022-2023**

## **Inspect 12V Starter/Alternator Wiring Harness**

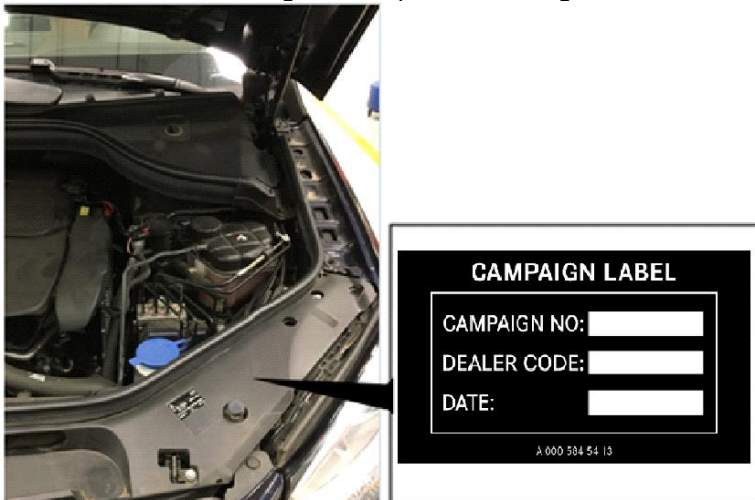
**Figure 1**

Apply Proof of Correction Label (A 000 584 54 13) to area identified in **Figure 1**. Fill in the blank areas of the label. The campaign number for the California Proof of Correction is unique and must be entered as such (**231014**), your dealer code, and the date of the repair, using a black permanent marker.

**i** Note: Clean bonding surface prior to affixing label.
