## IMPORTANT SAFETY RECALL

**NHTSA Recall Number:** 23V216

**Altec Identifier:** CSN-3064

# CUSTOMER SERVICE NOTICE CSN-3064-A

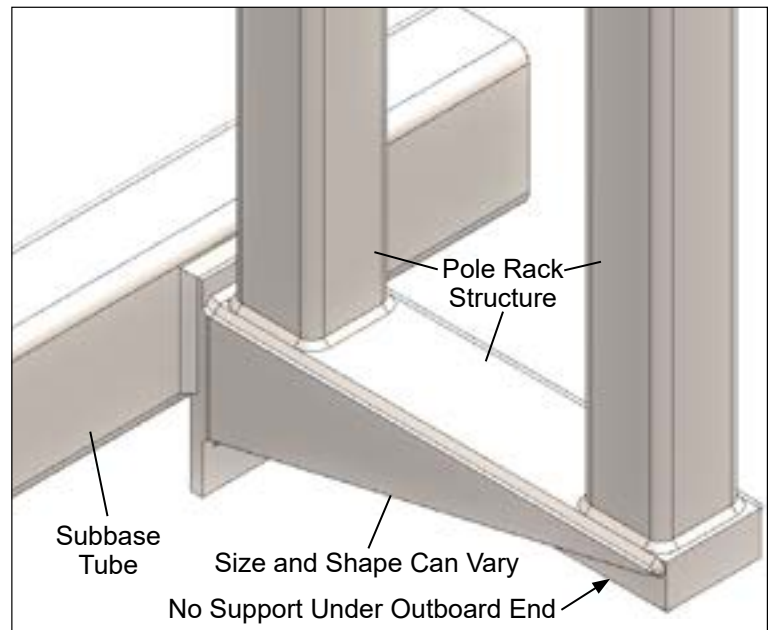
**Figure 2 — Cantilevered Rear Pole Rack Example**

3. Look under the unit to determine the mounting method of the rear pole rack(s).
  - If the pole rack uses a cantilevered mounting, which is welded to the side of the subbase tube and projects outward with no support structure at the outboard end (refer to Figure 2 for an example, but the shape can vary greatly), proceed to step 4.
  - If the pole rack does not use a cantilevered mounting, proceed to step 6.
