Recall Number:	23E-008	
Product:	Global Latch	Labor F
Date:	Original: 02.23.2023   Revision: 04.13.2023

**NOTE:** This document supersedes the previously-released version dated 02.23.2023. The new section includes preliminary procedures for the inside latch assembly part replacement.

This section of document refers to the replacement of the inside latch assembly of the complete door lock assembly with latch on certain motorized entry doors. A portion of the latch is breaking off when attempting to exit the coach. The instructions are applicable to using a replacement inside latch assembly PN 2023005033 for the 920 Series door and inside latch assembly PN 2022010407 for the 3500 Series door.

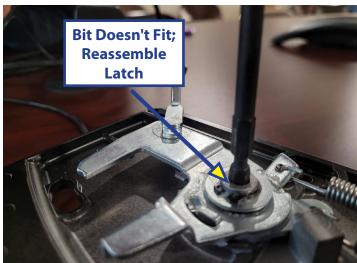
Fig. 5

- 1. Using a 1/4" screwgun bit, try to insert the bit into the spun rivet of the inside latch assembly (Fig. 5).
- **2.** If bit fits into rivet opening there are two options:
  - **A.** Replace the complete latch assembly, including both inside and outside latch assemblies.
  - **B.** Replace just the inside latch assembly to be combined with current outside latch assembly.
- **3.** If the bit does not fit, no action is required. Proceed to latch reassembly instructions.
