Recall Number:	23E-008		
Product:	Global Latch		
Date:	02.23.2023	Labor Rate:	Inspection Only - 0.3 Hour/Inspect & Replace - 0.7 Hour

Preliminary procedures for inside latch assembly part replacement

This section of document refers to the replacement of the inside latch assembly of the complete door lock assembly with latch on certain motorized entry doors. A portion of the latch is breaking off when attempting to exit the coach. The instructions are applicable to using a replacement inside latch assembly PN 2023005033 for the 920 Series door and inside latch assembly PN 2022010407 for the 3500 Series door.

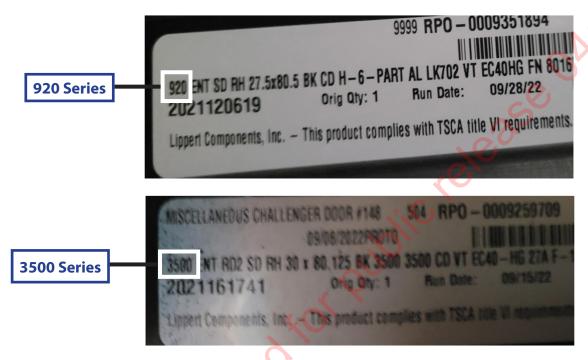
Determine Correct Latch Assembly Part

The replacement latch assembly part is determined by the serial number on the door tag. Replacement inside latch assembly for the 920 Series door is PN 2023005033. Replacement inside latch assembly for the 3500 Series door is PN 2022010407.
