SAFETY RELATED RECALL

Global Recall Action Number: N763v3

Camshaft Carrier Drill Hole

Publication No.: N763v3 Model: Range Rover (LK) Model Year: 2023 Model: Range Rover Sport (L1) Model Year: 2023 Model: Discovery (LR) Model Year: 2022 - 2023 Model: Defender (LE) Model Year: 2020 - 2023 Model: Range Rover Velar (LY) Model Year: 2023 - 2024 Model: Range Rover (LG) Model Year: 2020 - 2022 Model: Range Rover Sport (LW) Model Year: 2019 - 2022 Date of Issue: 18 May 2023

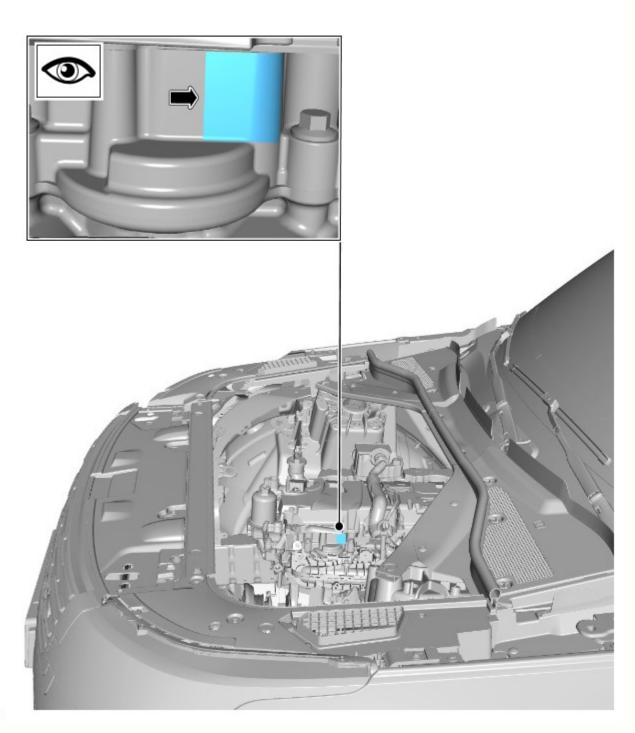
E323282

- 3. Inspect the camshaft carrier tooling stamp using steps 4 to 7 below for reference.
 - The 3 illustrations below show 3 INDIVIDUAL failure conditions.
 - If ANY of the 3 INDIVIDUAL failure conditions are present, then the vehicle has failed the inspection.
 - If NONE of the 3 INDIVIDUAL failure conditions are present, then the vehicle has passed the inspection.
 After completing the SERVICE INSPECTION, continue to
 - the SERVICE INSTRUCTION below.
- 4. Steps 5, 6 and 7 show 3 INDIVIDUAL failure conditions.
