RSB 597
April 28, 2023

NHTSA #23V 138
TC #2023-110

RECALL SERVICE BULLETIN

GLOBAL ENTRY DOOR LATCH INSPECTION/ REPLACEMENT INSTRUCTIONS *MOTORIZED UNITS ONLY

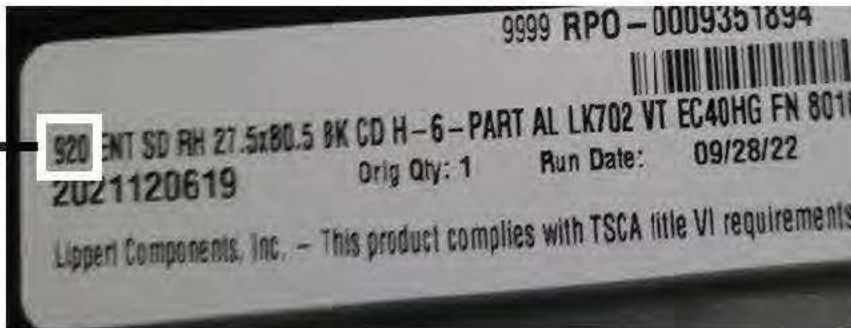
The replacement latch assembly part is determined by the serial number on the door tag. Replacement inside latch assembly for the 920 Series door is PN 2023005033. Replacement inside latch assembly for the 3500 Series door is PN 2022010407.

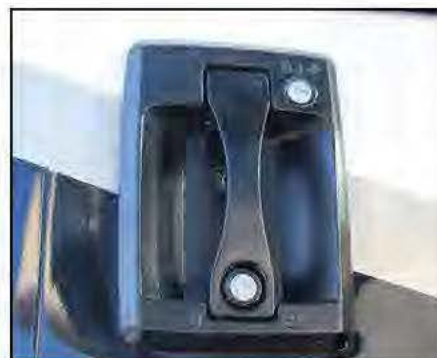
Inside Latch Assembly

The section of this document refers to the replacement of the complete door lock assembly with latch on certain motorized entry doors. A portion of the latch is breaking off when attempting to exit the coach. The complete door lock assembly with latch, PN 2021097898, is to be replaced with a redesigned part.
